Albania – Kosovo Highway

Nick Koor – Center for Applied Geosciences
University of Portsmouth

Geological Society – IOM³
8th April 2013

Client – loss adjuster – five failures during construction

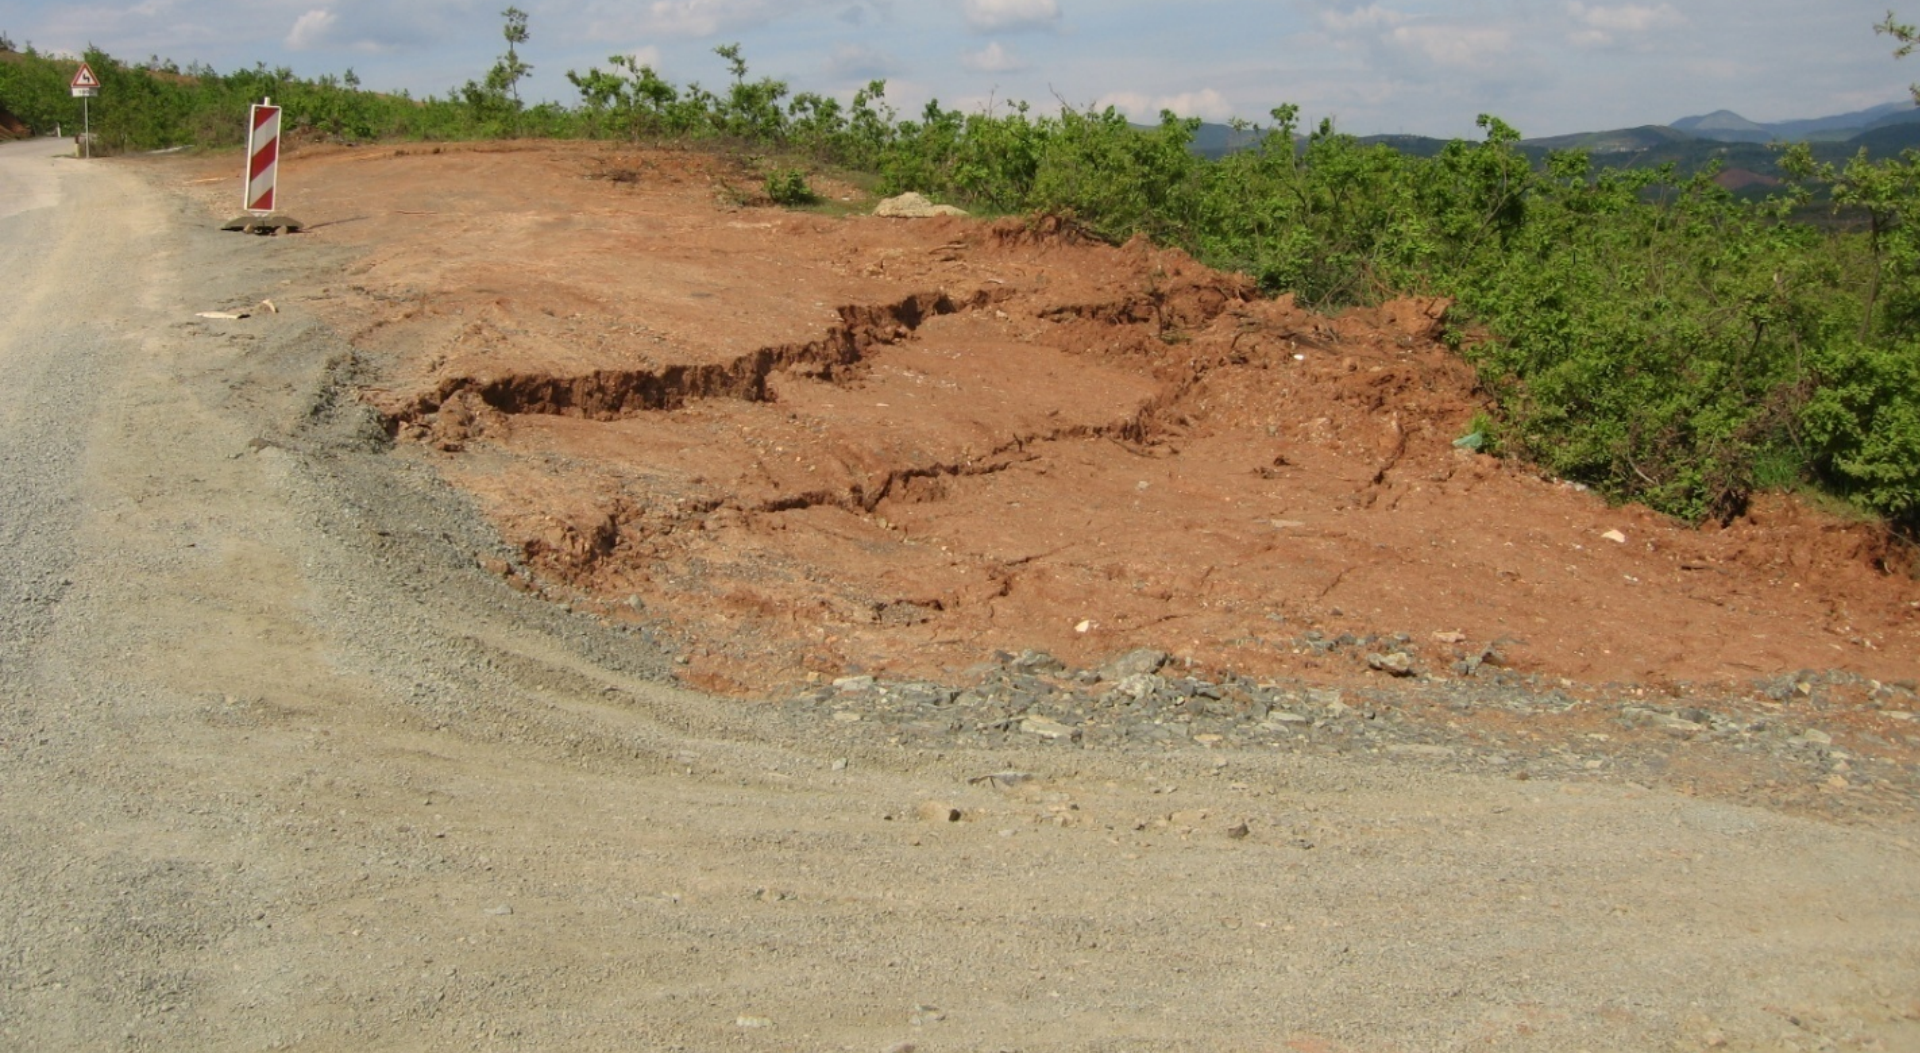
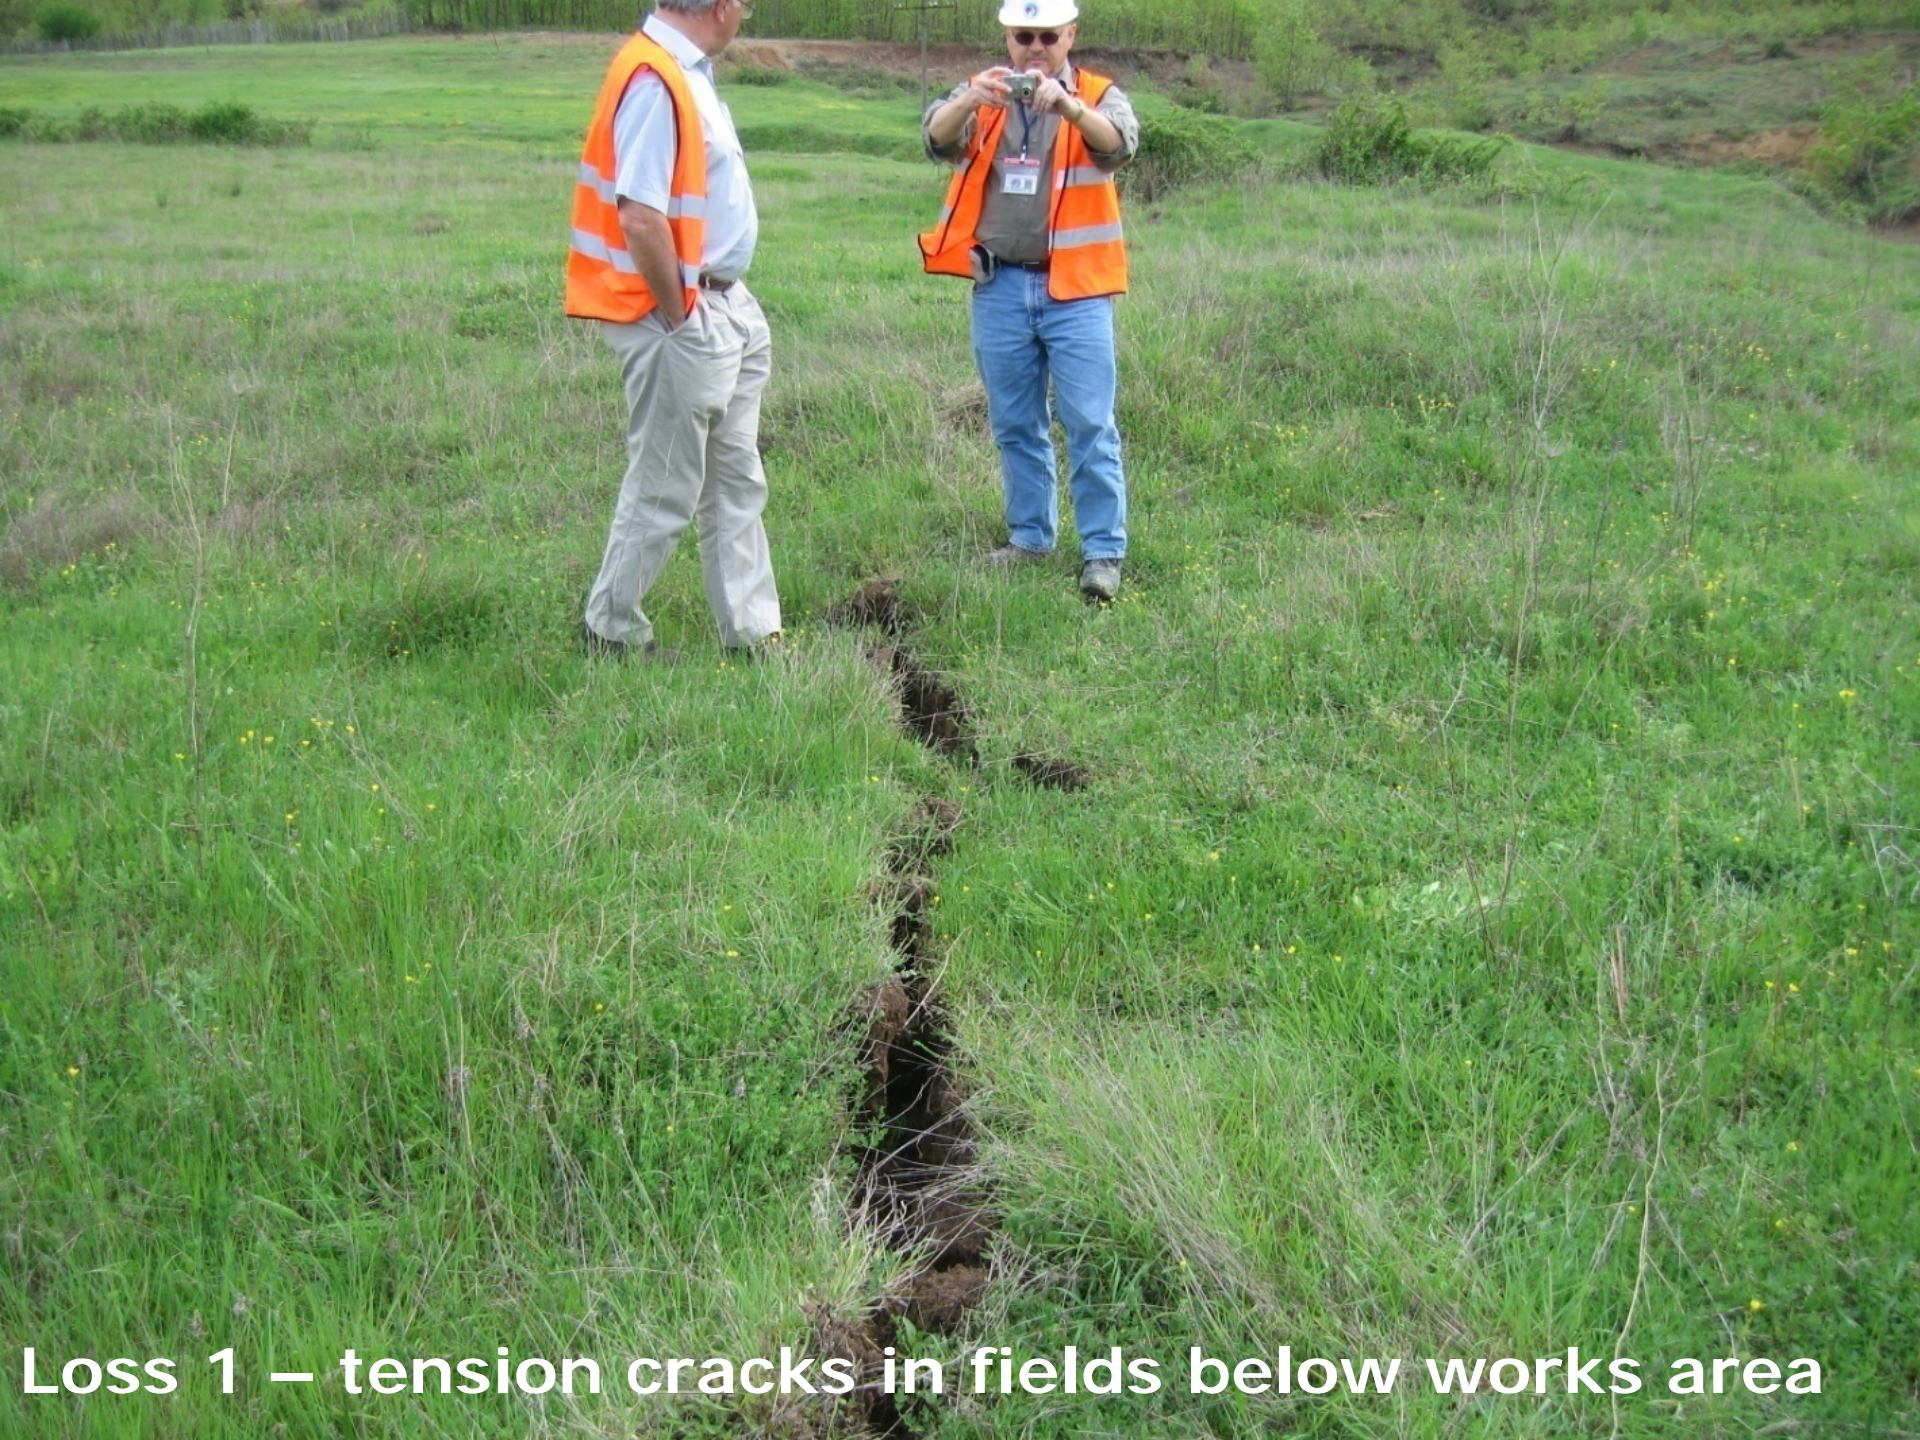
Loss 1 – movement up-slope adjacent to old Kosovo Road

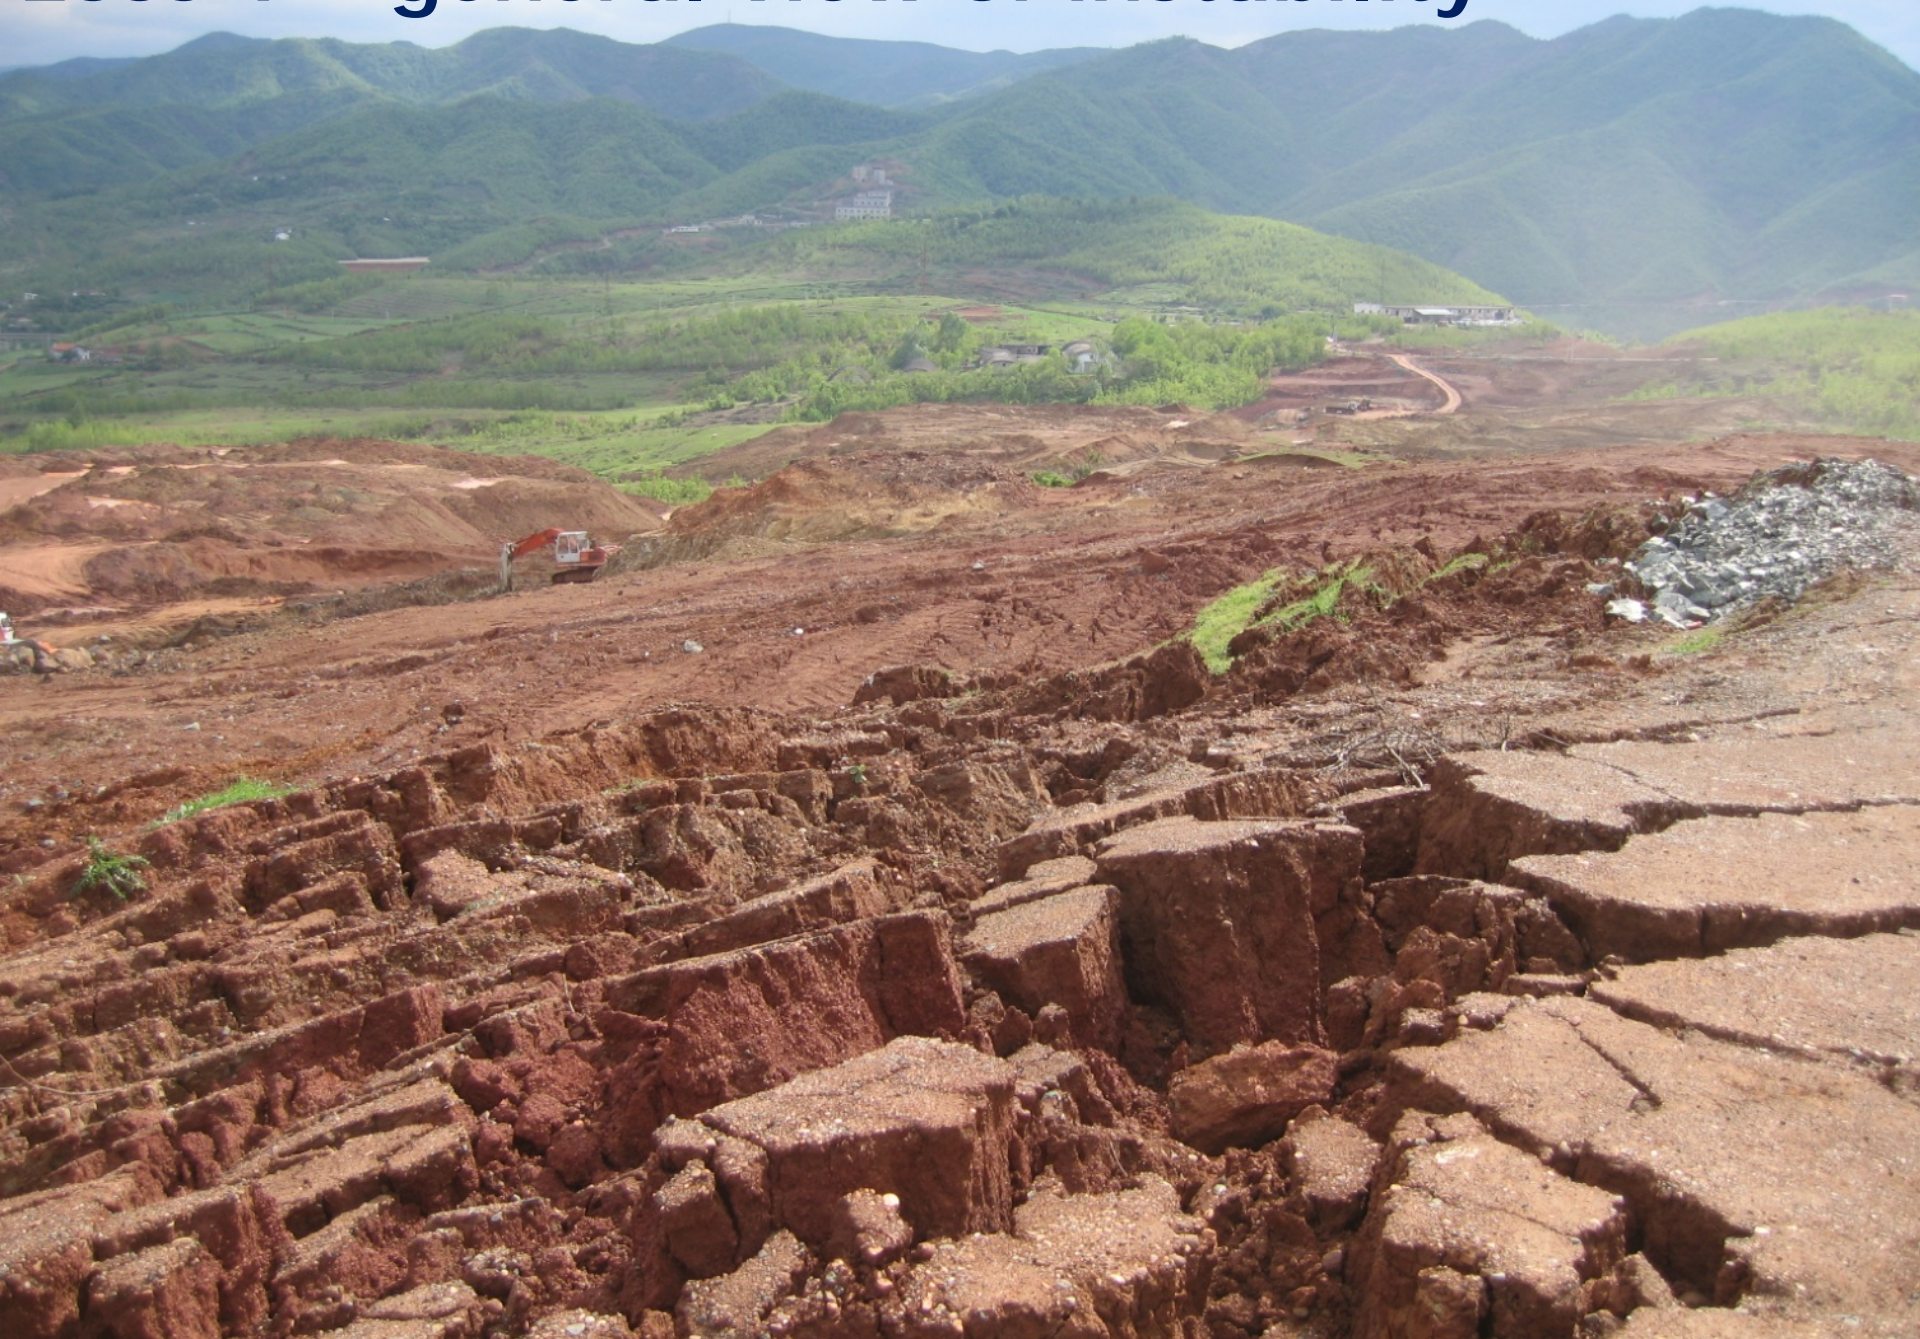
Loss 1 – tension cracks in fields below works area

Loss 1 – general view of instability

- Loss 1 – reactivation of translational slide – possibly periglacial in origin
- Loss 2 – cut through existing active large slope failure
- Loss 3 – cut slope formed in a failed rock mass – wedge failure

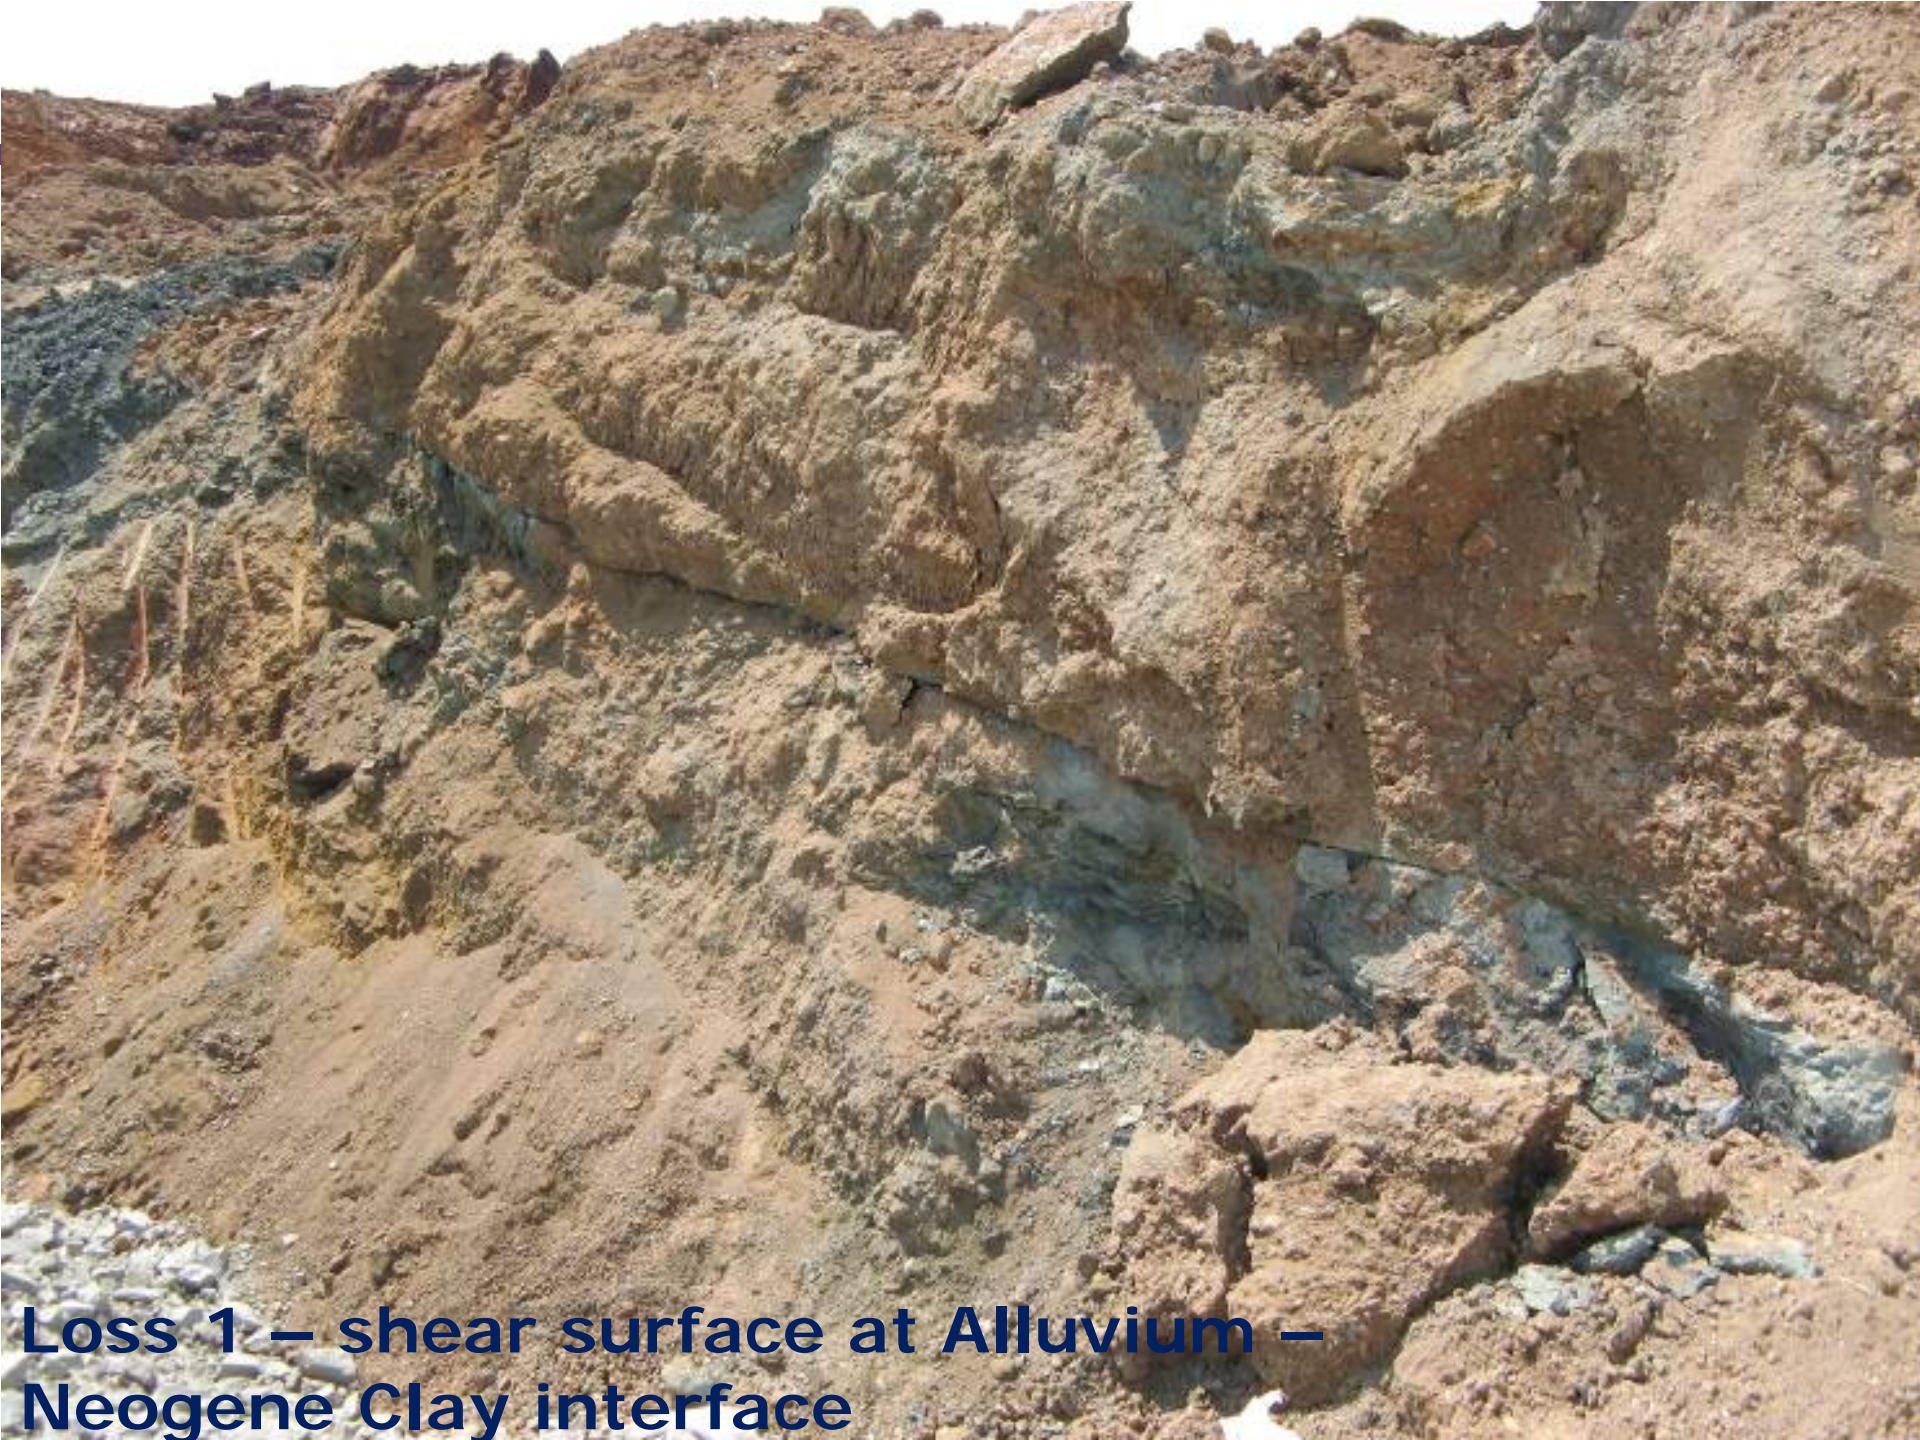
**Loss 1 – shear surface at Alluvium –
Neogene Clay interface**

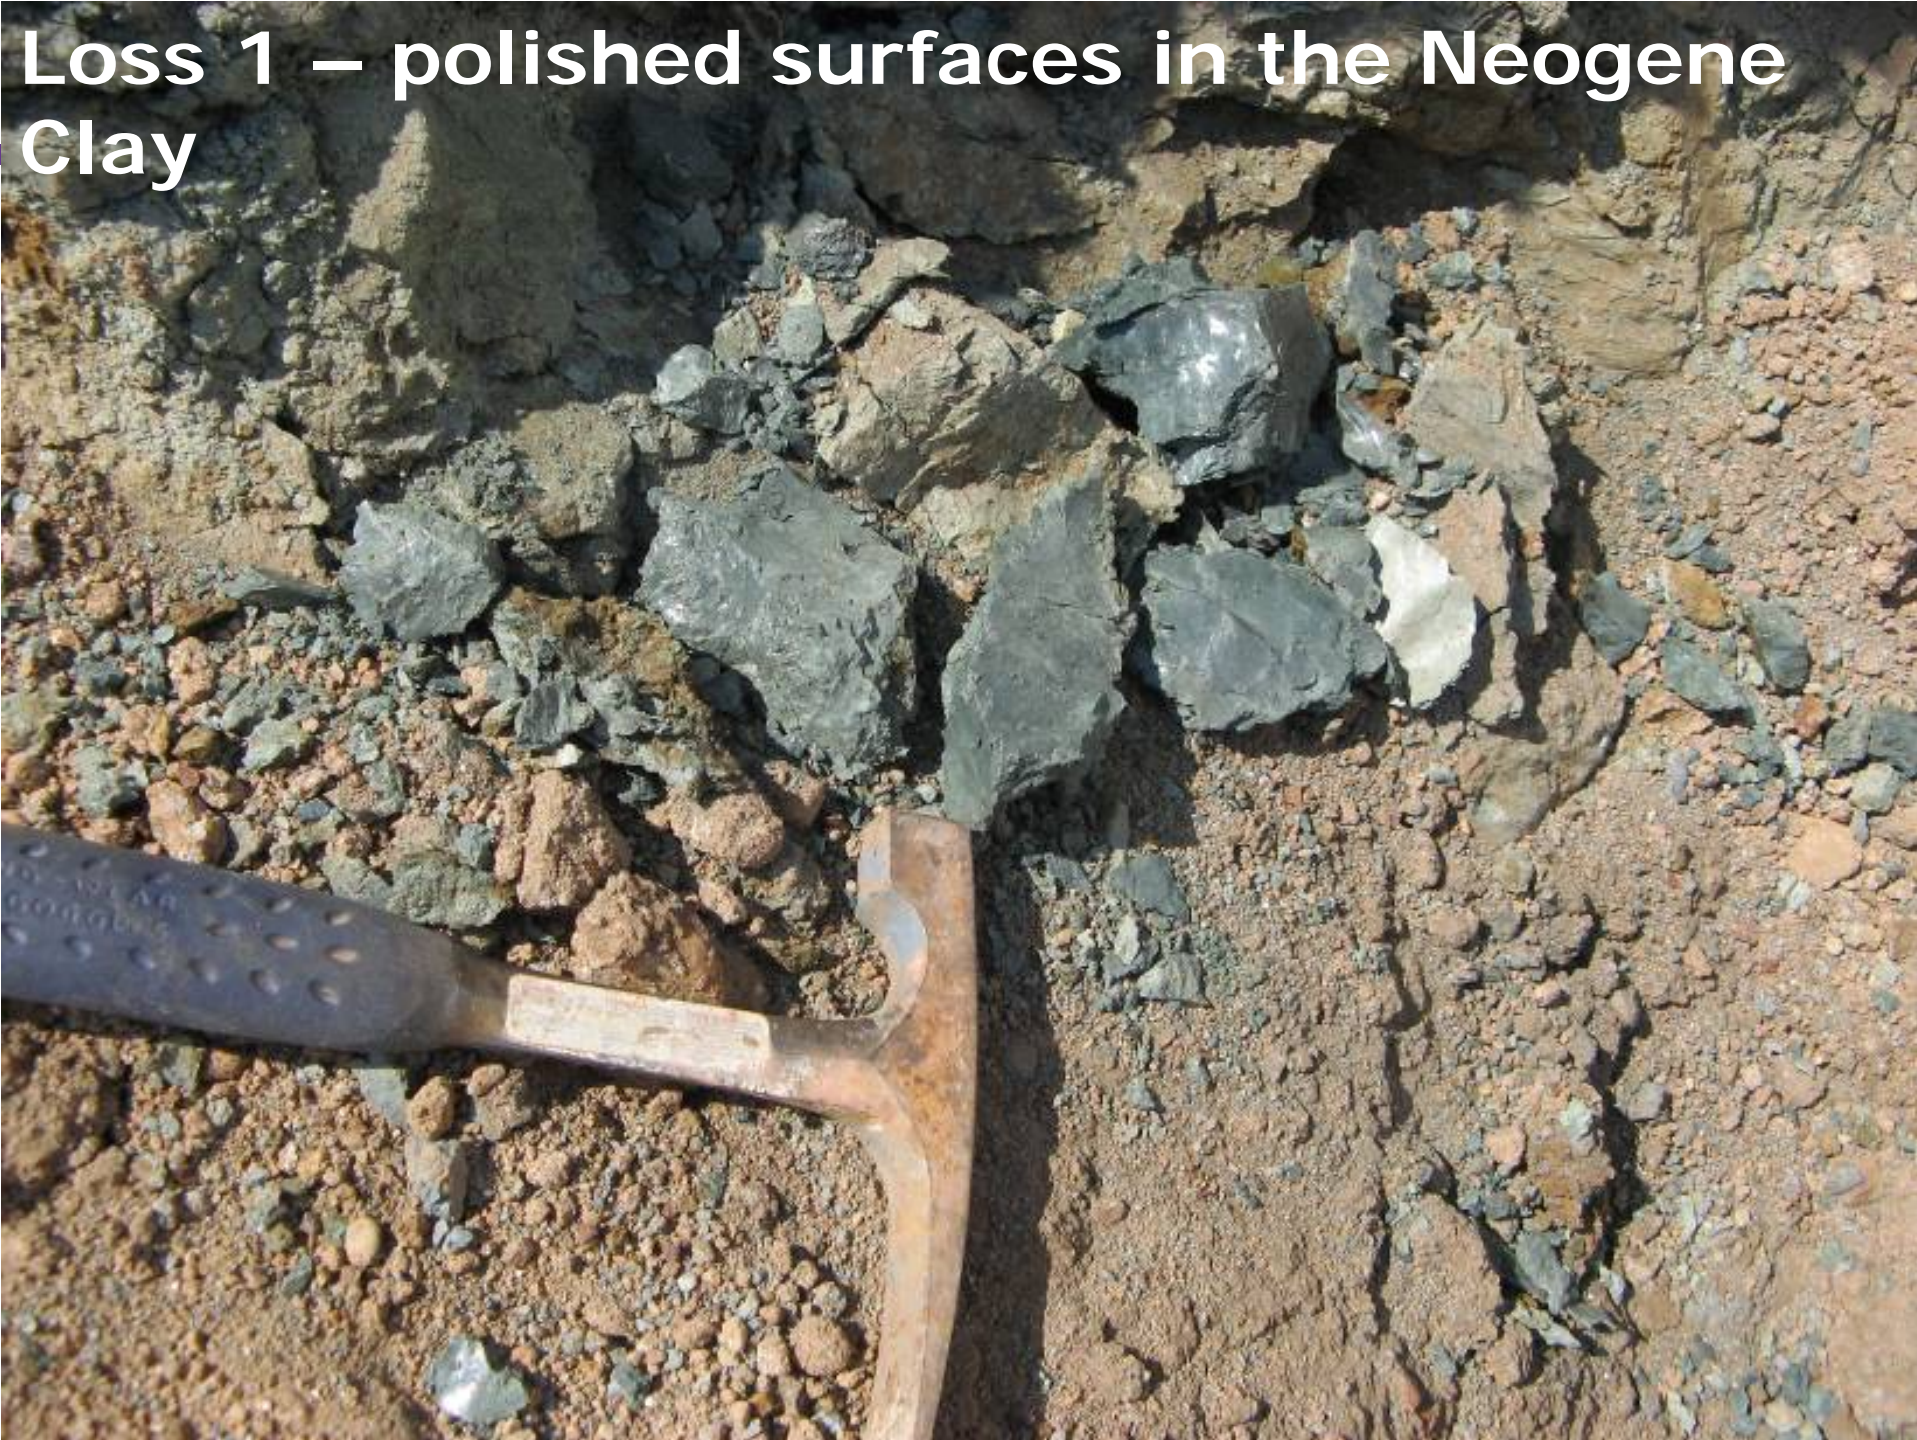
Loss 1 – polished surfaces in the Neogene Clay

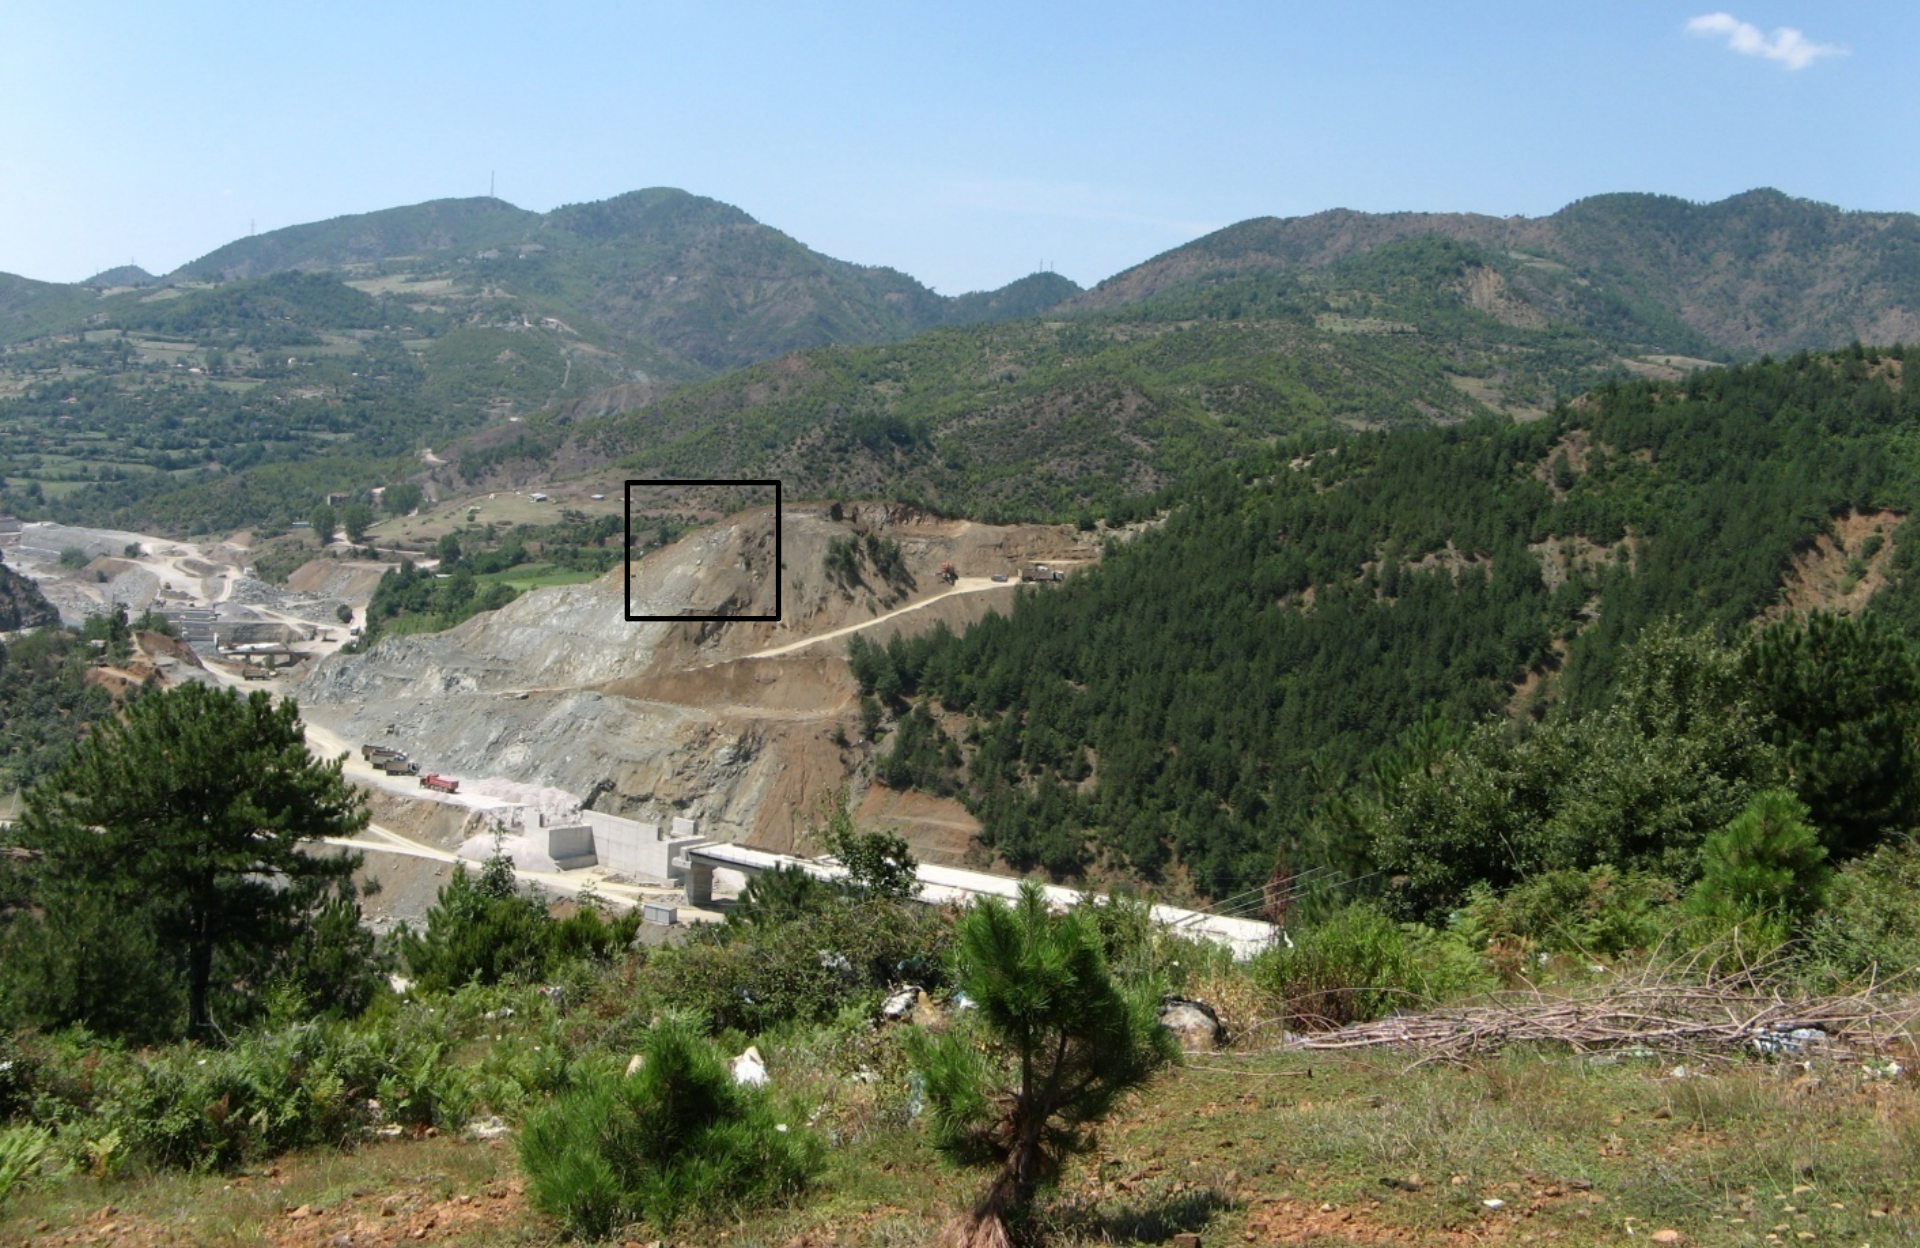
Bridge 1 from Reps – junction of Section 1 & 2 – Loss 2

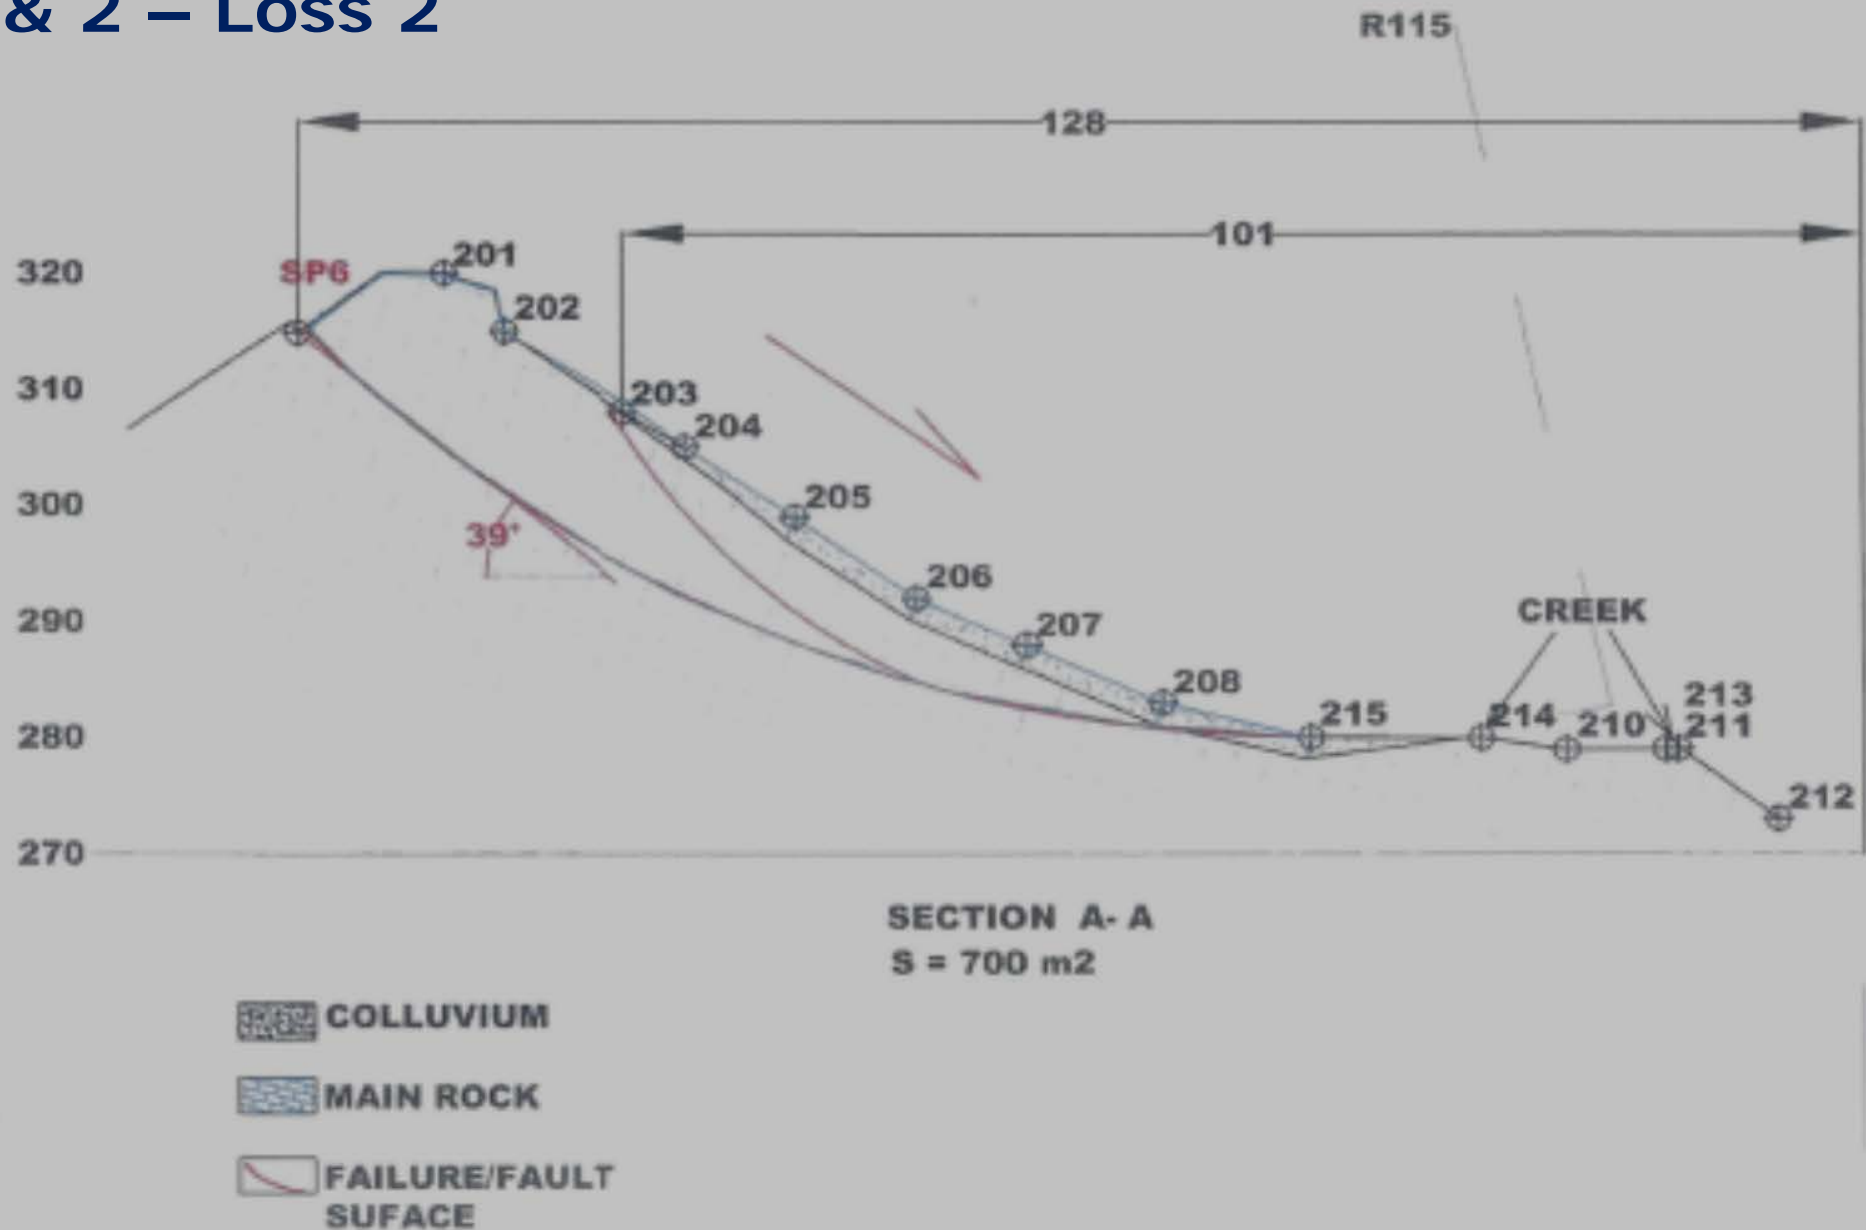
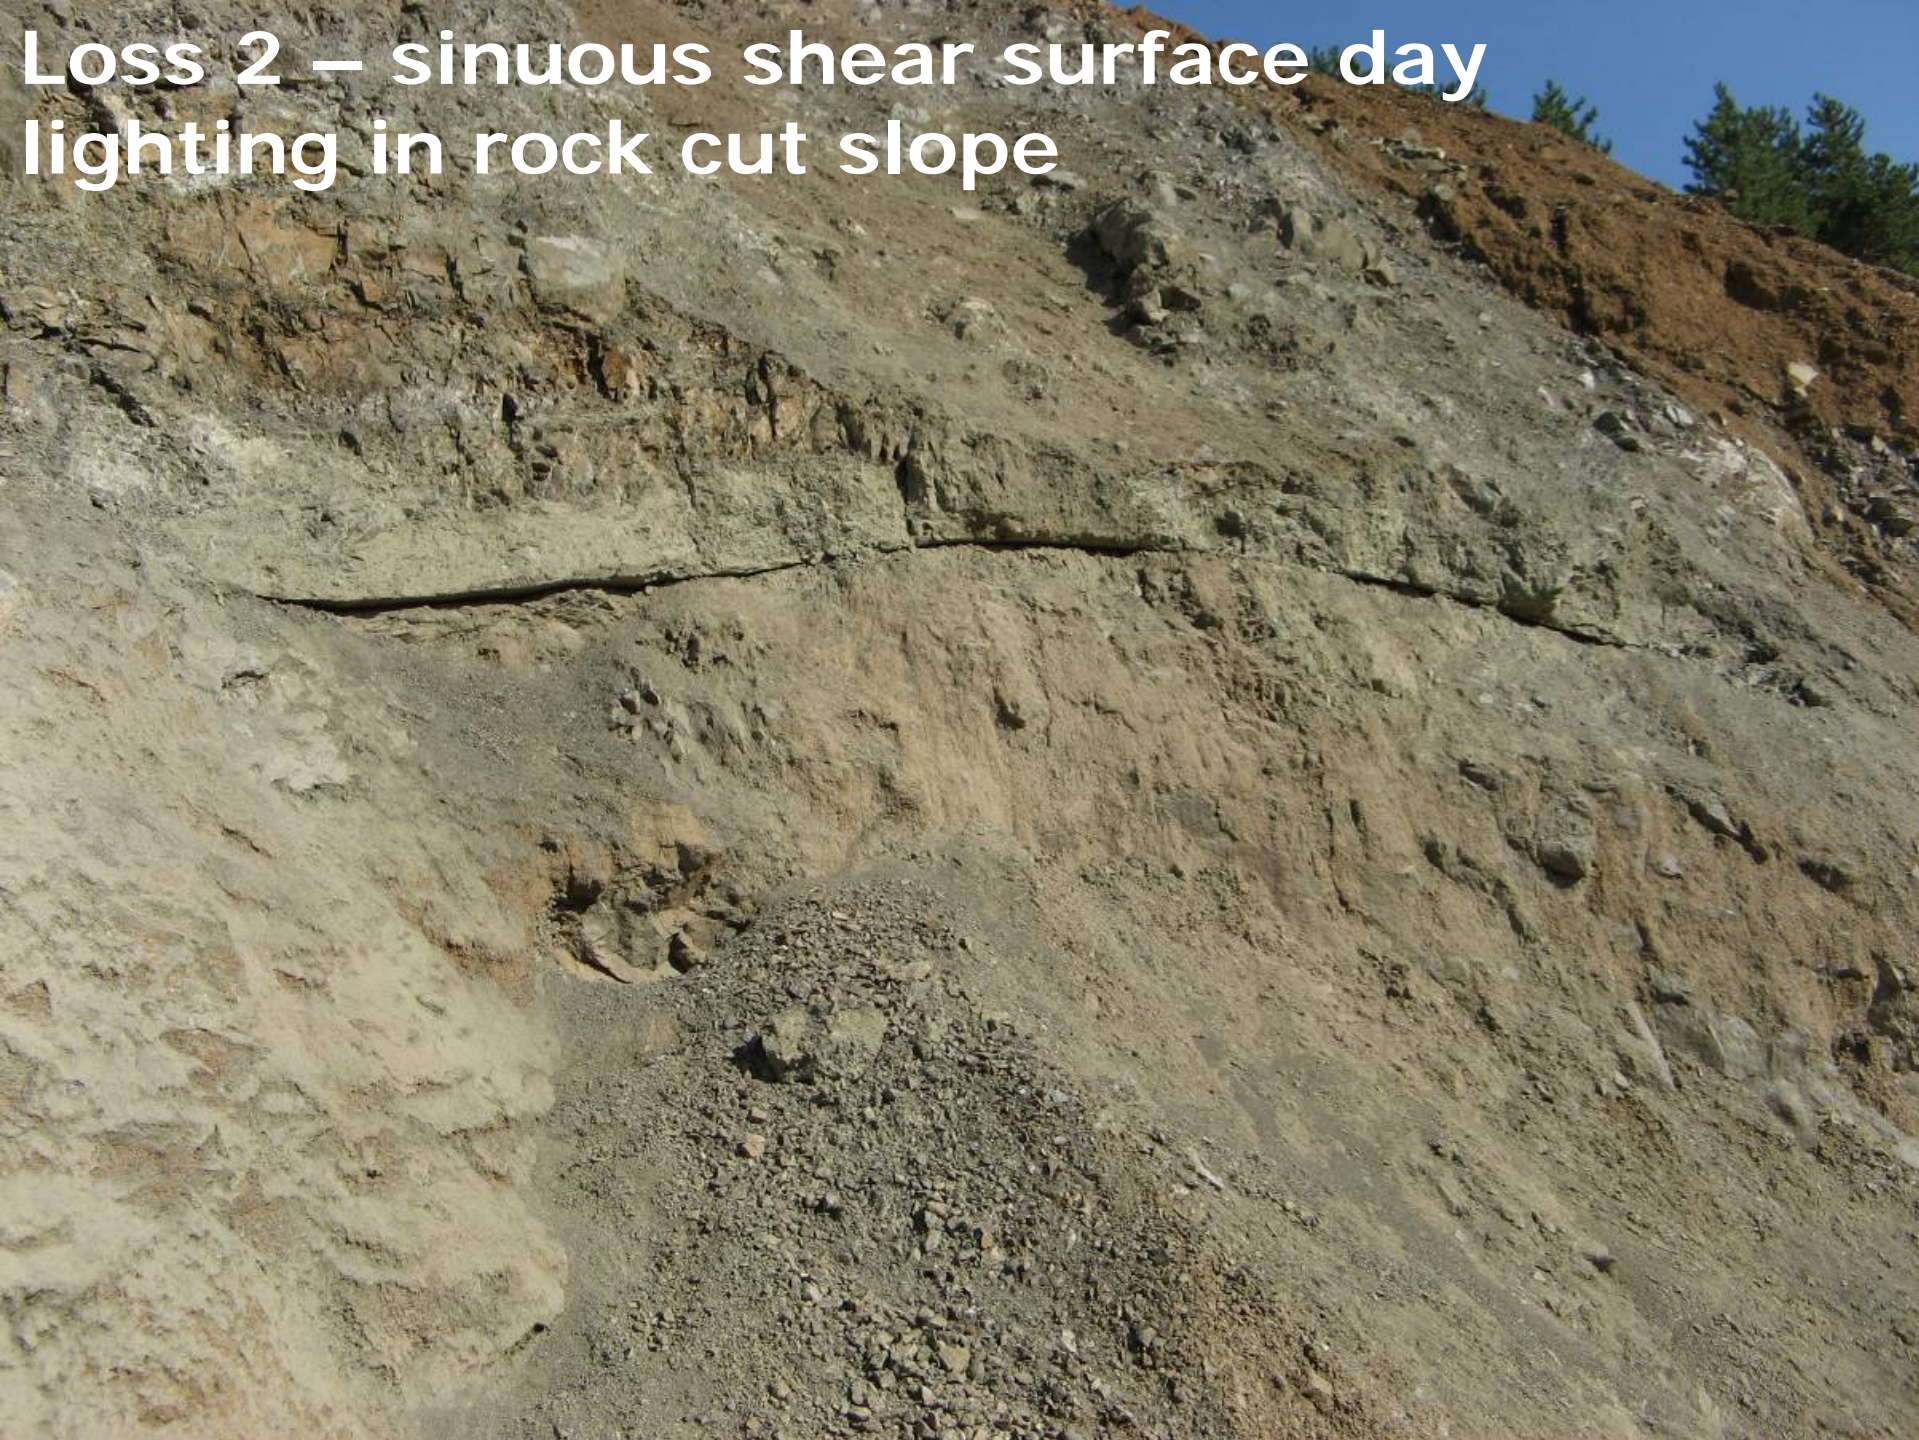
Bridge 1 from Reps – junction of Section 1 & 2 – Loss 2

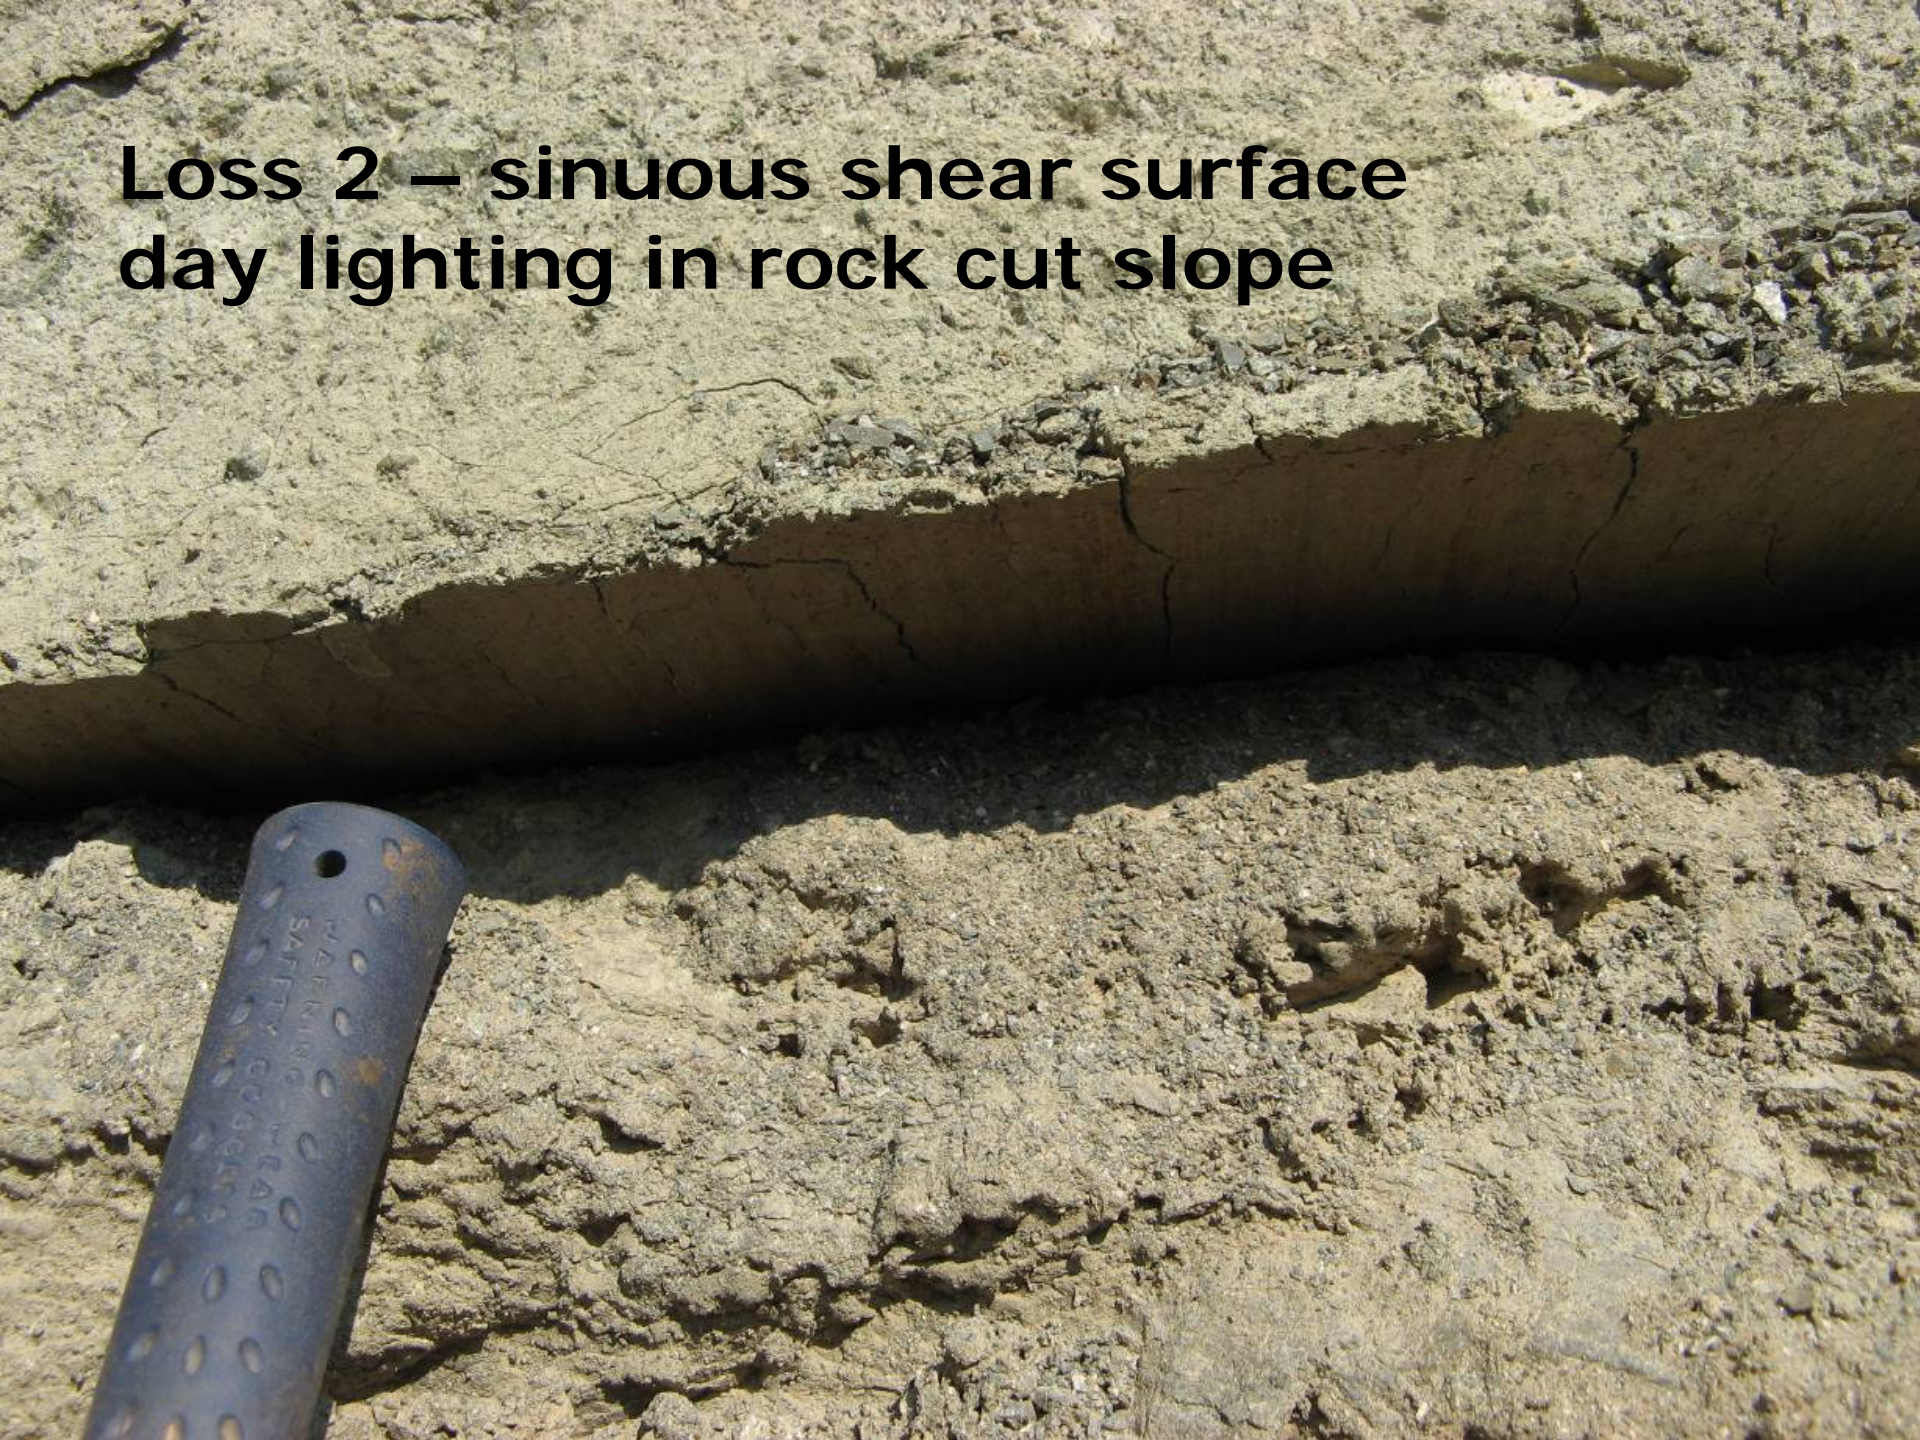
Loss 2 – sinuous shear surface day lighting in rock cut slope

**Loss 2 – sinuous shear surface
day lighting in rock cut slope**
