Albania – Kosovo Highway

Nick Koor – Center for Applied Geosciences
University of Portsmouth

Geological Society – IOM³
8th April 2013

Client – loss adjuster – five failures during construction

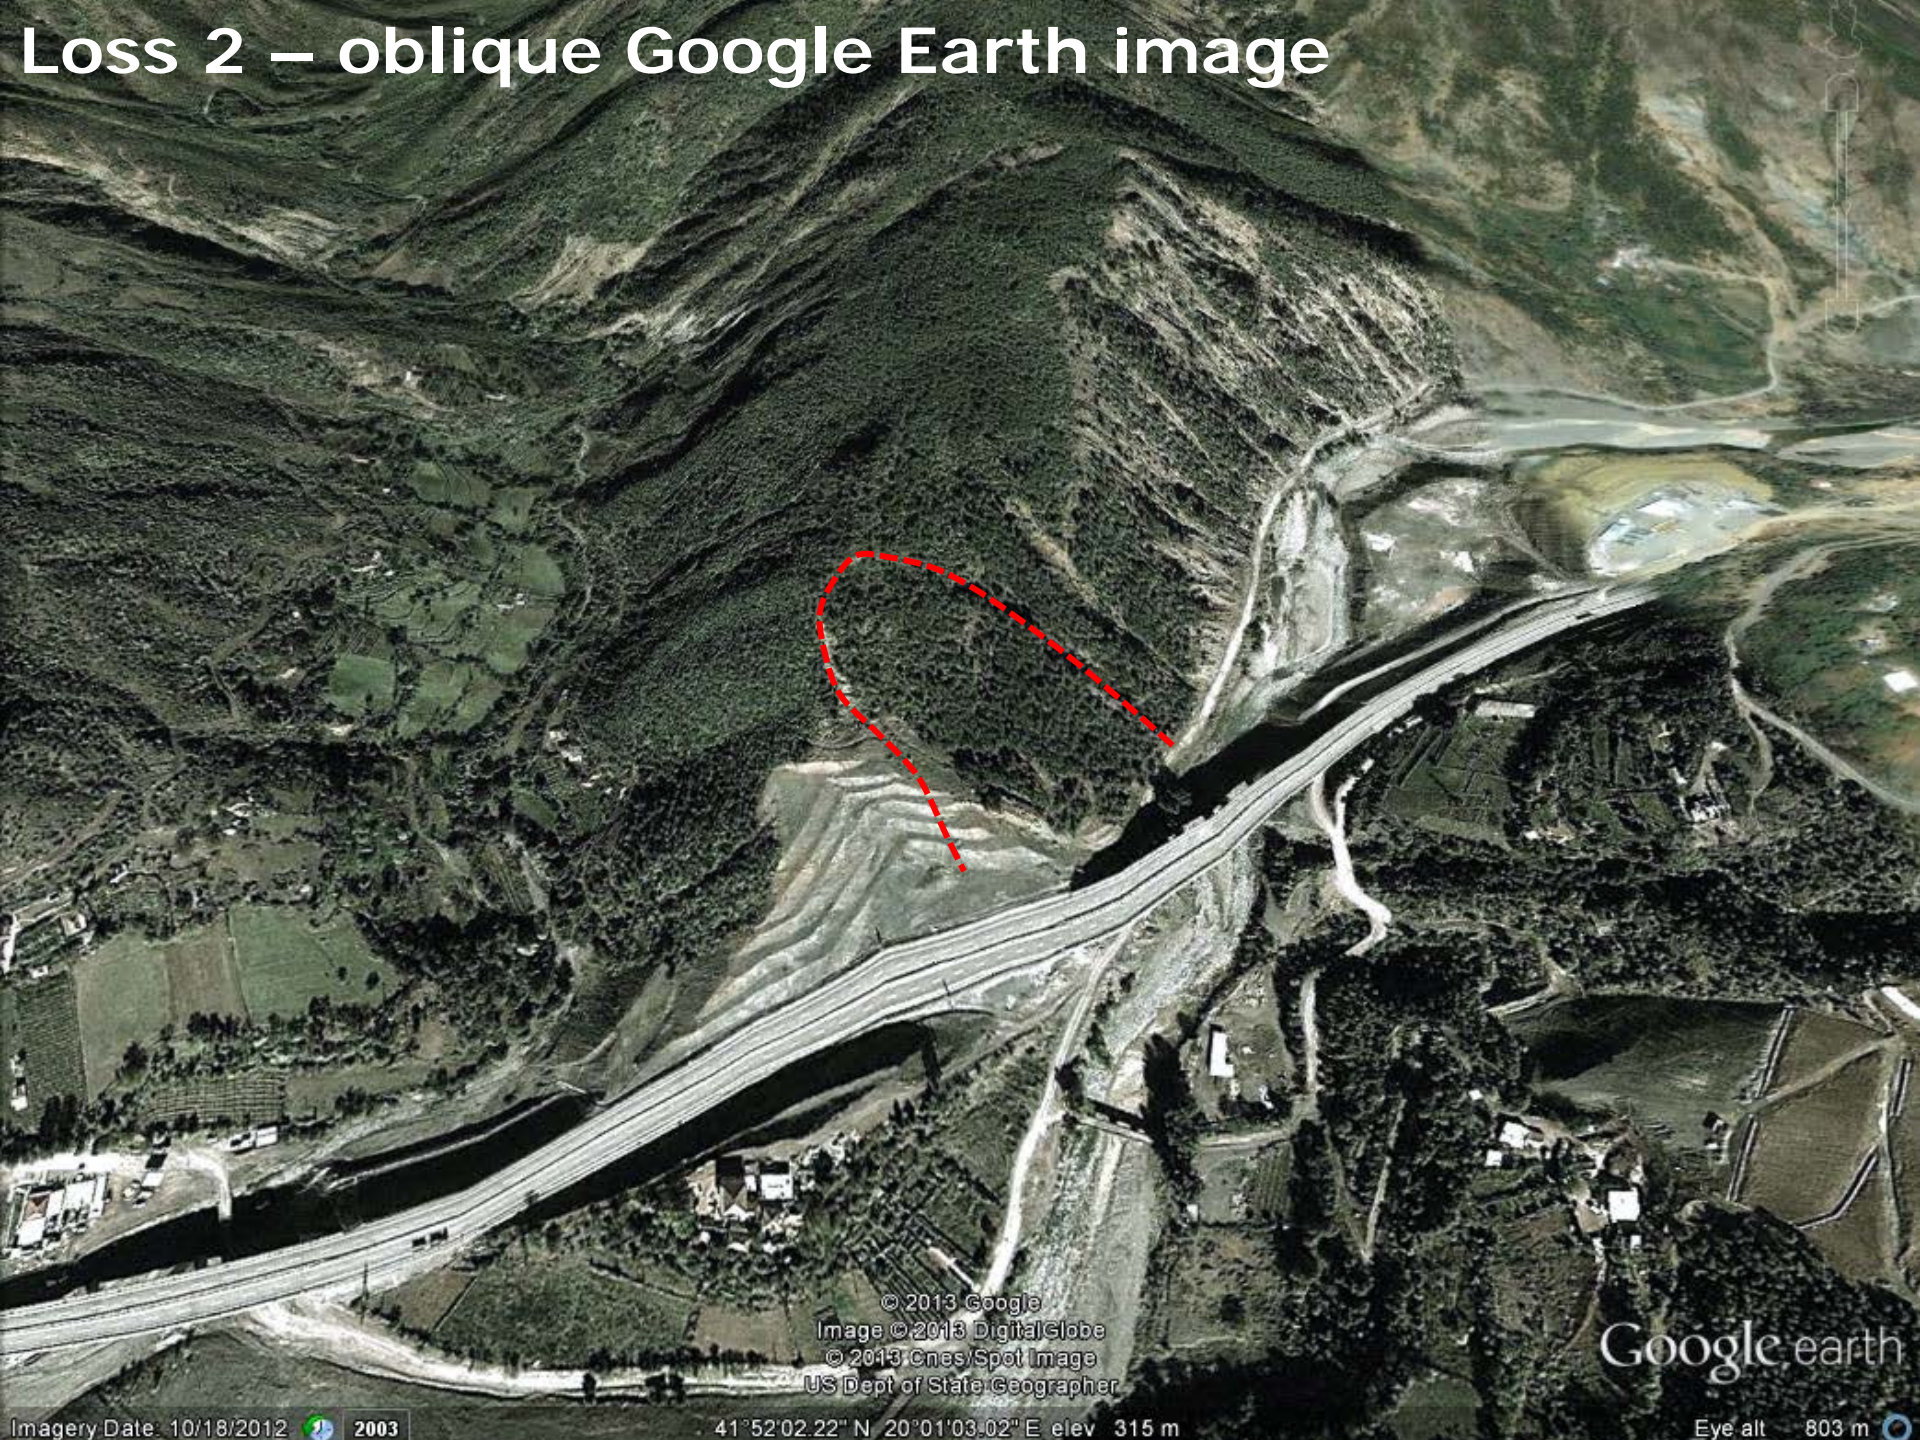
Loss 2 – surface exposed during
construction

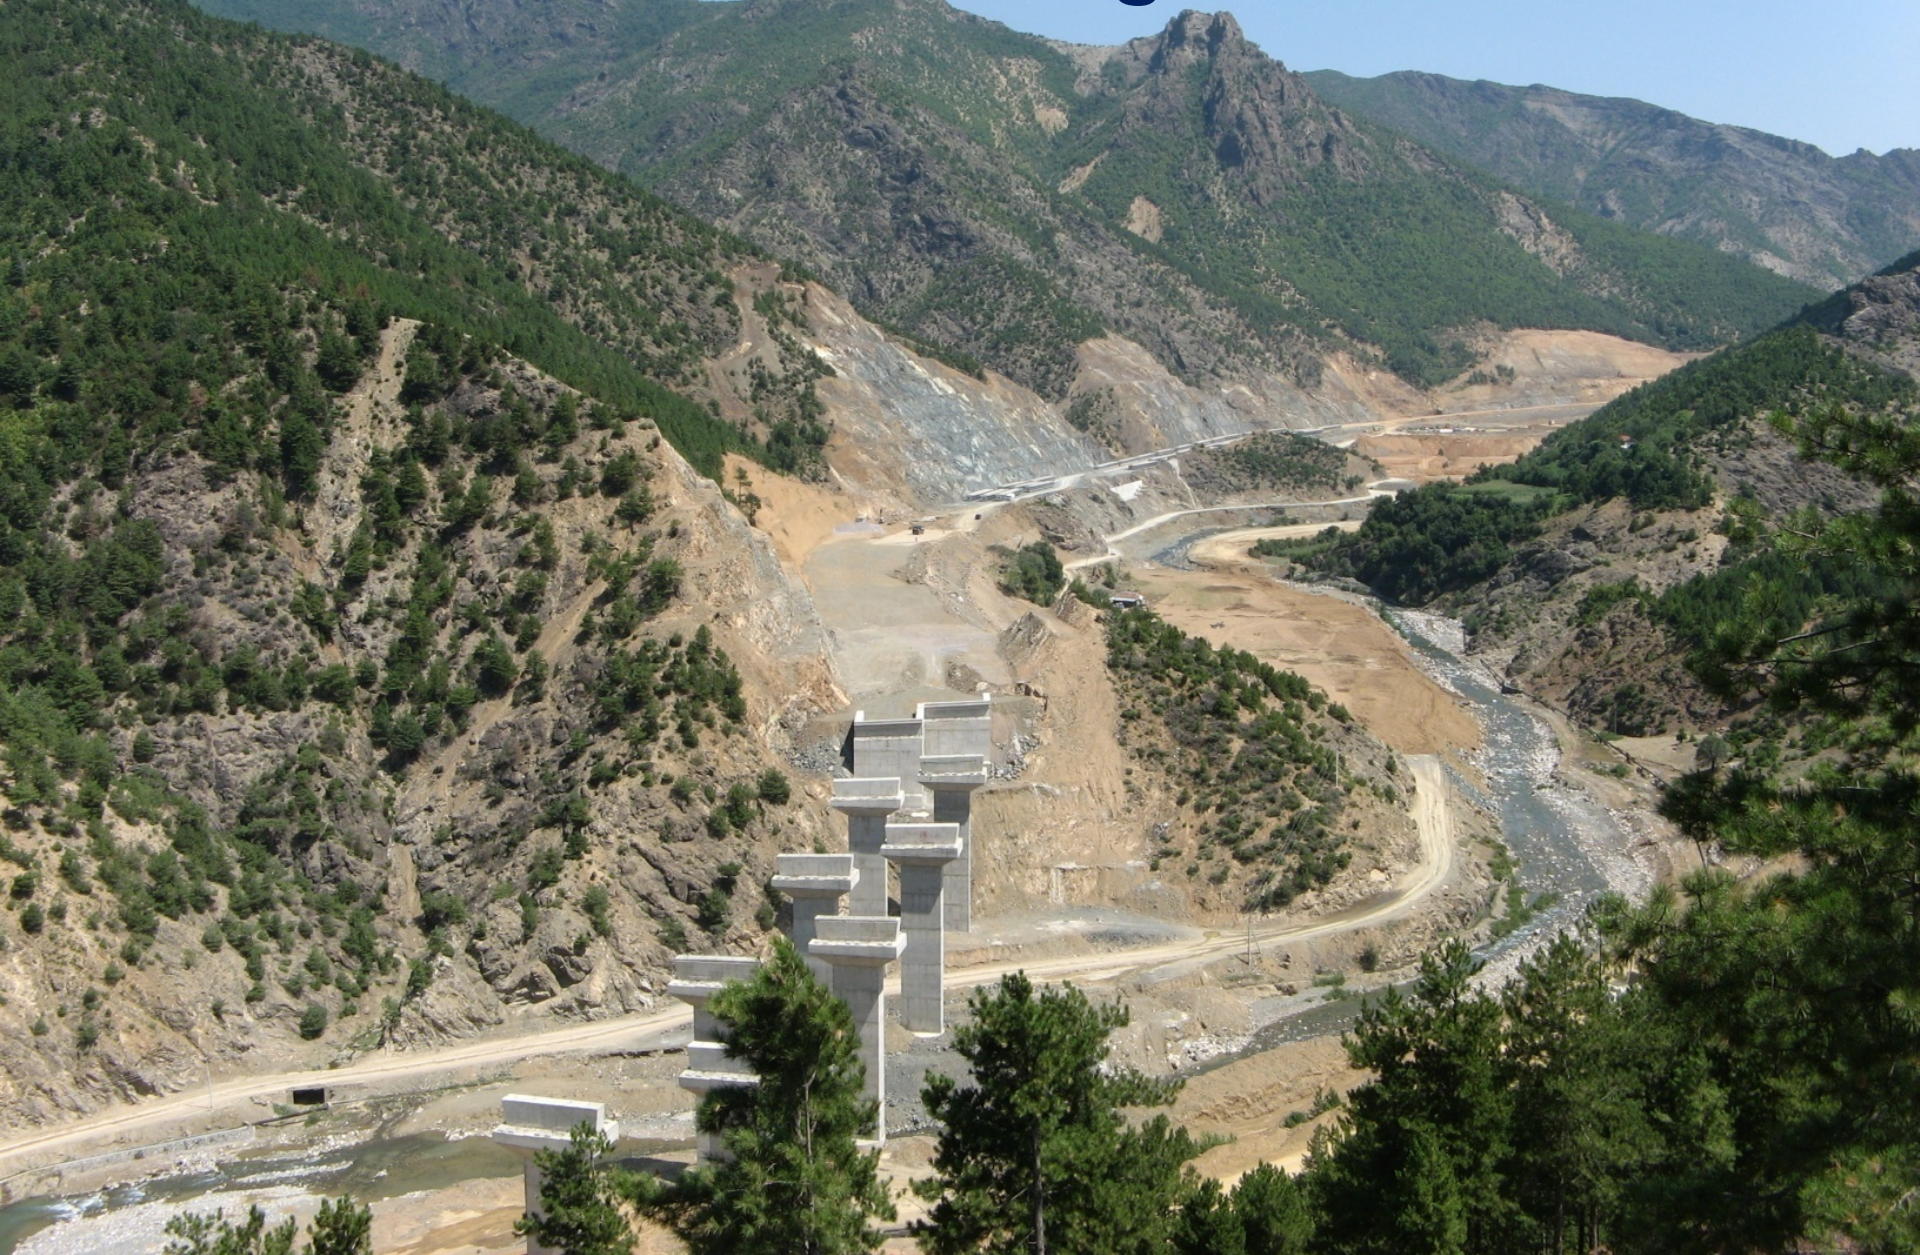
Loss 3 – cut slope adjacent to bridge foundations - view looking west

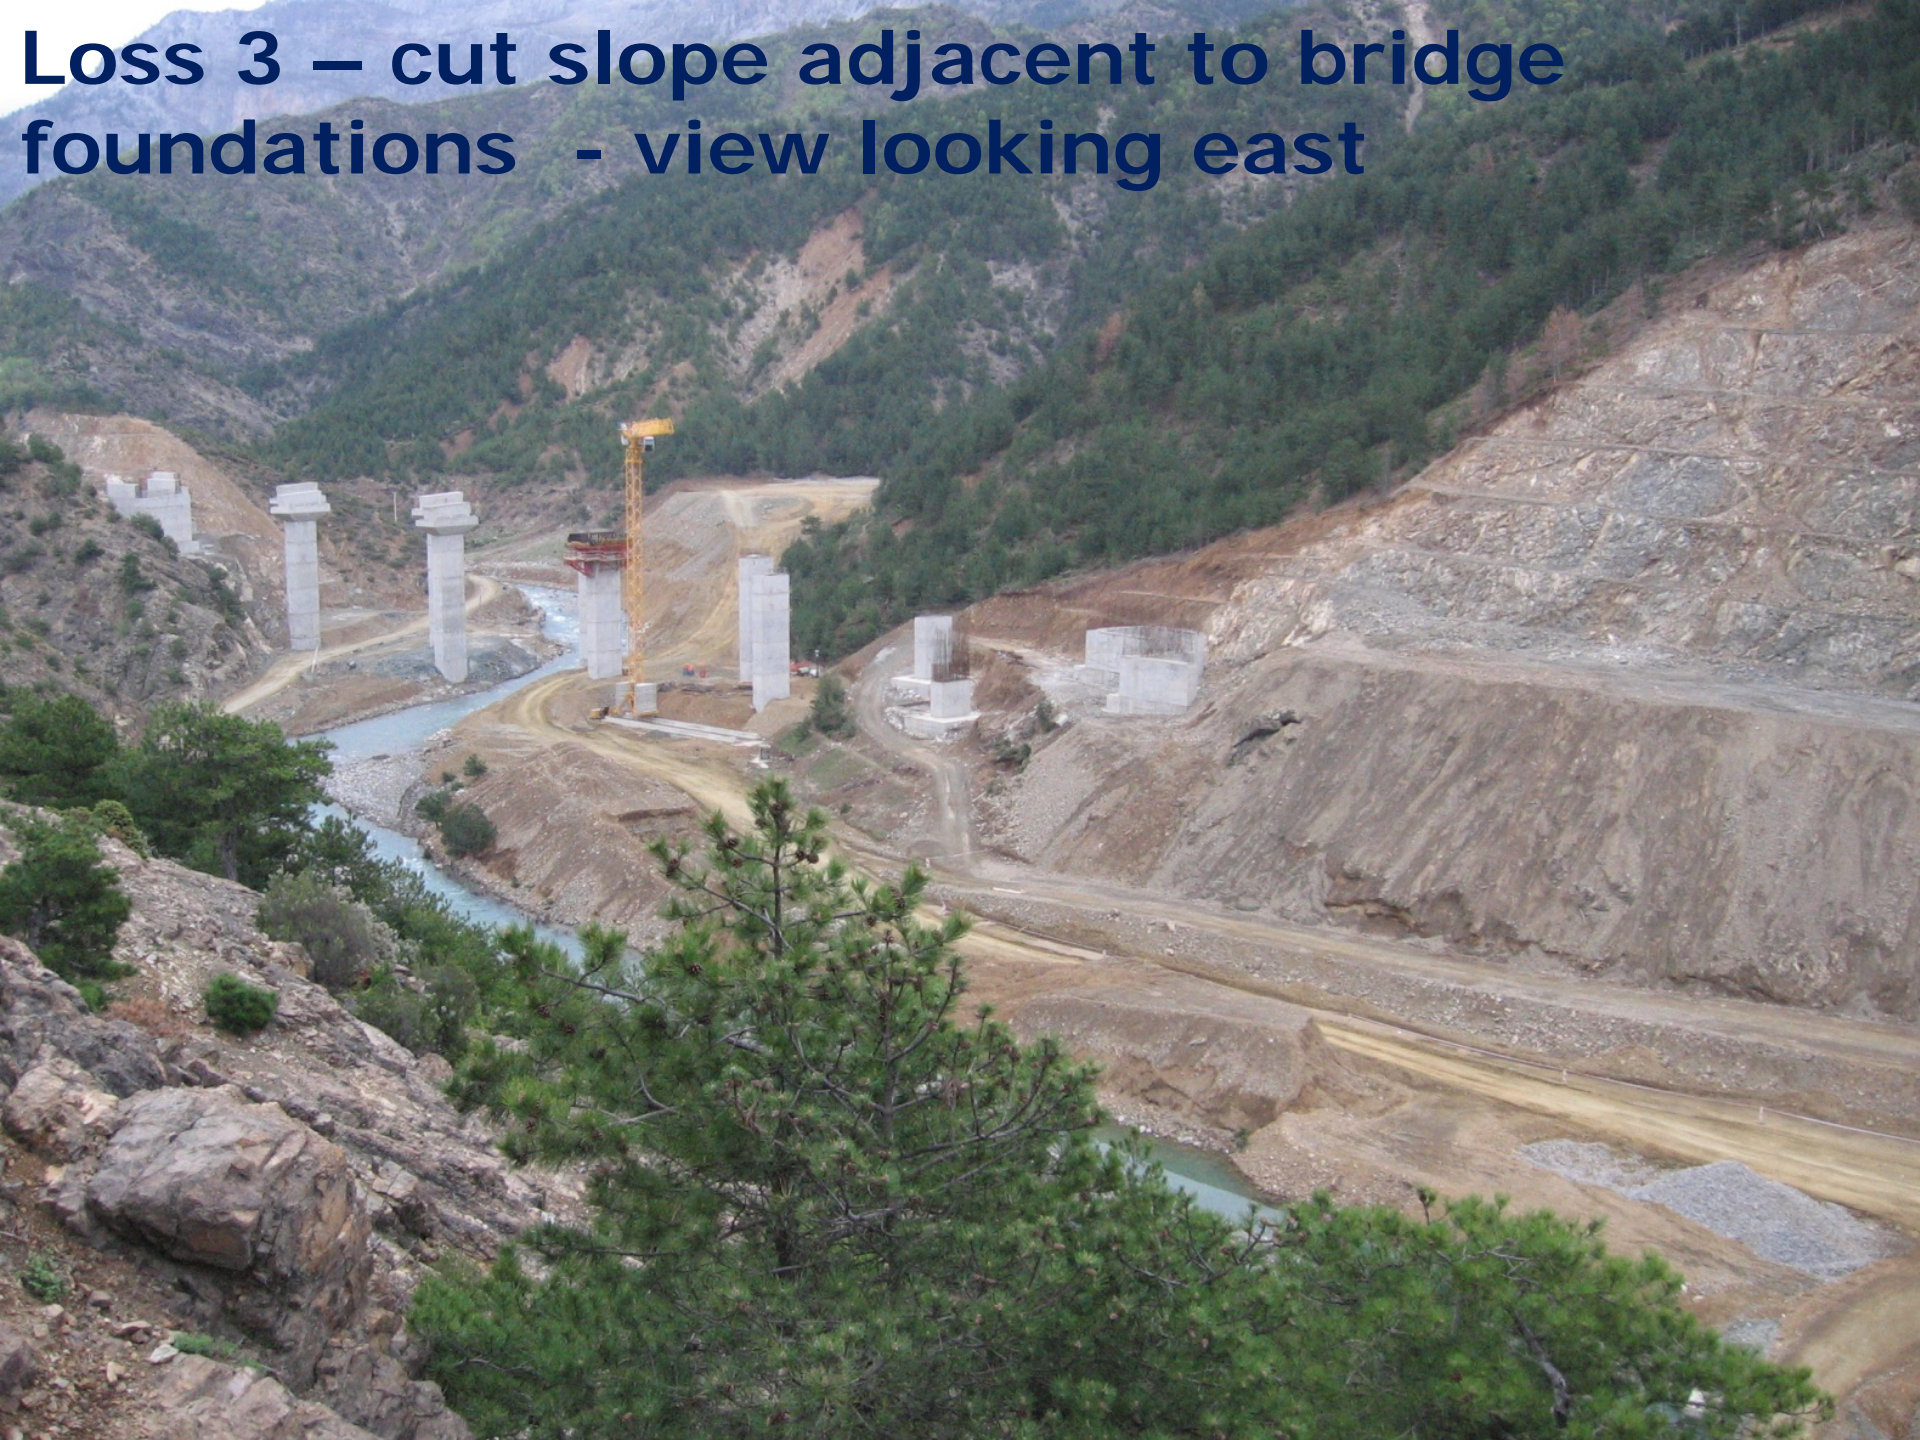
Loss 3 – cut slope adjacent to bridge foundations - view looking east

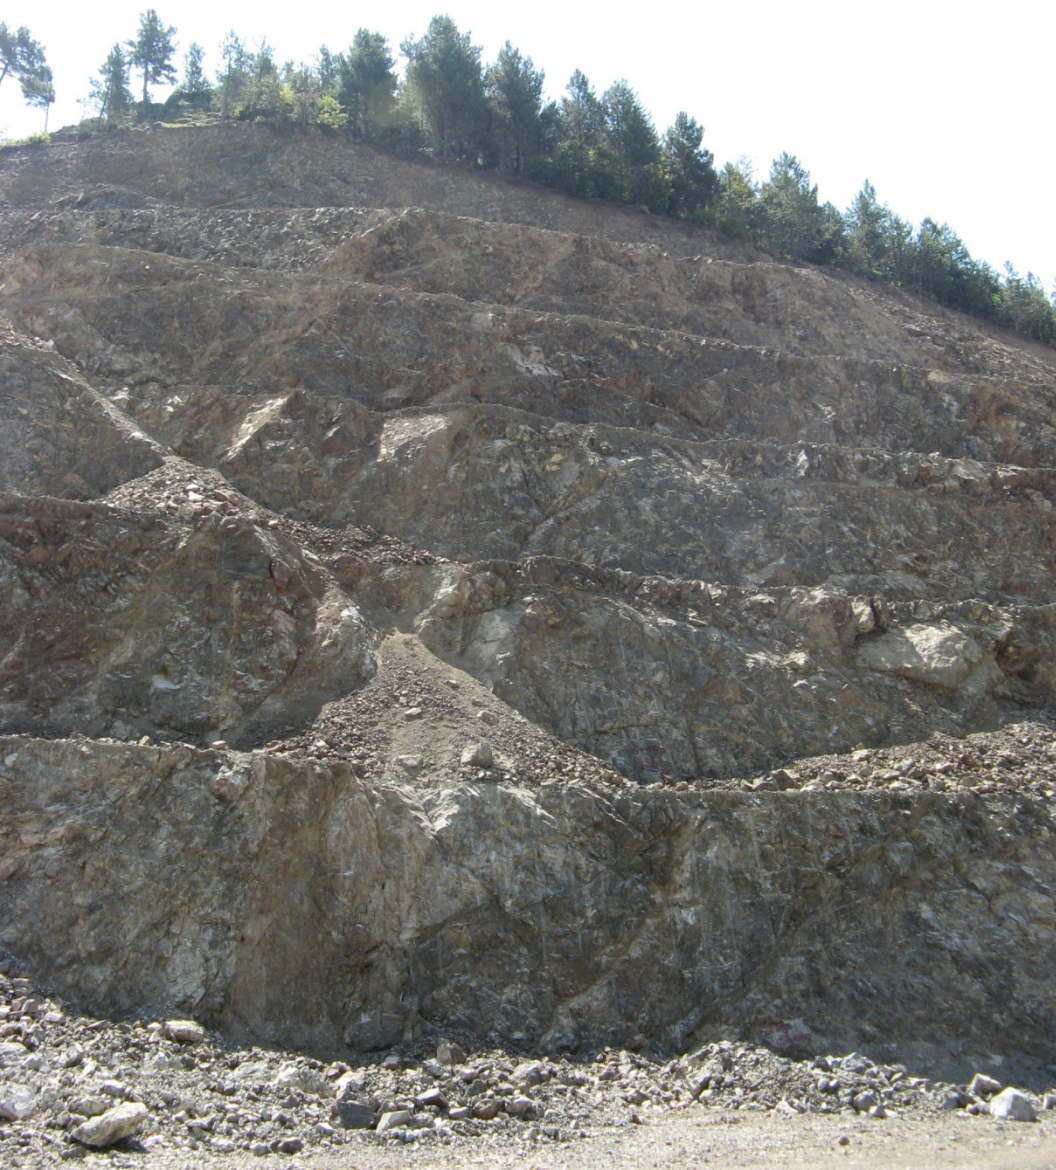
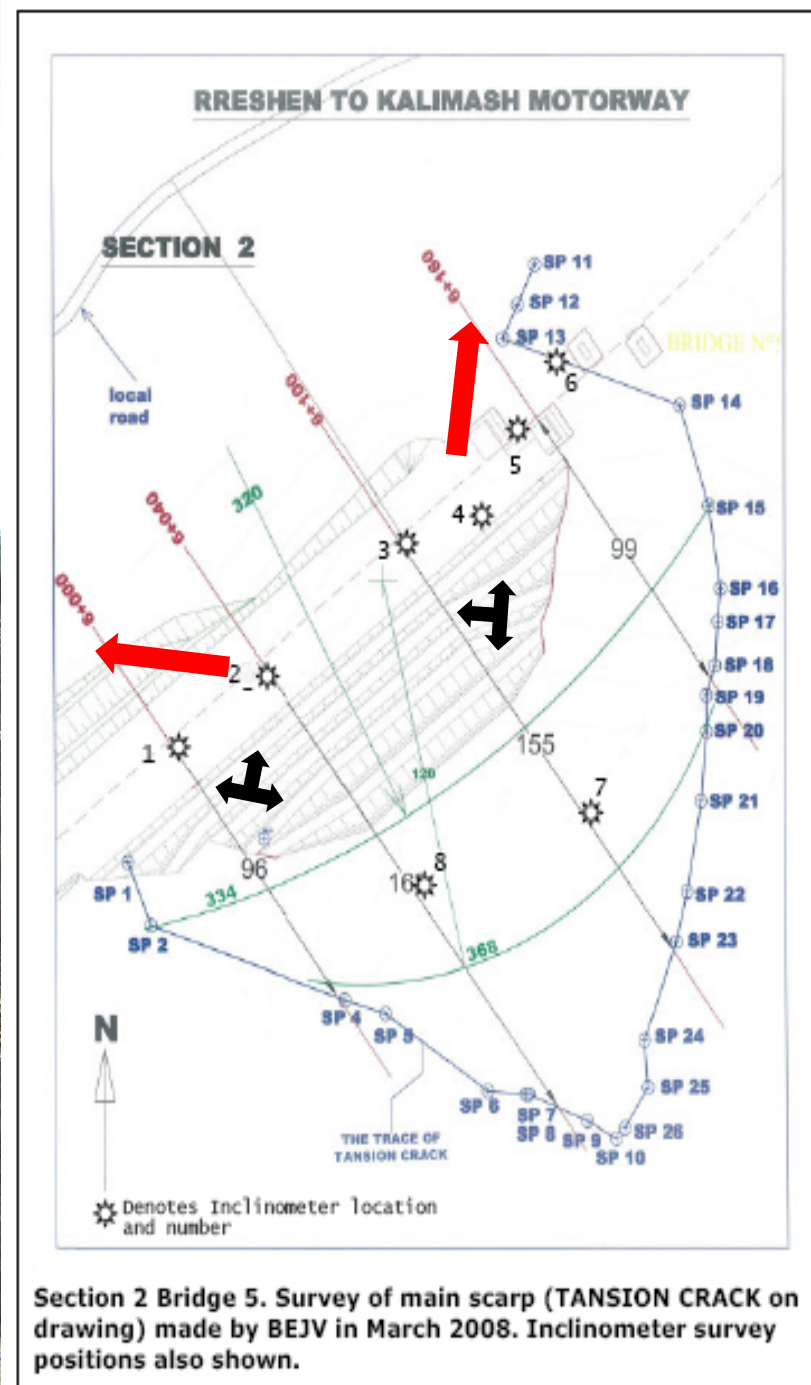
Loss 3 – cut slope

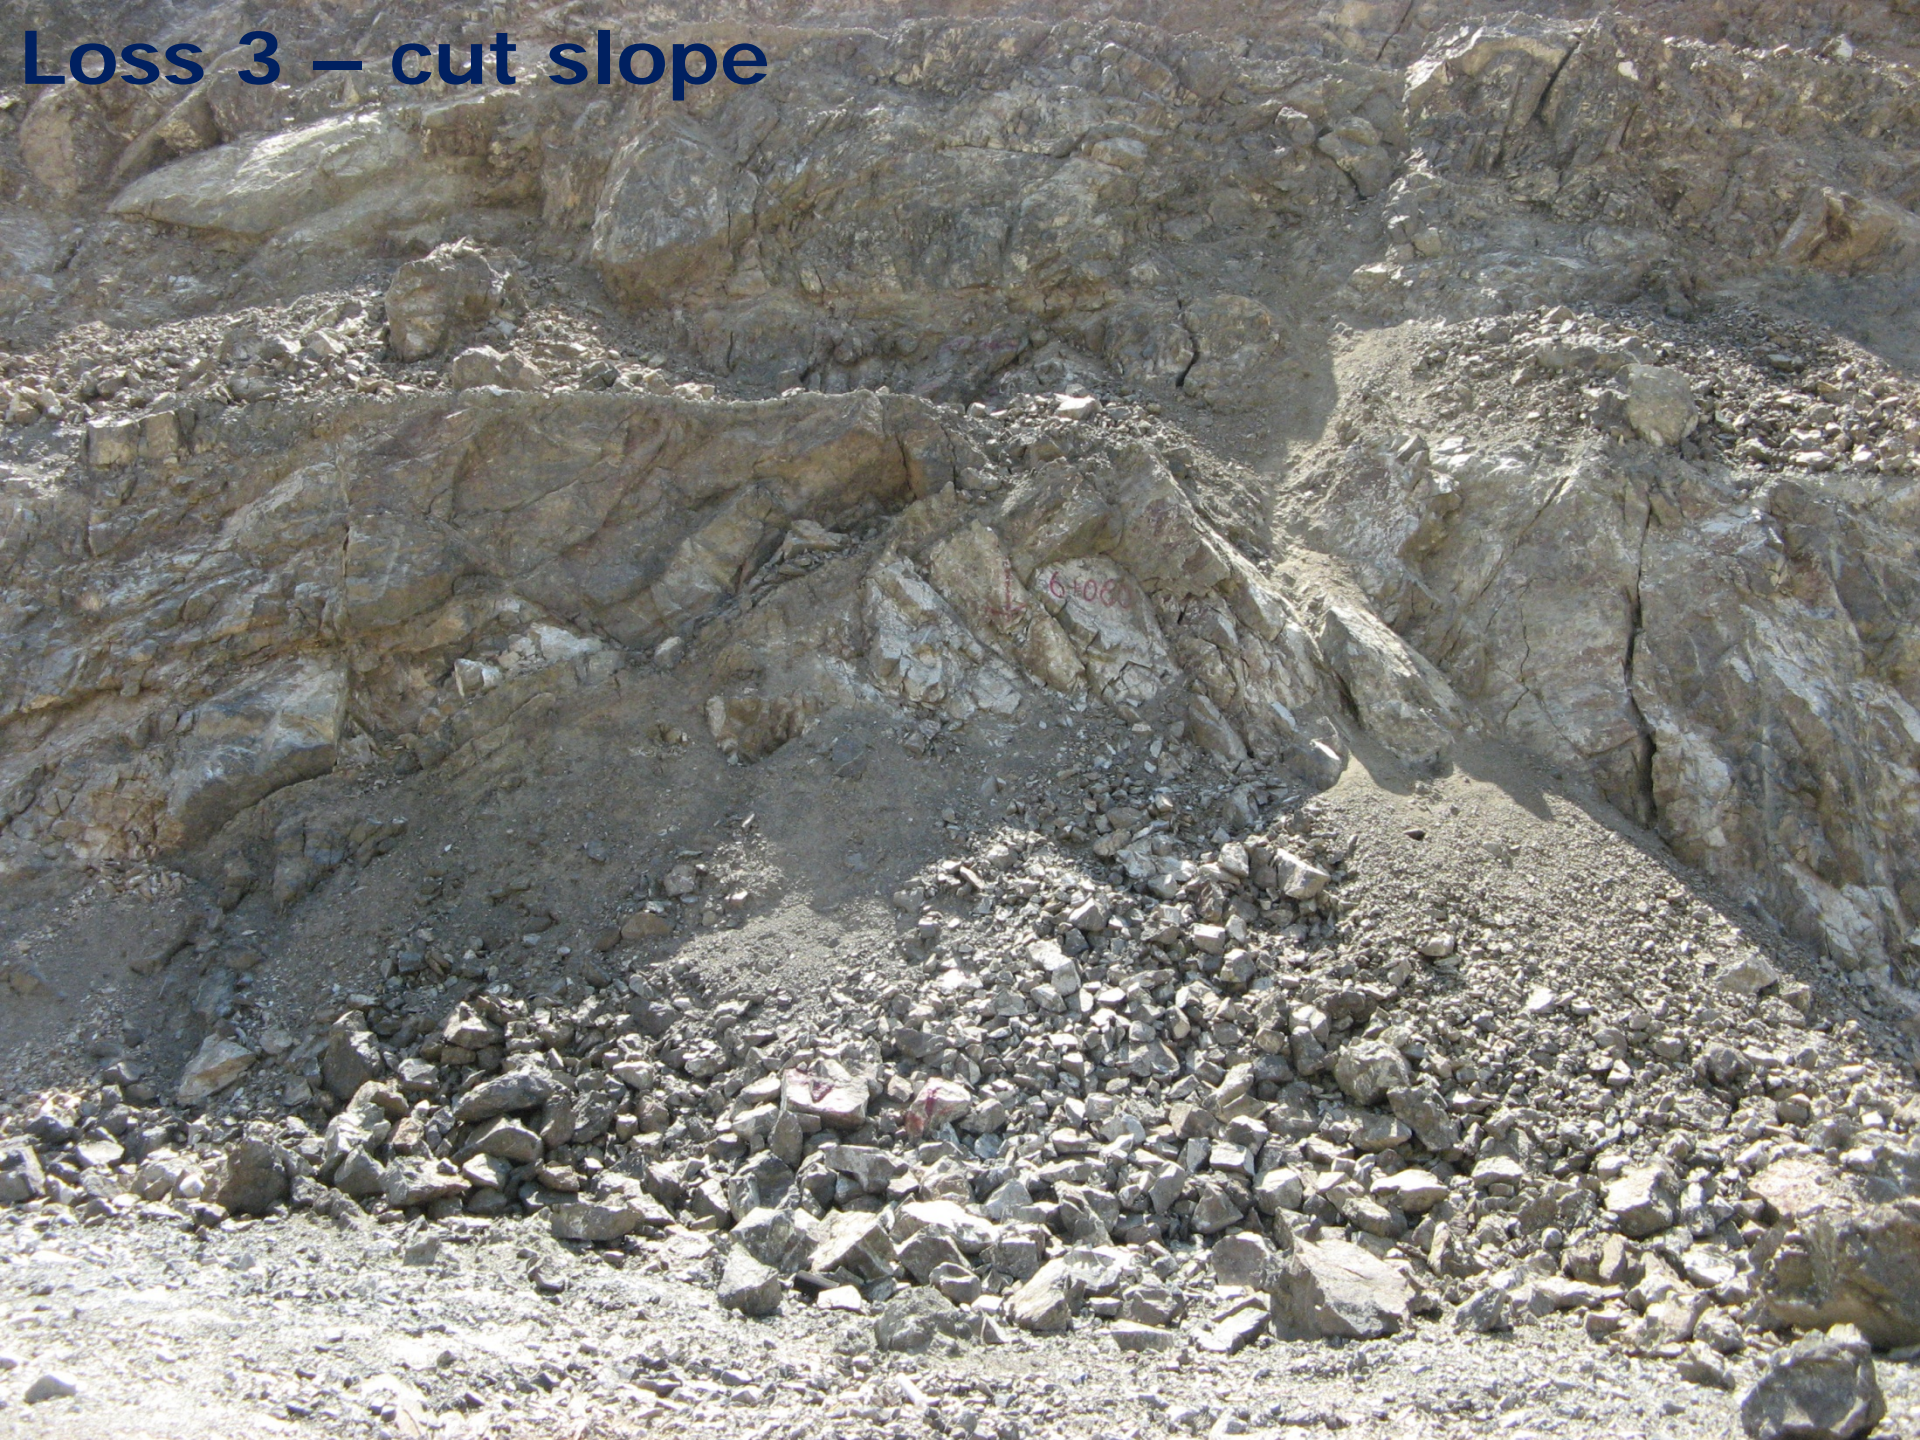
Loss 3 – cut slope

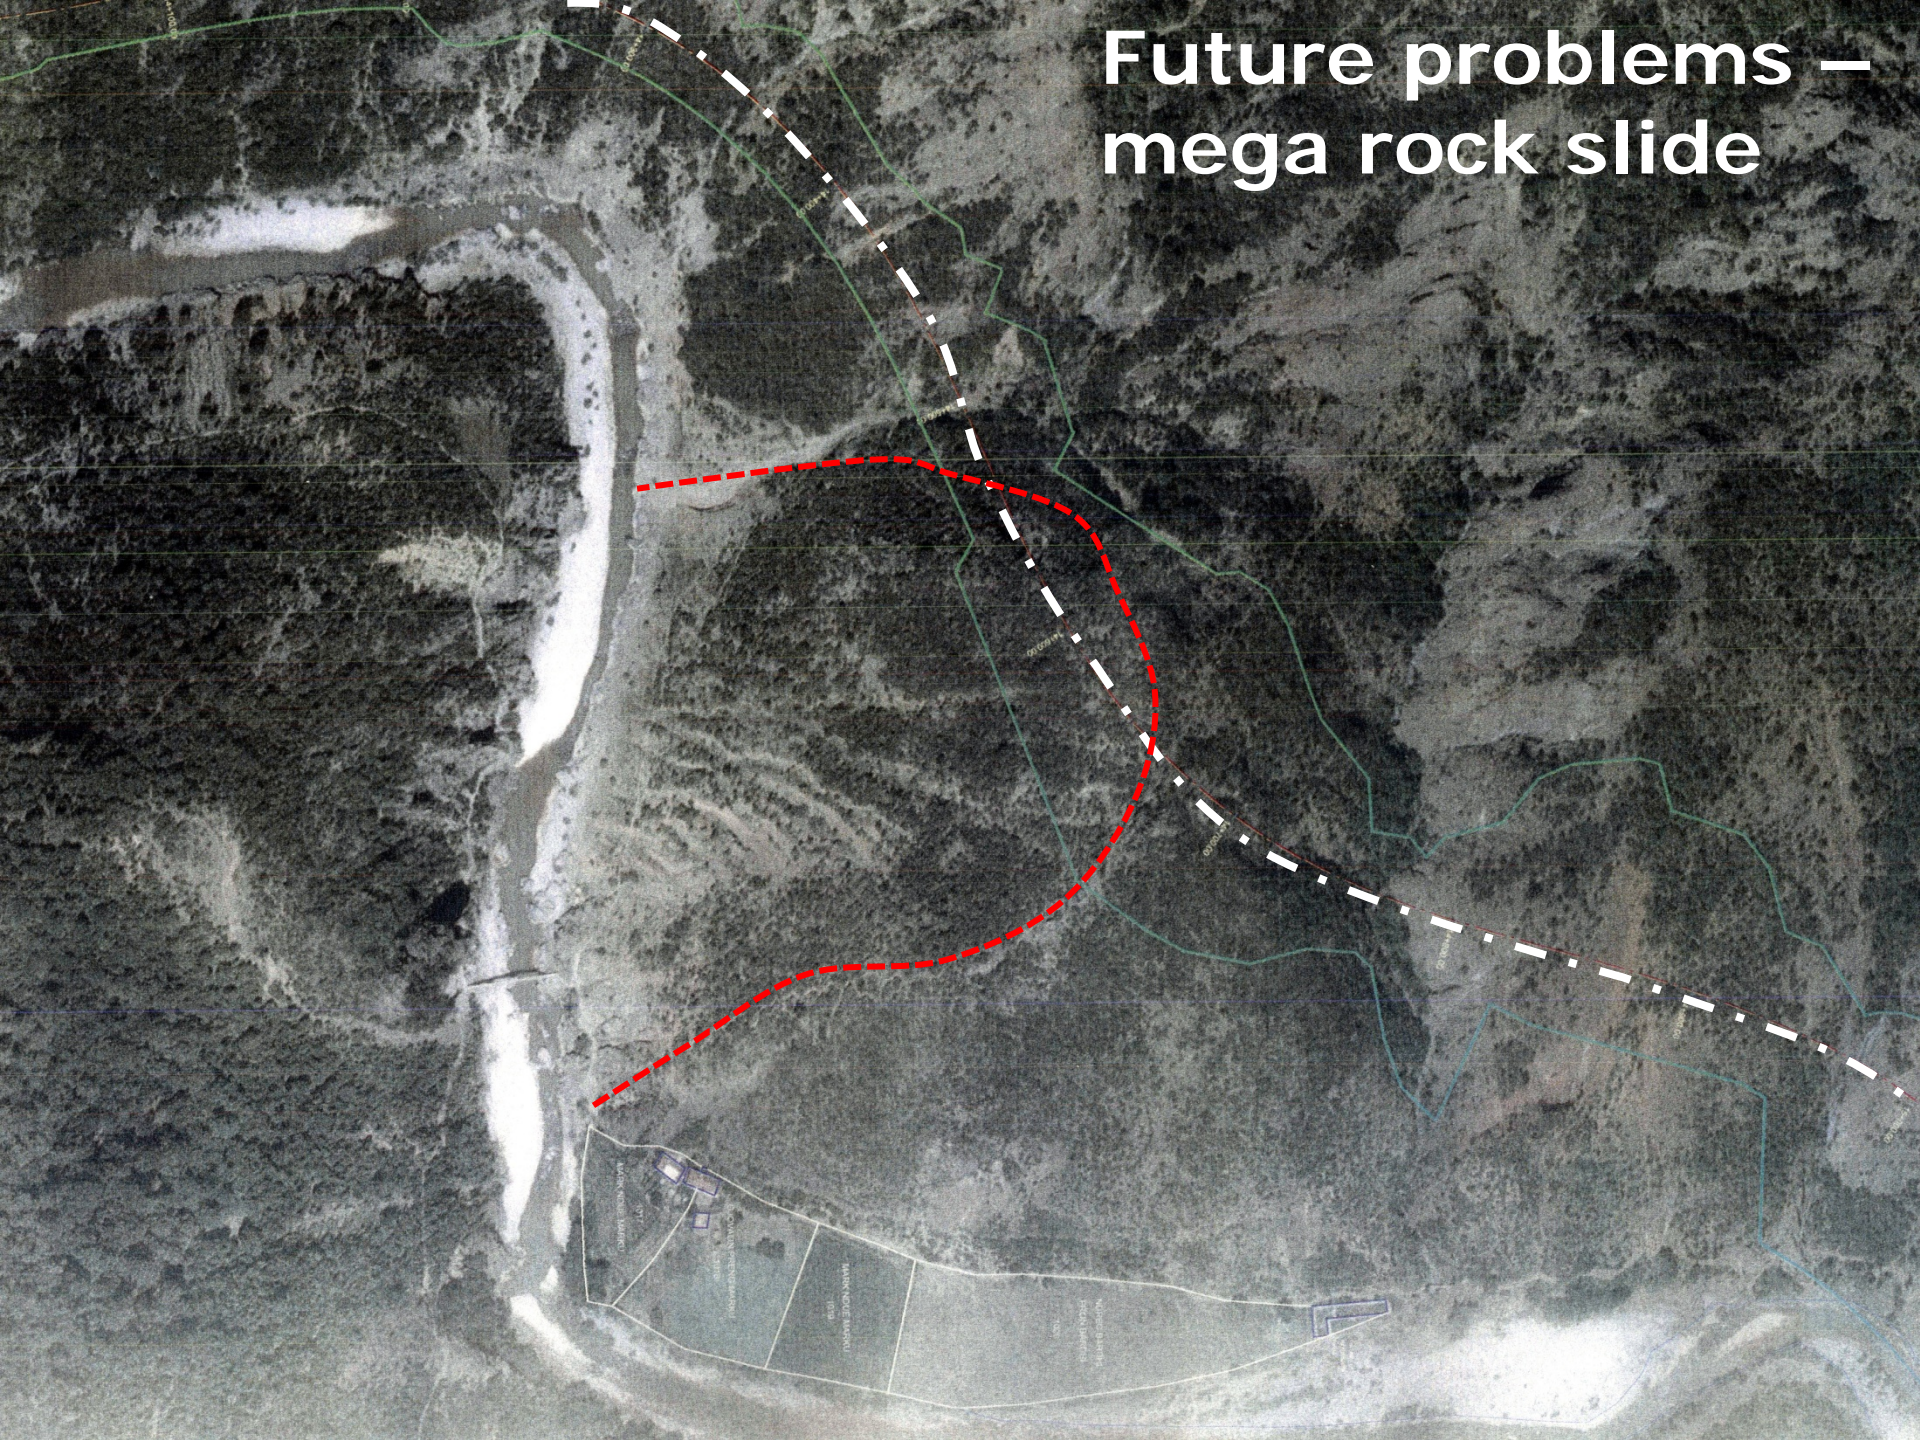
Future problems – mega rock slide

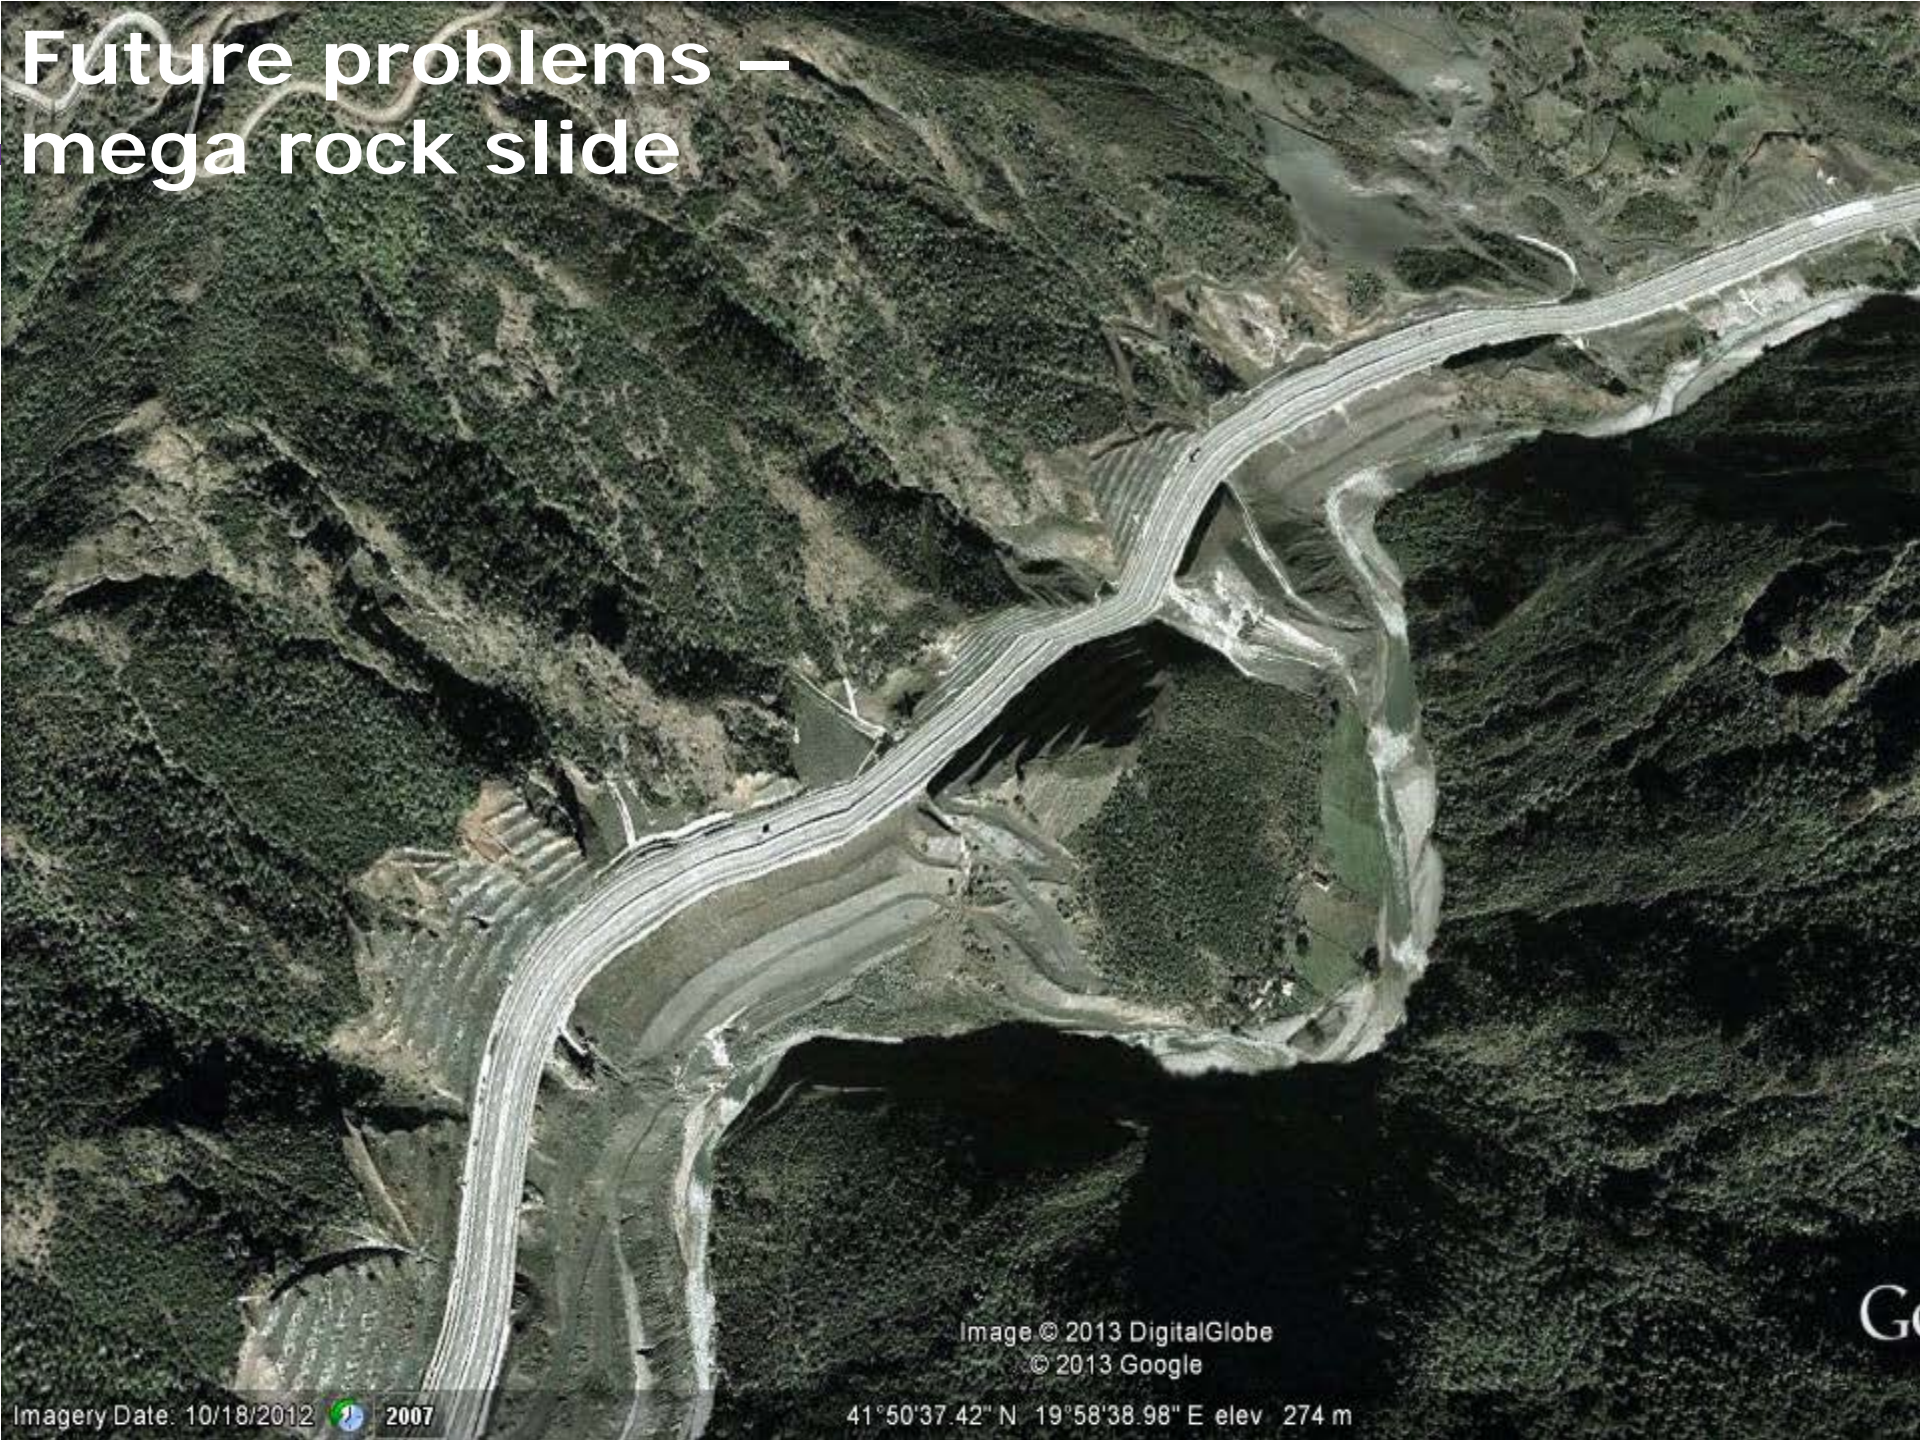
Future problems – mega rock slide

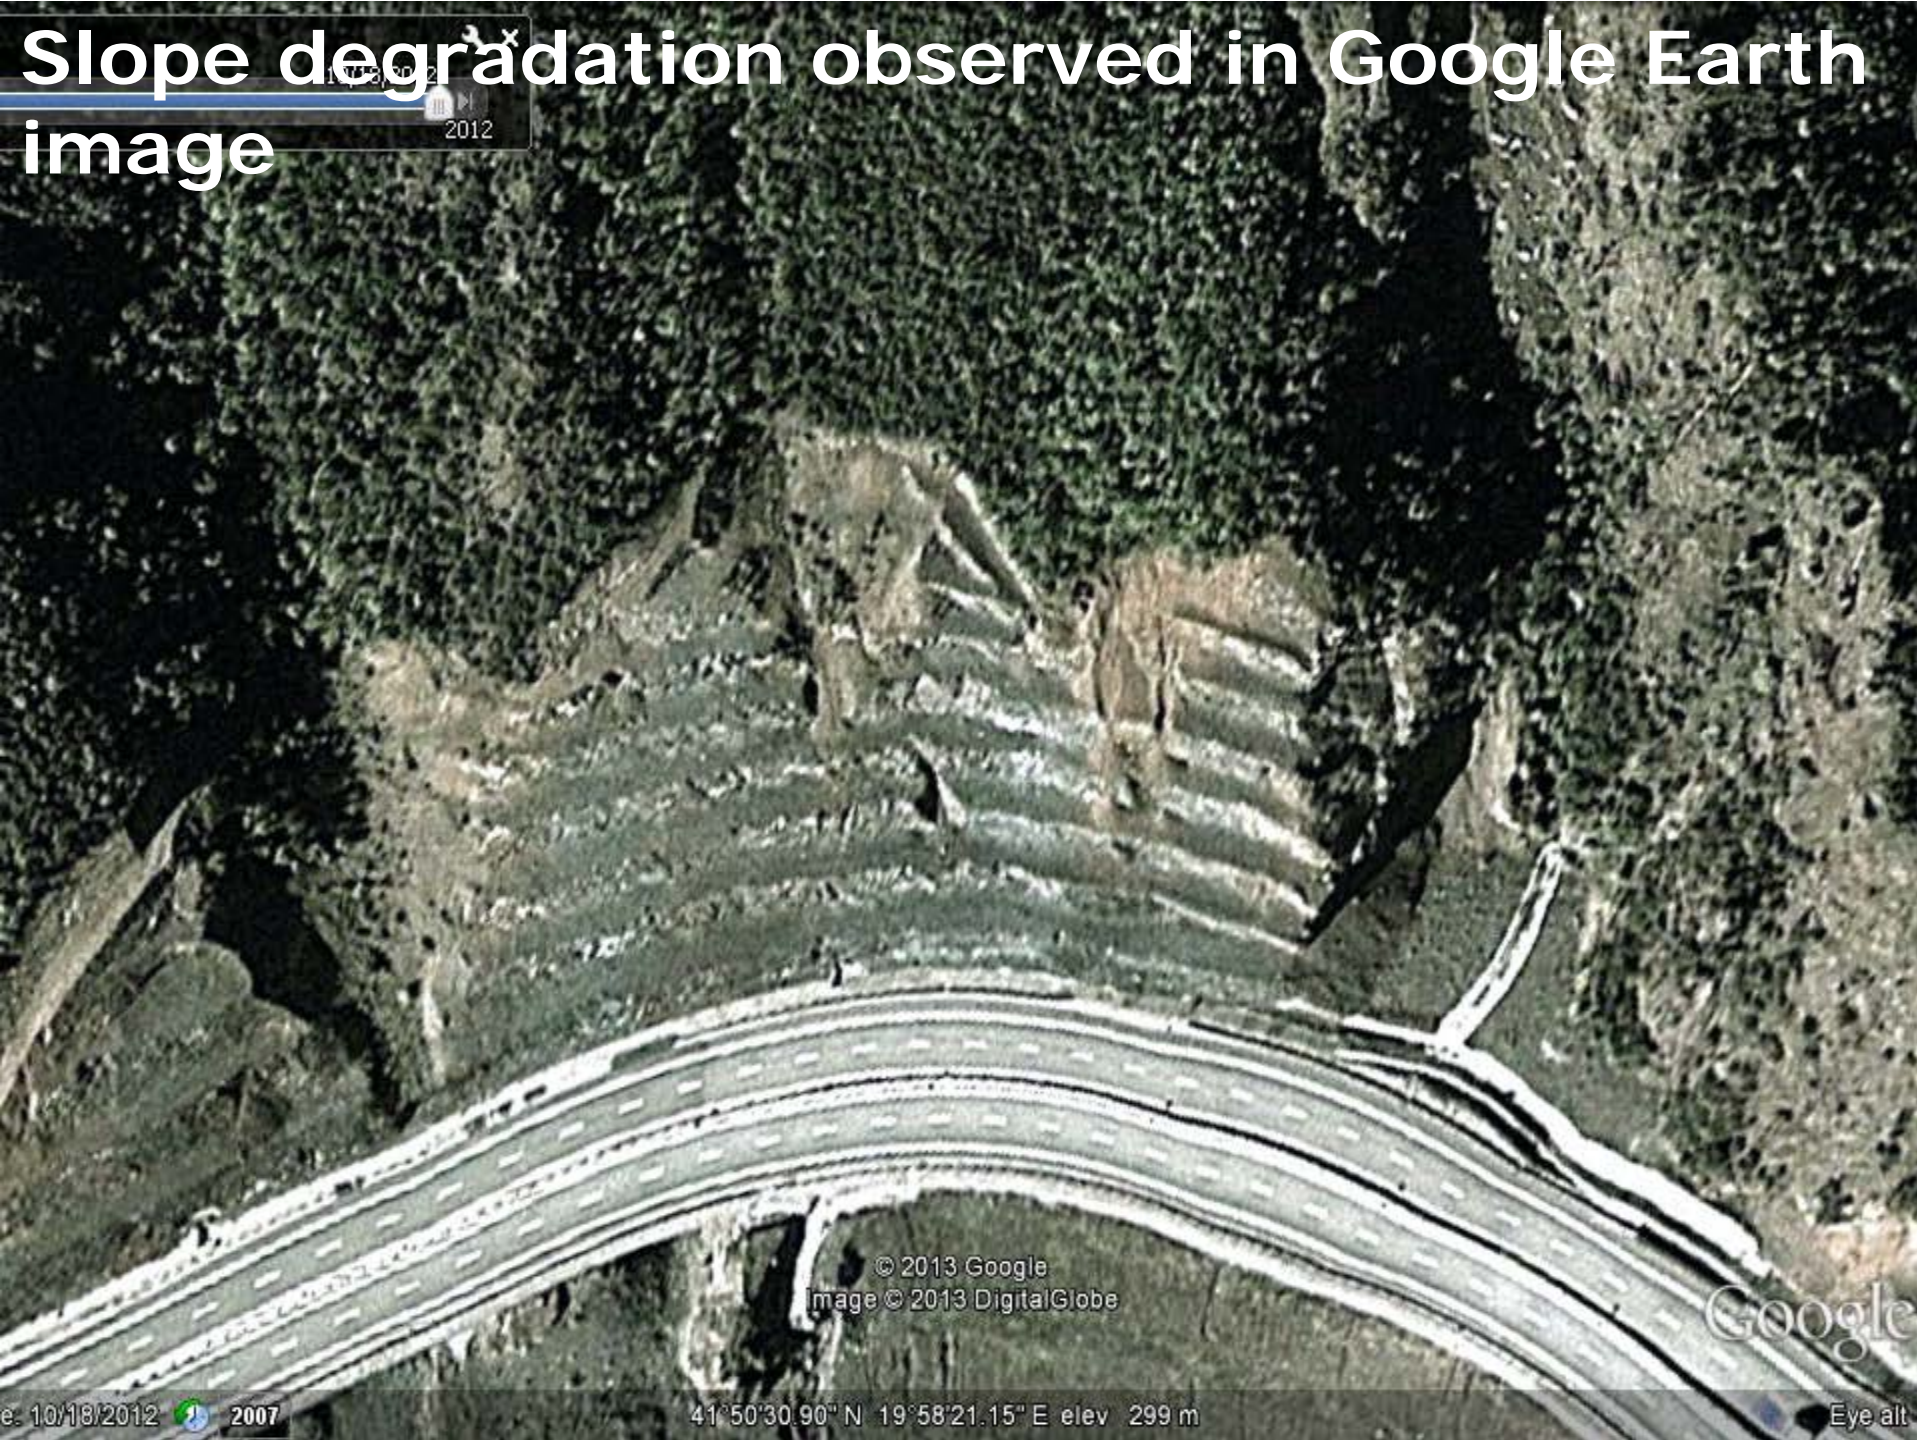
Slope degradation observed in Google Earth image
