Further Developments with Embankment Dams on the Mercia Mudstone

Tim Blower, CEng, FICE, CGeol, FGS

Lincoln WTW Project – Storage Reservoir

- Anglian Water raw water storage reservoir
- Earth fill embankment dam, oval shape
- 10 days storage including outage time
- Capacity 285,000m³
- Earthworks volumes cut & fill: 220,000m³

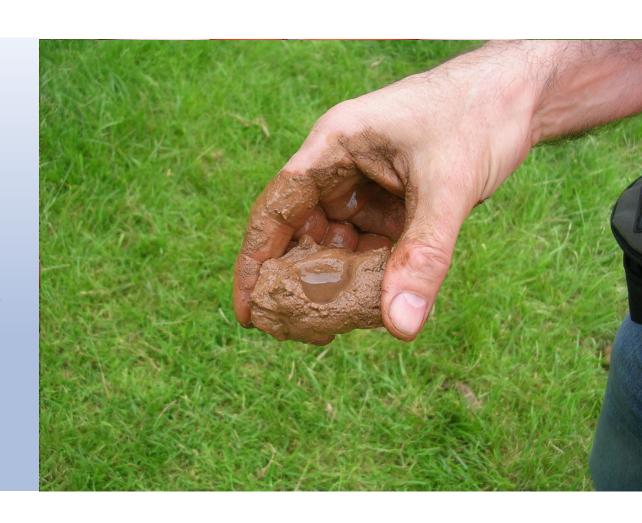
Field Observations on Permeability

- Trial pit spoil crumbly, almost granular appearance
- When wetted & moulded, became very plastic – "gritty clay"
- Appears to be of low permeability

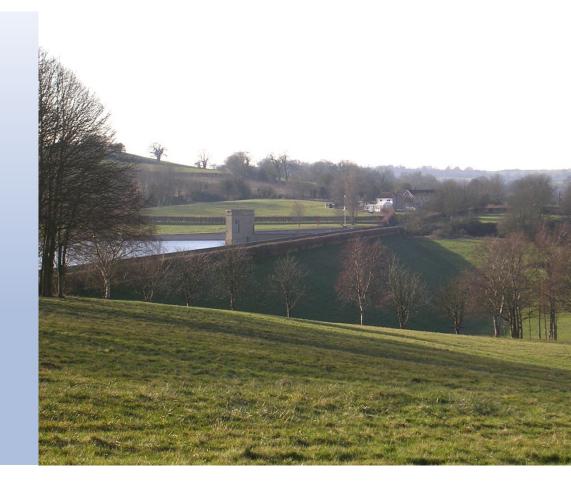
Chew Valley Dam, Bristol

- Bristol Water
- Constructed 1957
- Public Water Supply
- 12m high, 470m long
- Capacity 20,457,000 m3
- Clay core with concrete cut-off
- Minor leakages only

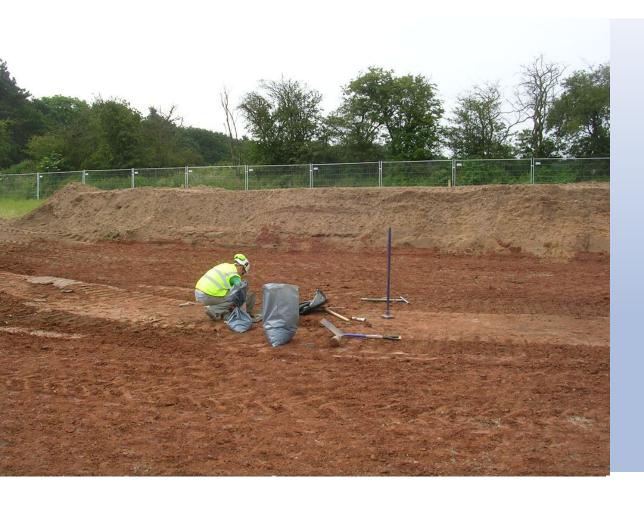
Lincoln RWR – Compaction Trials

Earthworks trial: June 2012

Topsoil stripped

Borrow area selection

Compaction properties

Strength

Permeability
