Comparison of approaches for assessing WFD significant damage to groundwater dependent wetlands from water quality

Natalie Phillips (Environment Agency)
Mark Whiteman (Environment Agency)
Andrew Brooks (AMEC)

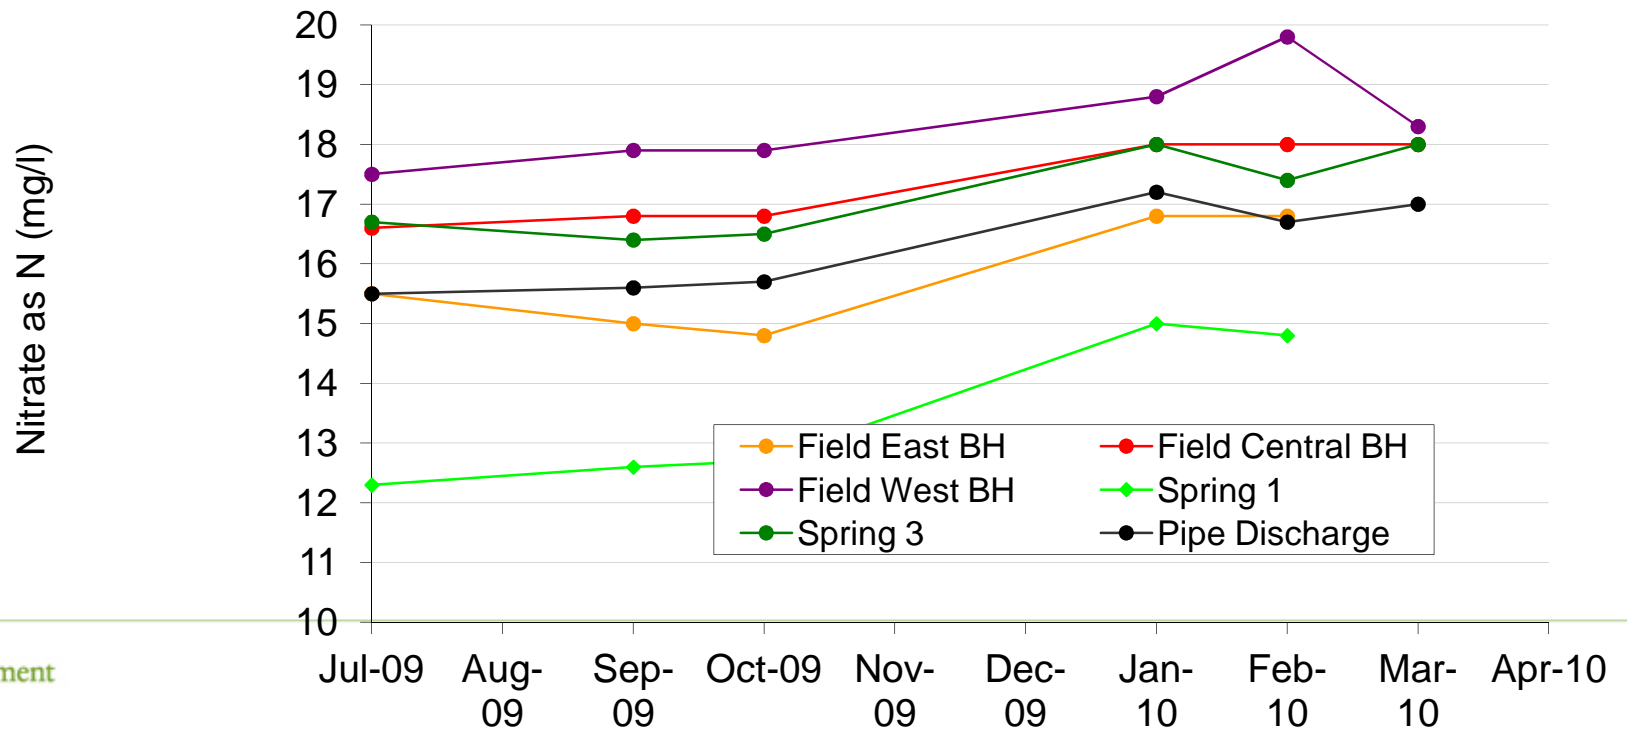
Newbald Becksies nitrate monitoring

- ➔ Investigation showed nitrates above threshold
- ➔ Evidence for ecological damage
- ➔ Source-pathway-receptor links confirmed
- ➔ Site at high risk from chemical pressure
