**British
Geological Survey**

An assessment of Pant-y-Llyn, Wales' only turlough and comparison to Irish sites

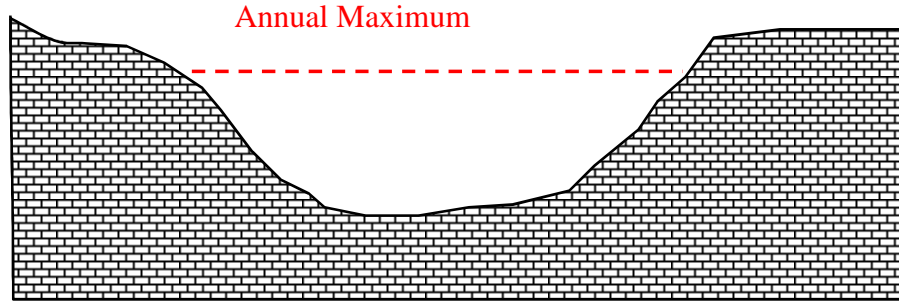
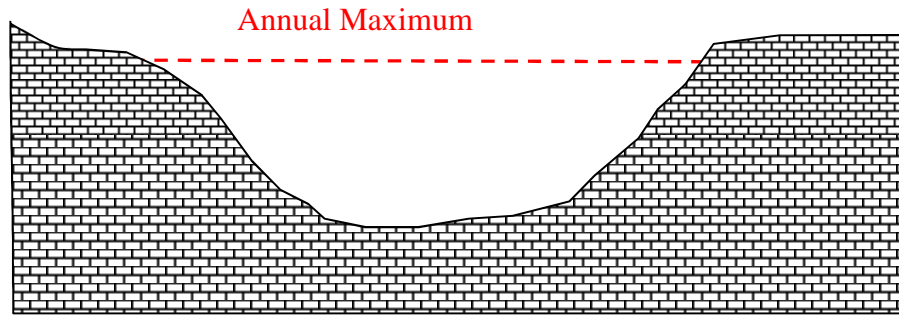
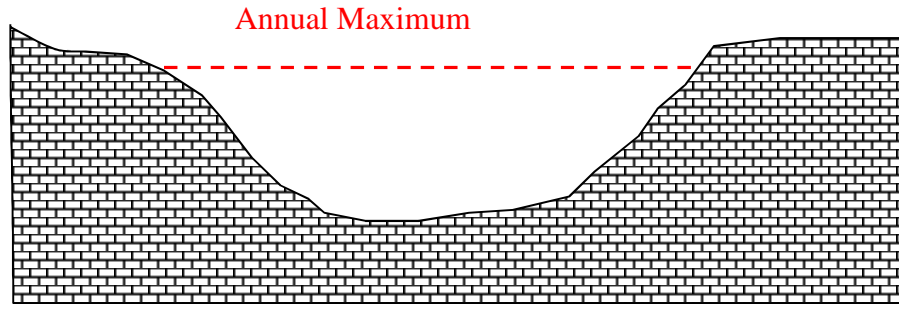
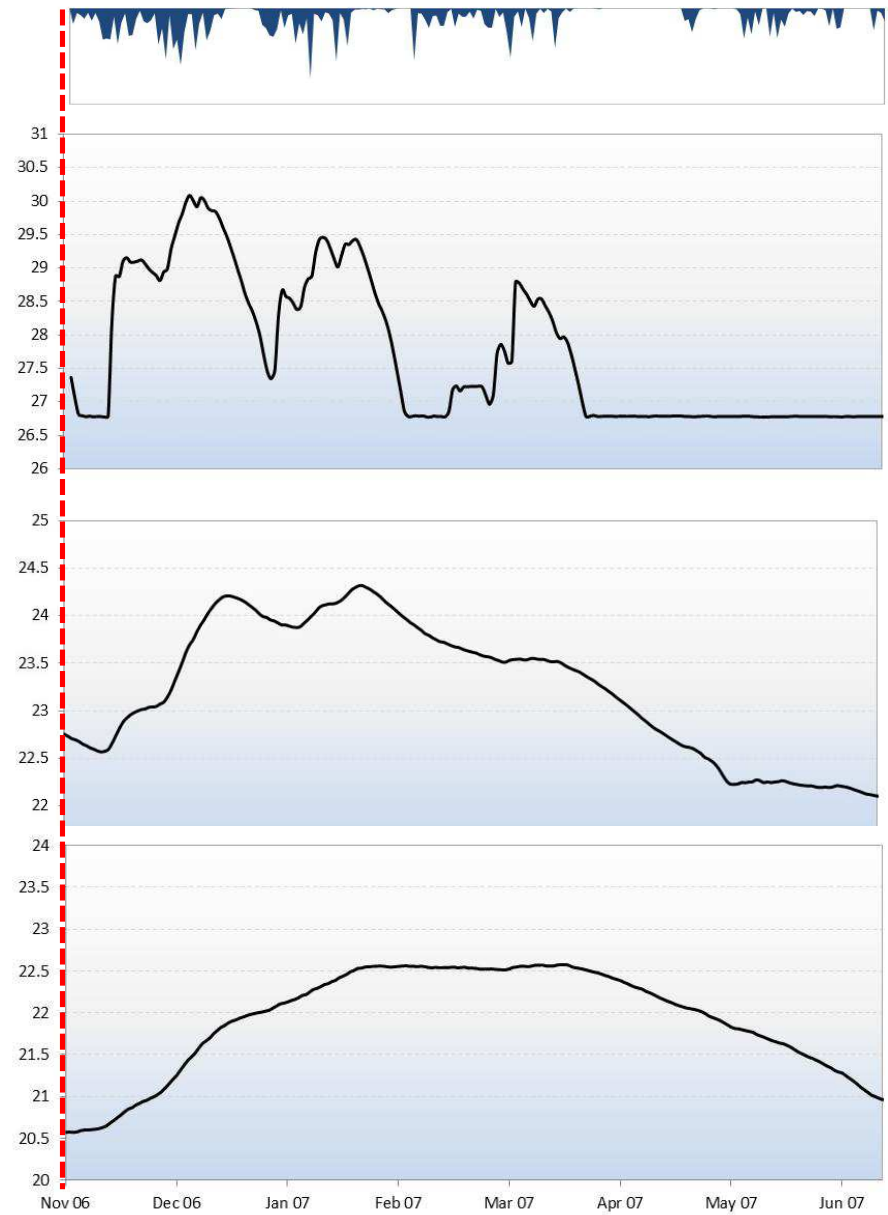
Turlough Hydrology

Diagrams: Owen Naughton

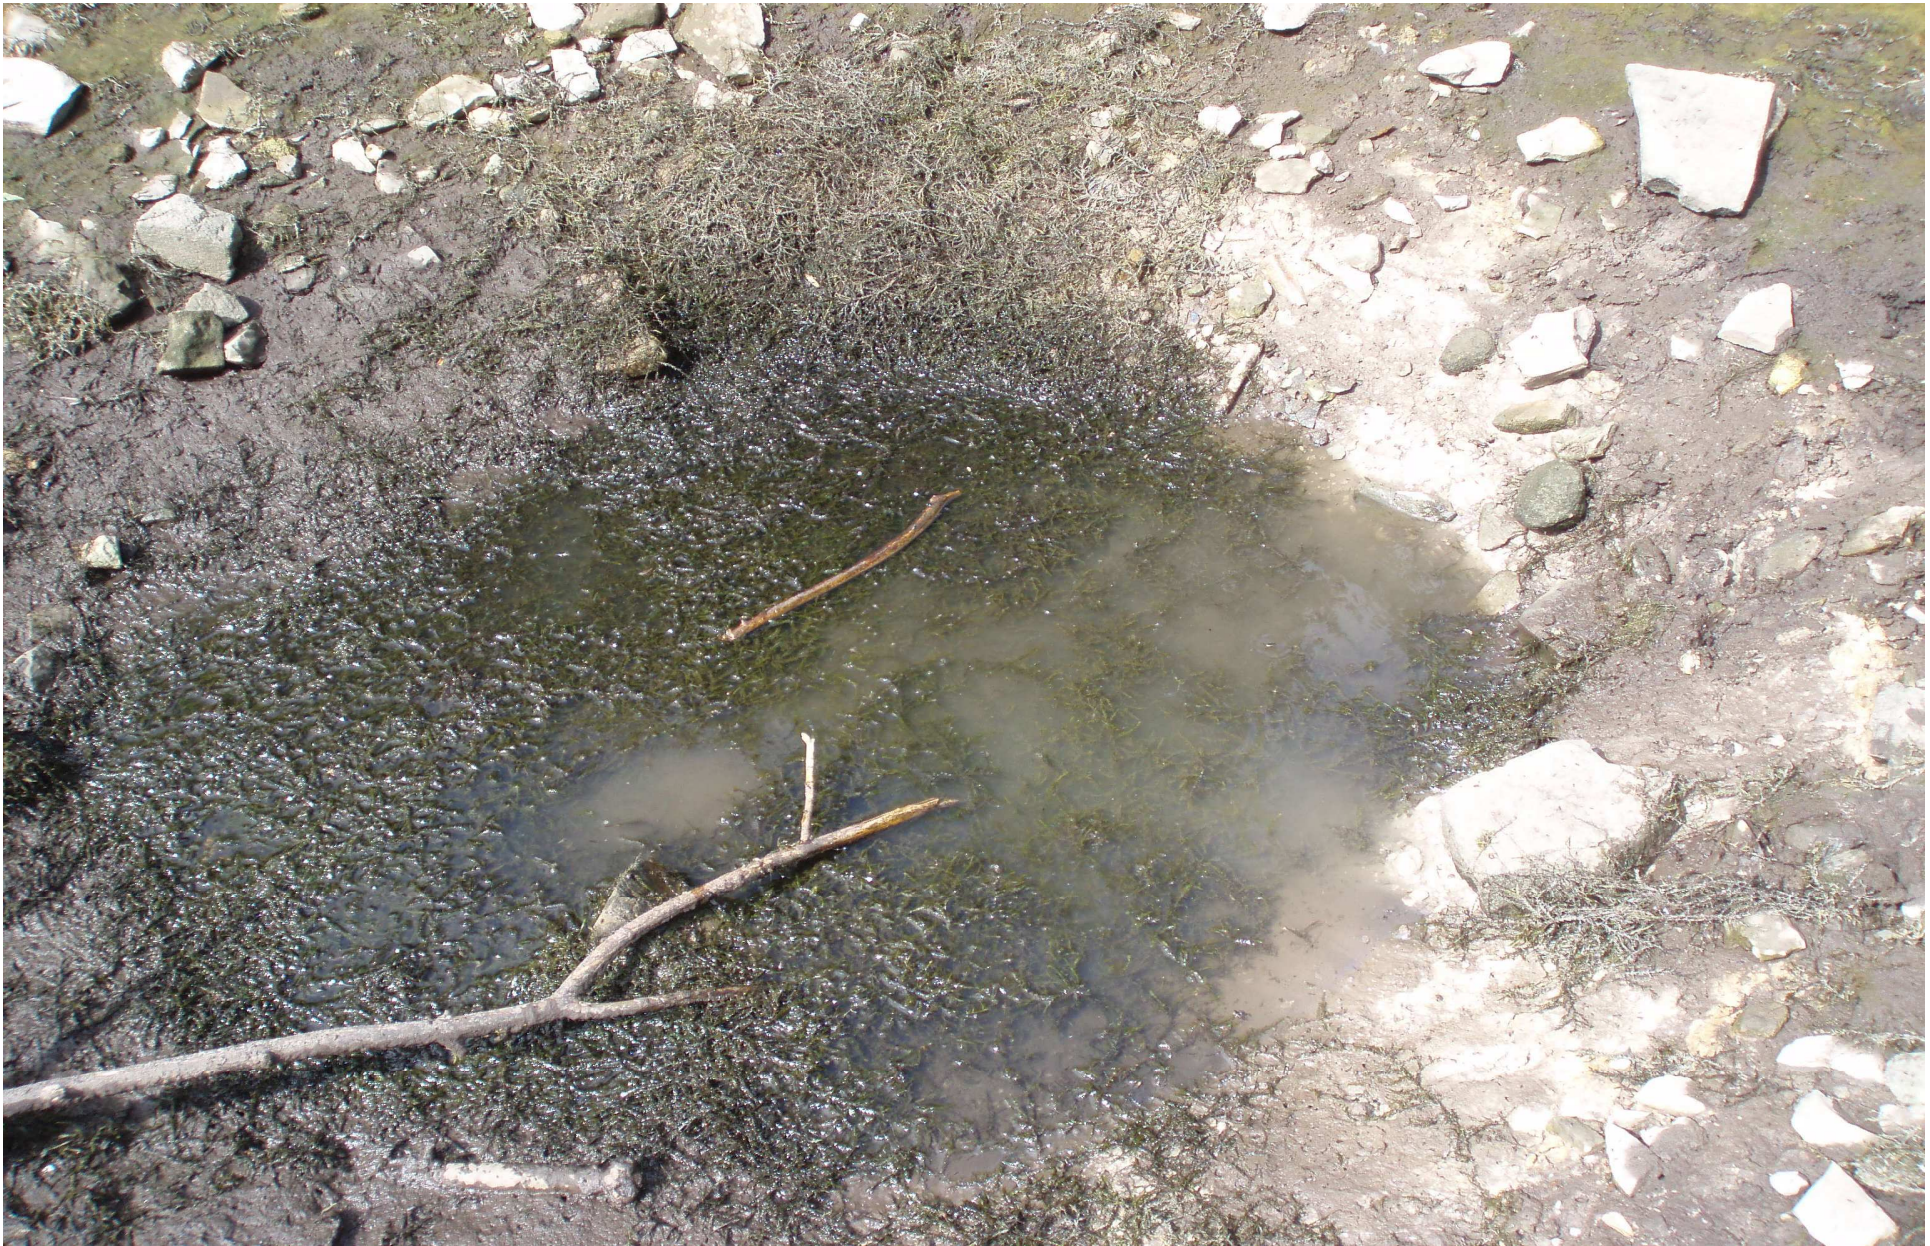
Estavelle – acts as both spring and sink

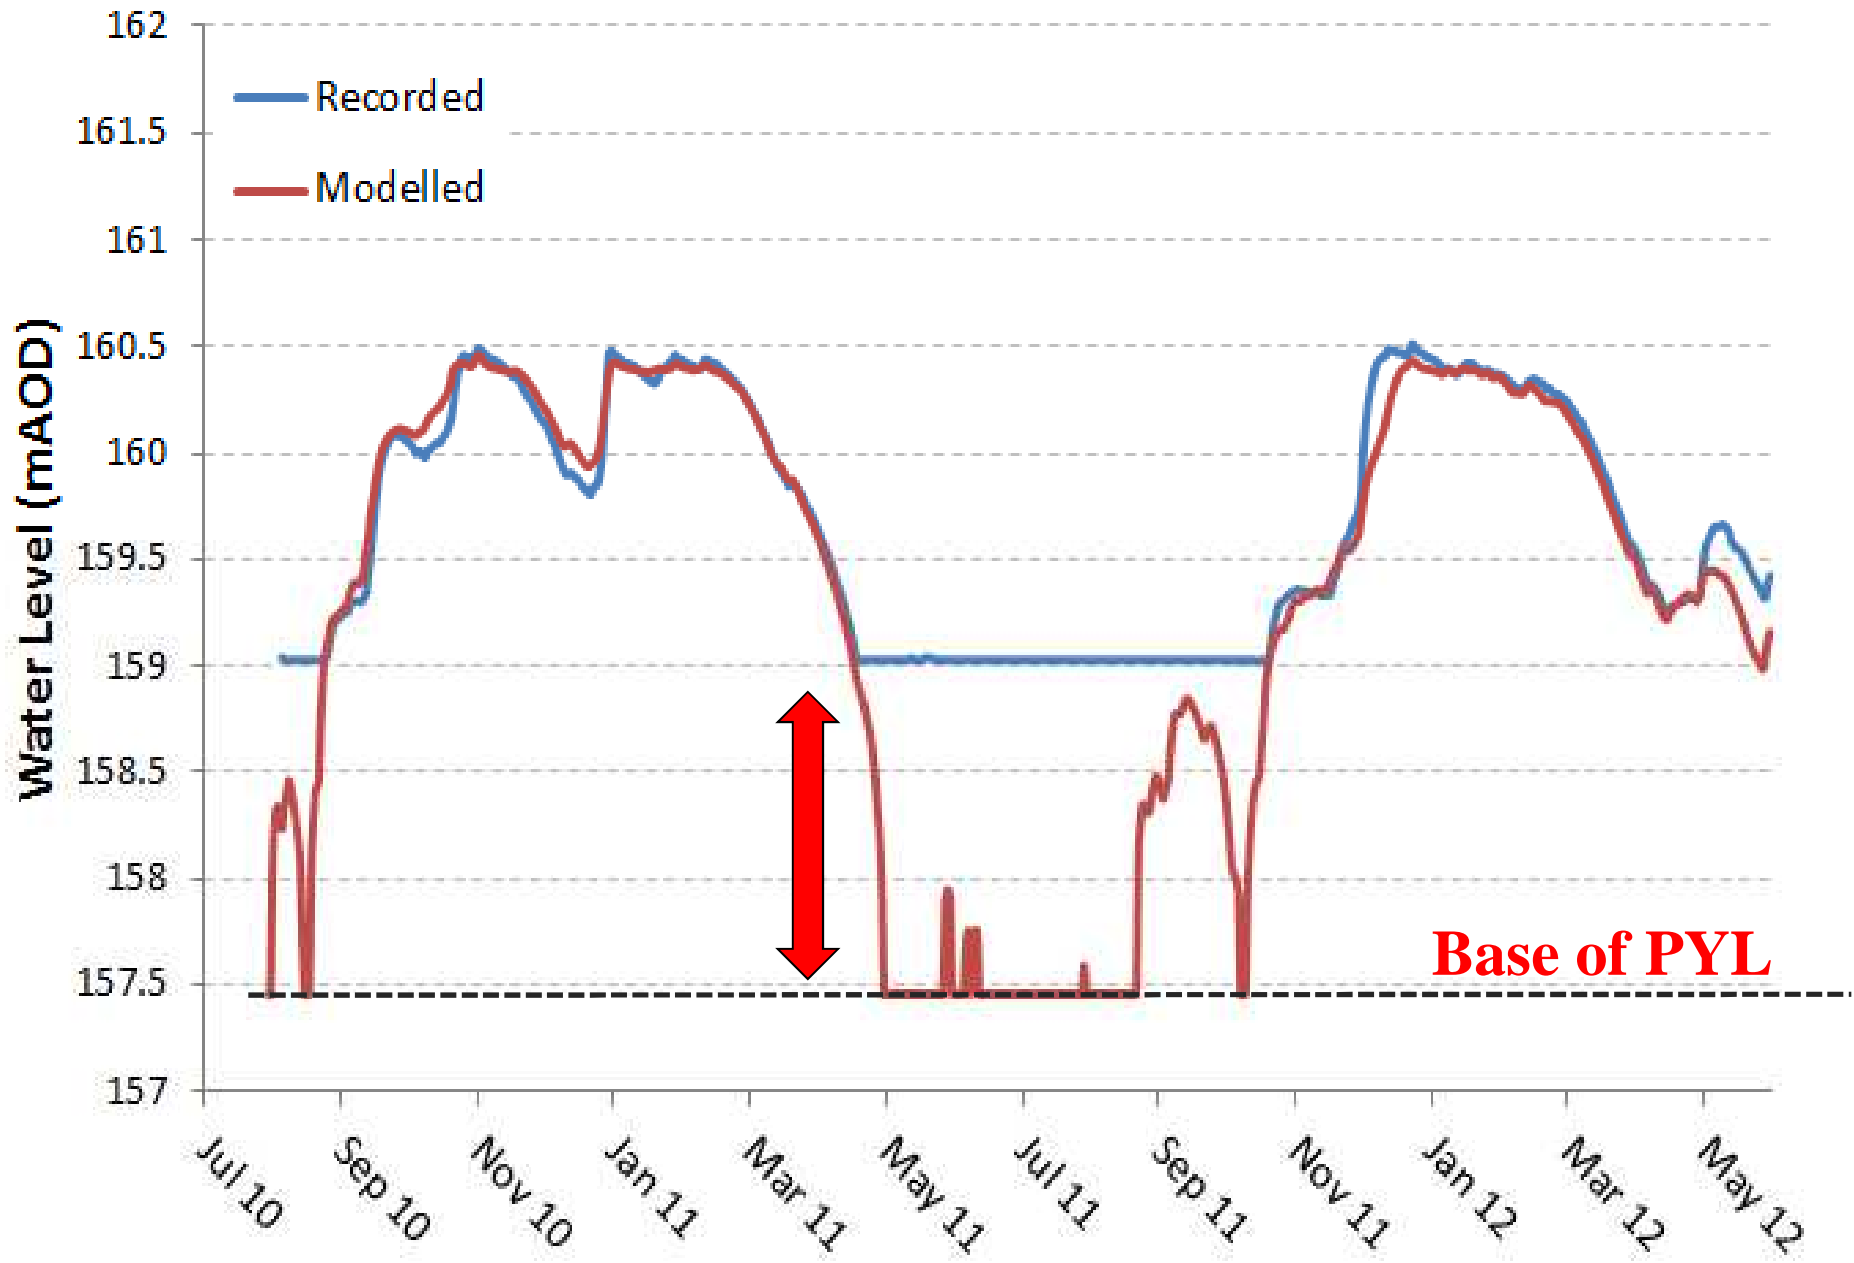
Recorded and Long Term Modelled Stage

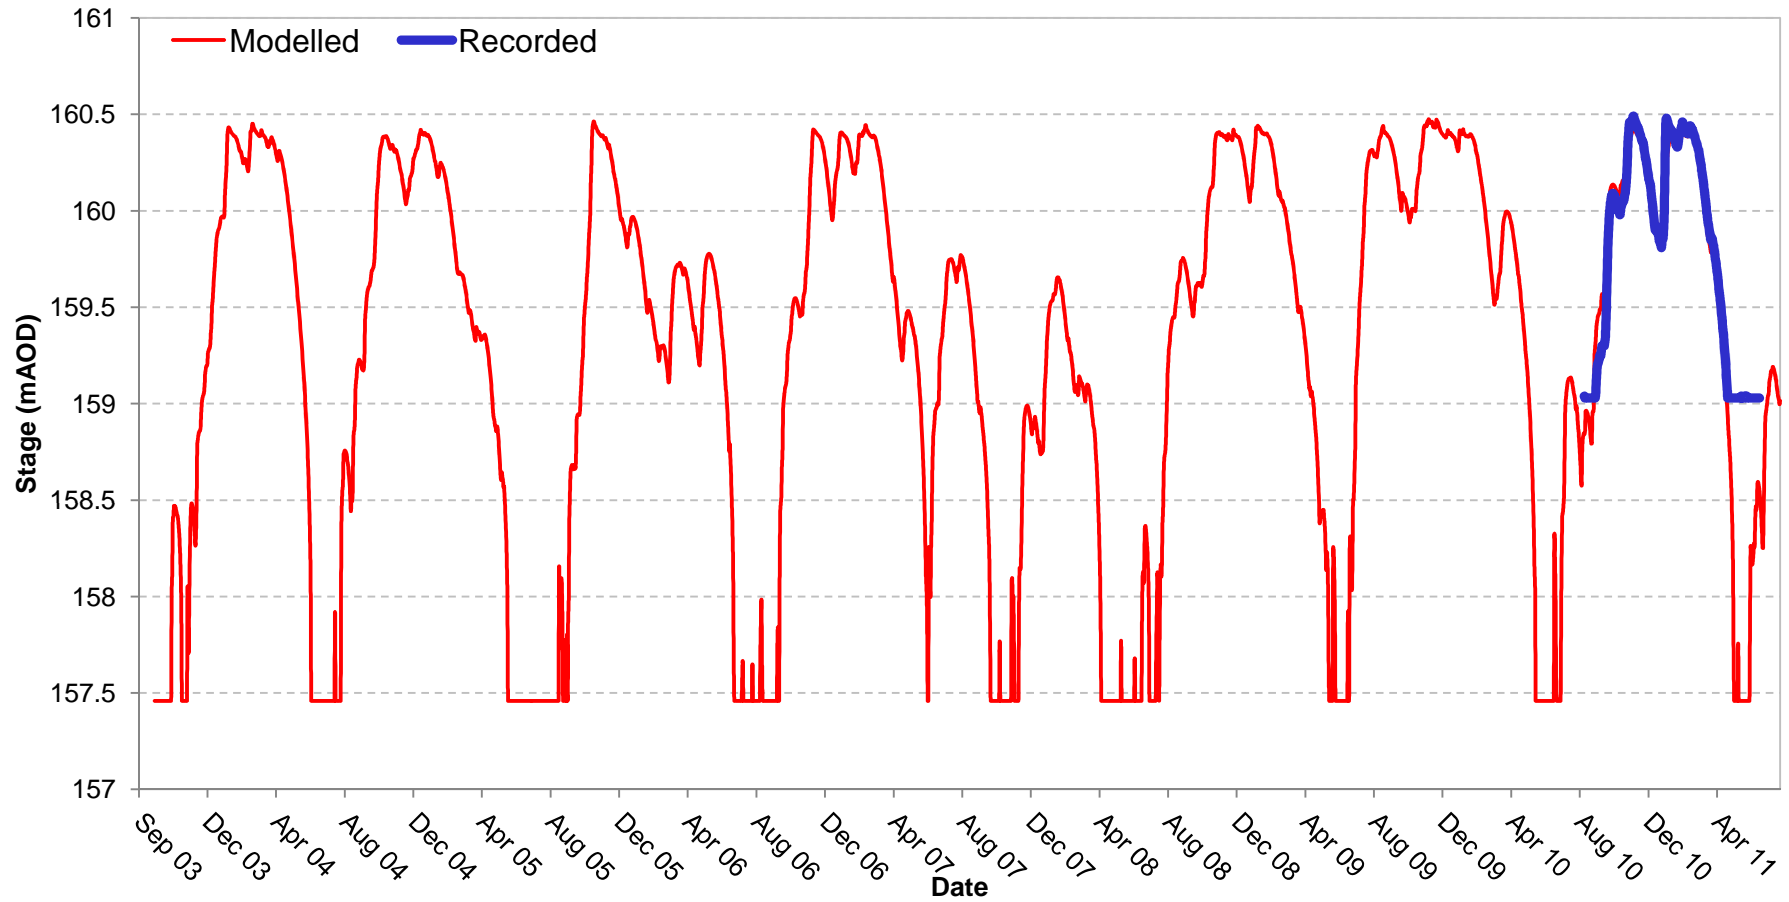
Flood Duration

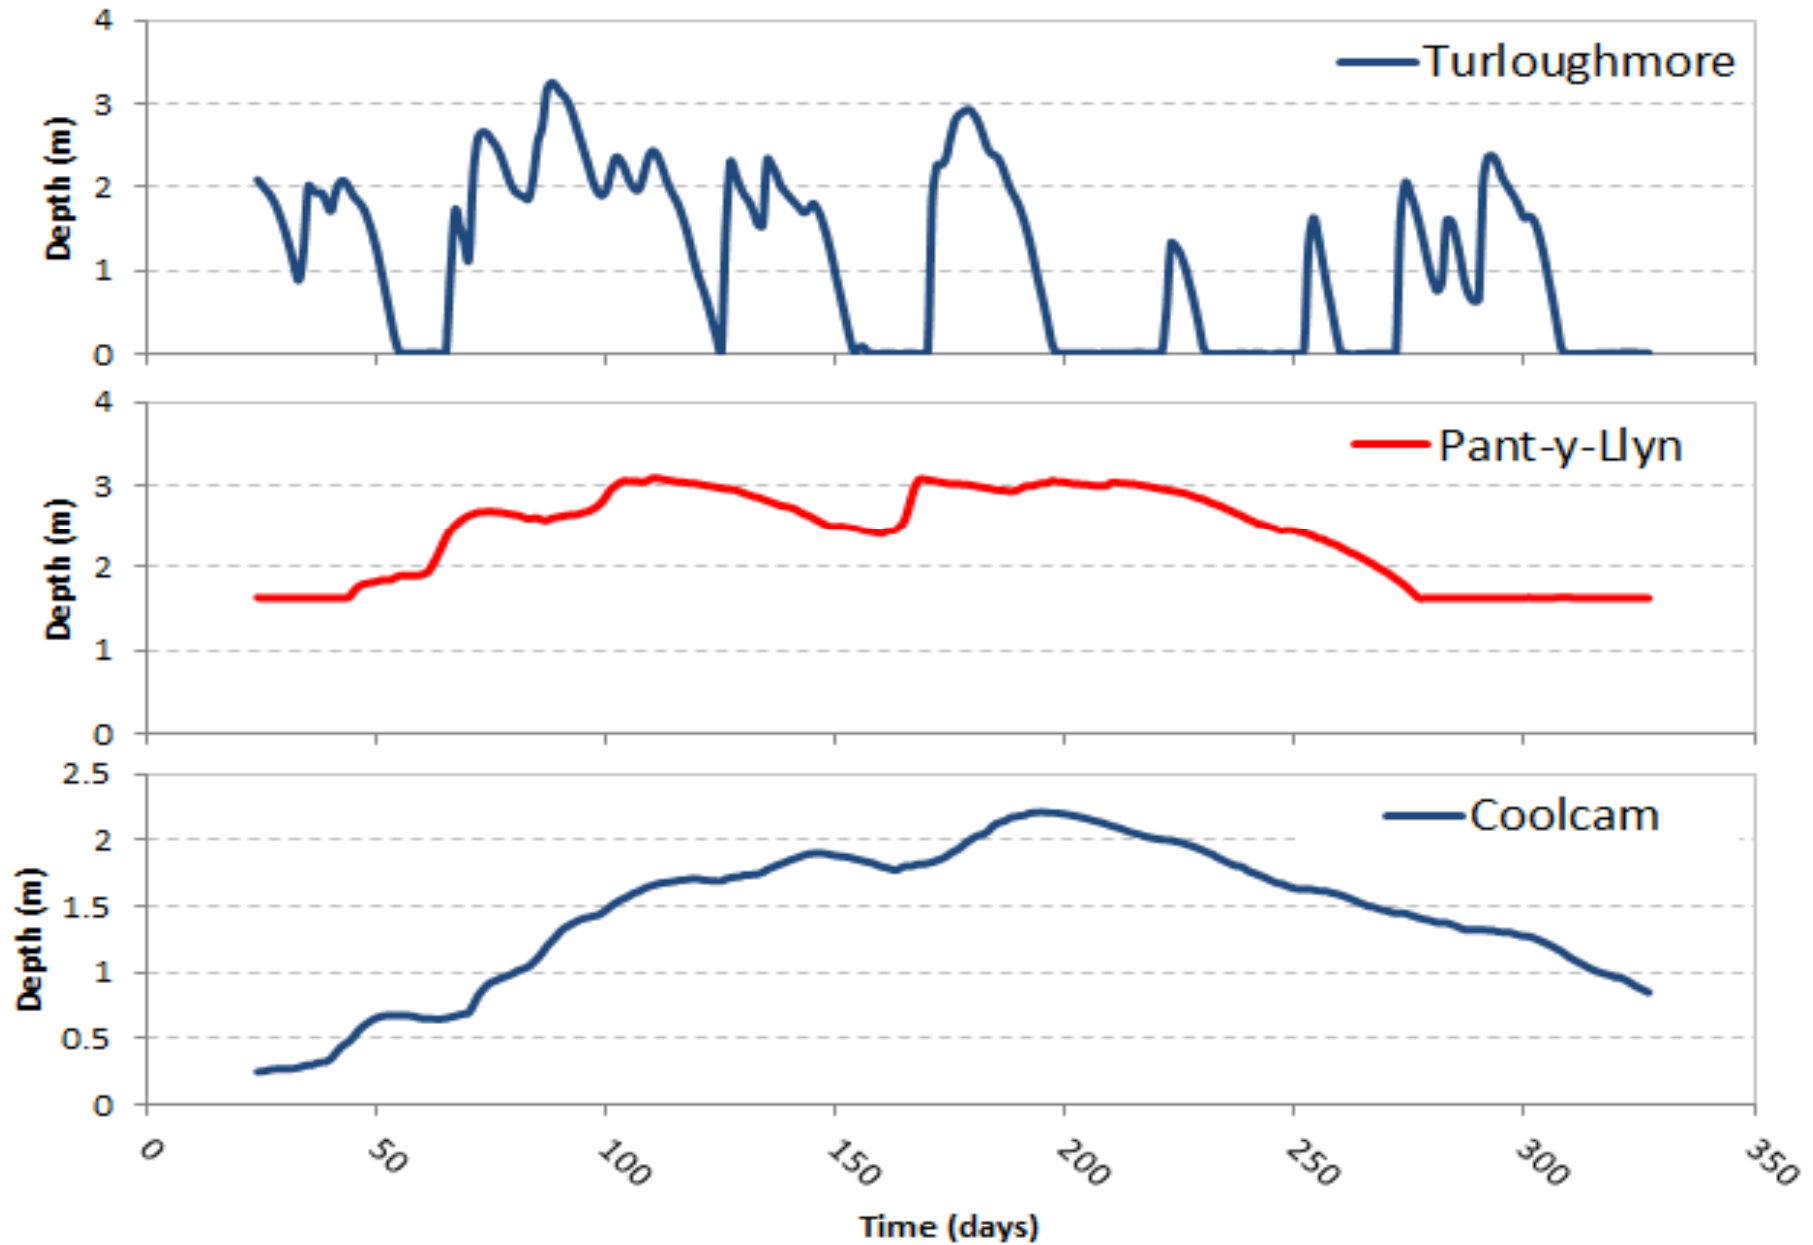
Comparisons with Irish sites
