Rusland Valley Mosses Site of Special Scientific Interest (SSSI), South Cumbria, is a raised mire system with three distinct domes: Hay Bridge Moss, Hulleter Moss and Rusland Moss. The mosses originally developed through the infilling of a former lake which occupied the western side of the Rusland Pool valley (Dickinson, 1973). Initially a fen developed and then raised bogs formed as the peat gradually built up above the level of the surrounding land. Around the edges of the raised bogs a transitional lagg habitat formed, bounded to the east by the original course of Rusland Pool.

## Hydrogeological and Eco-hydrological investigations

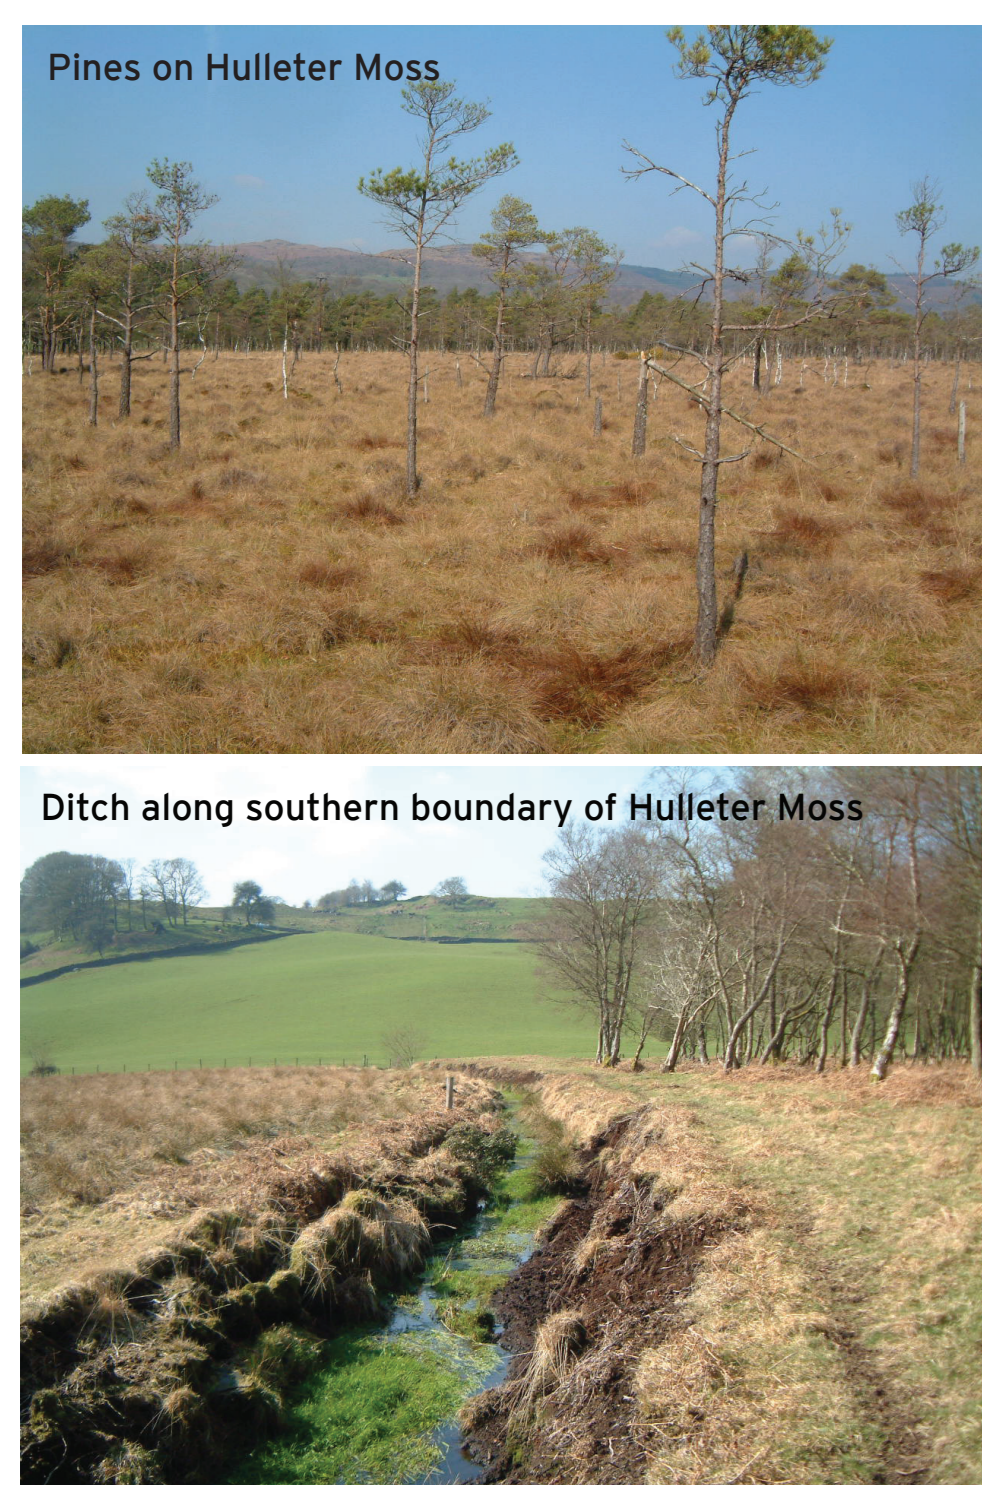
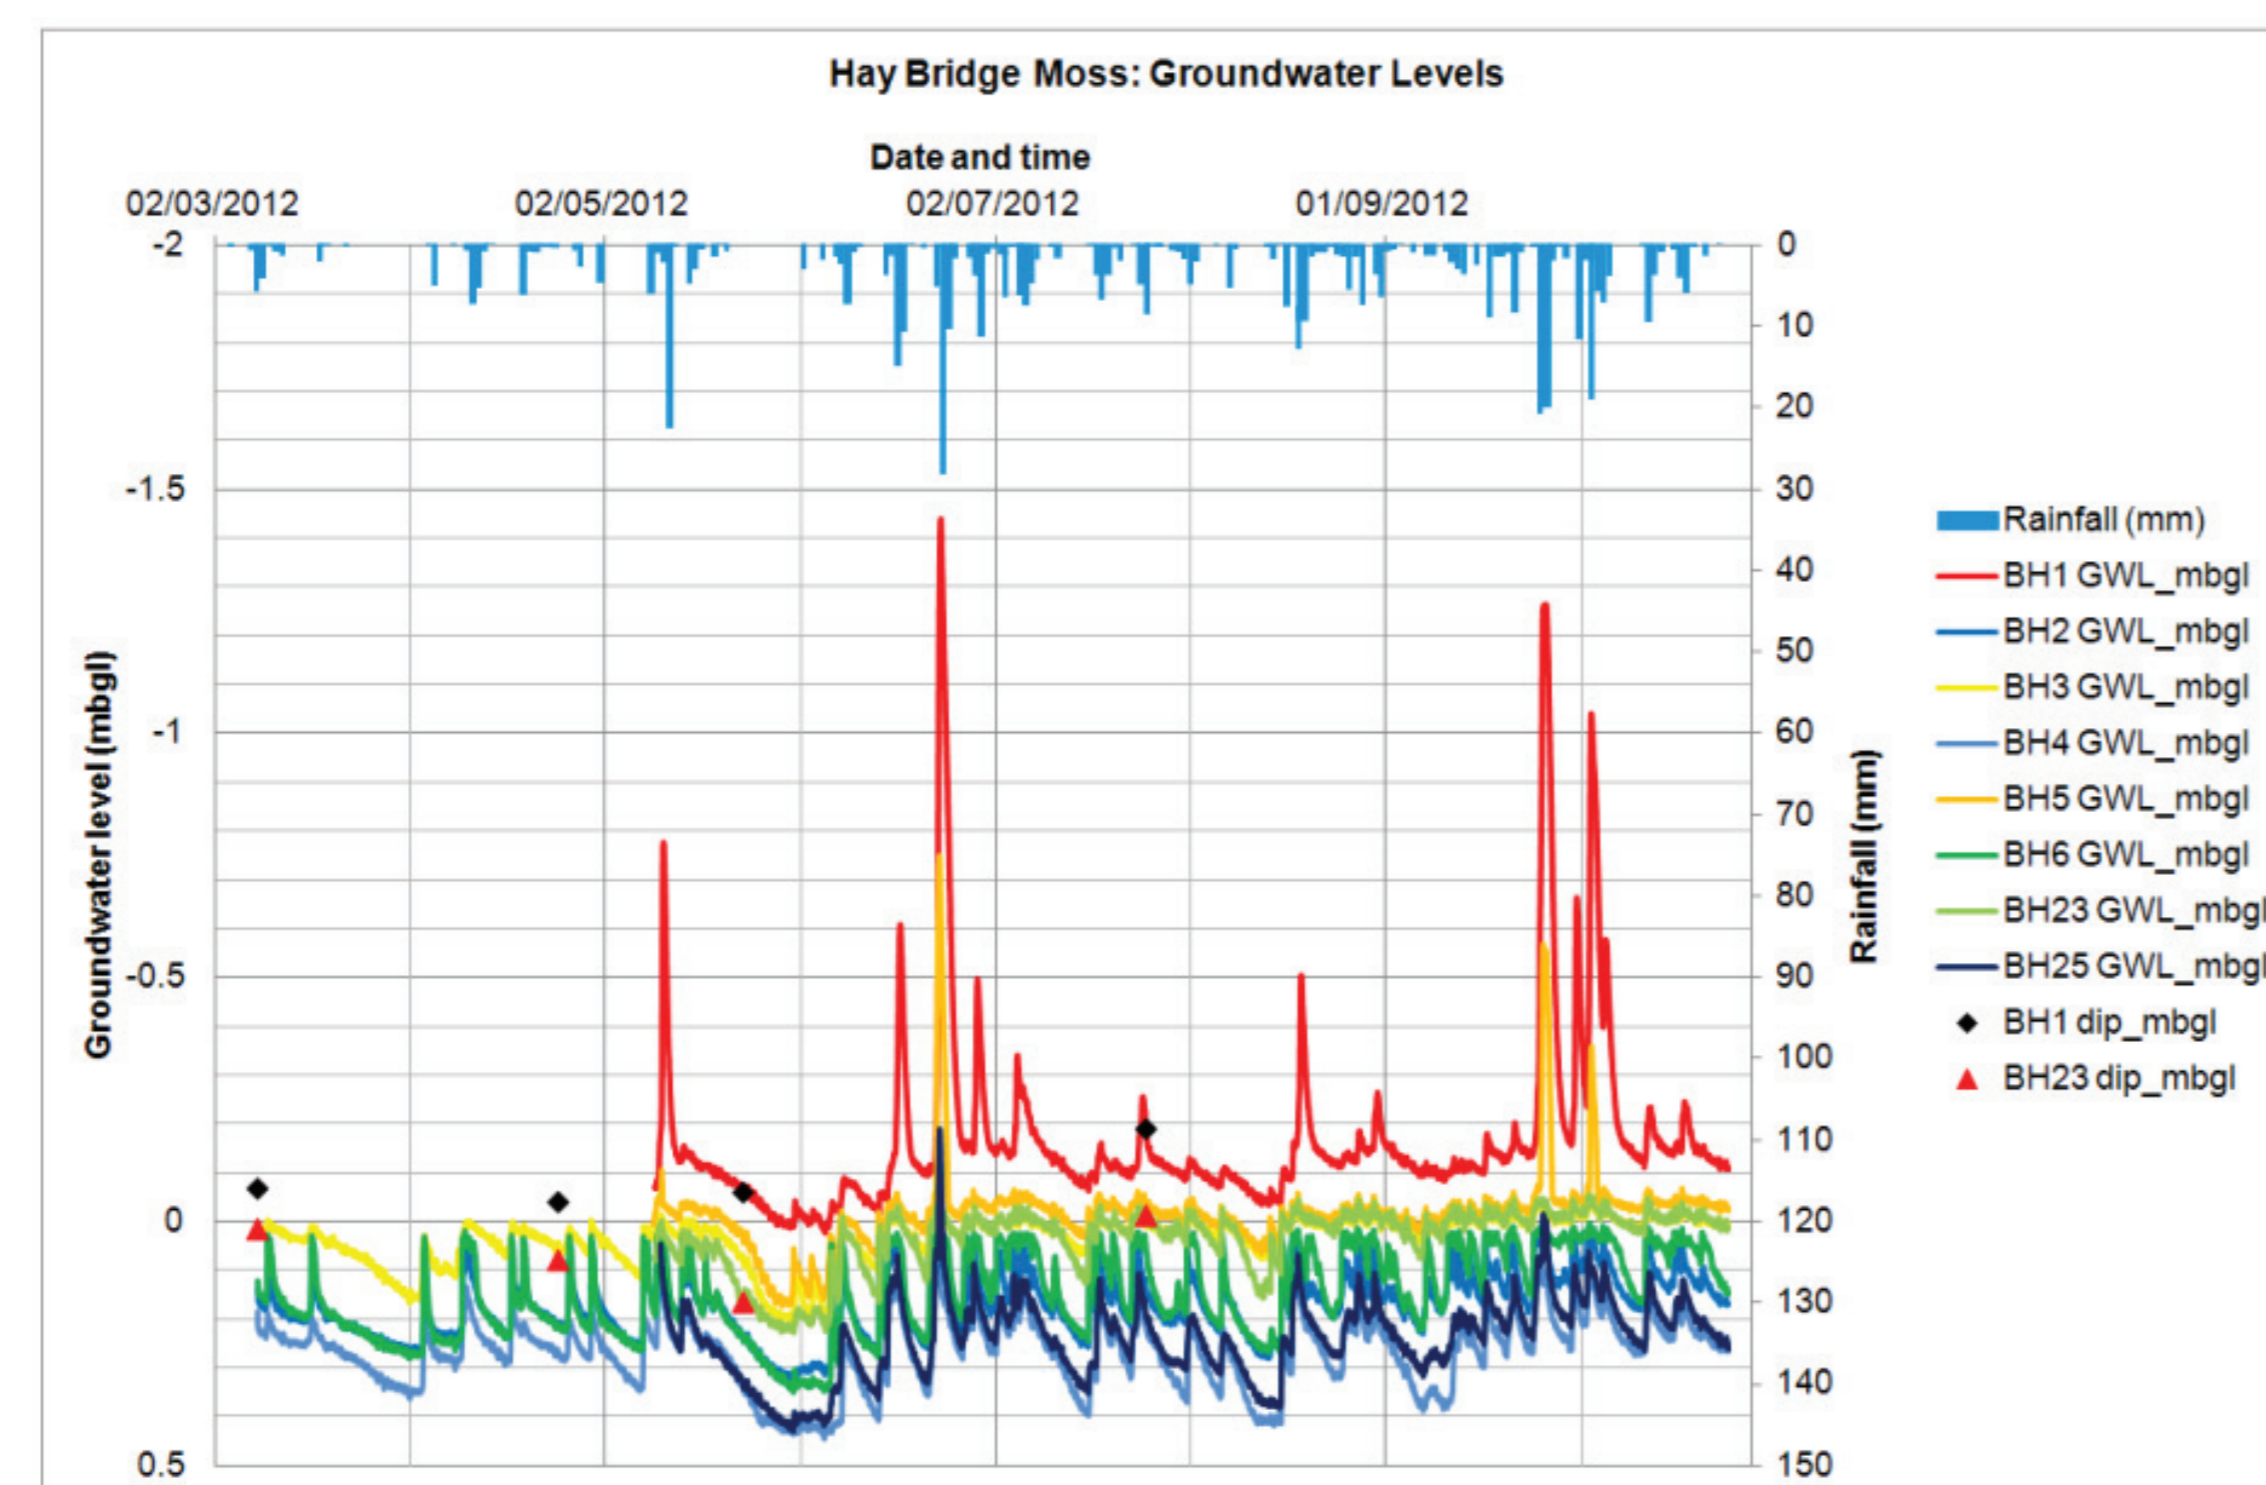
## Water level monitoring: Hay Bridge Moss

Groundwater levels on the dome of a raised bog should be at, or close to, the ground surface all year round: ideally no more than 0.1 m below ground level. Water level monitoring on Rusland Valley Mosses has revealed a mixed picture: some areas have water levels that are appropriate for the target habitat (at least during the limited monitoring period to date), but others display water levels that are too low and/or that fluctuate too widely.

All the groundwater level records show sharp rises in response to rainfall recharge, followed by more gradual recessions. Very spiky (flashy) groundwater level variations are likely to reflect the influence of artificial drainage or the presence of more degraded peat with a lower storage capacity (specific yield). In general the flashier responses to rainfall events occur in boreholes with deeper background groundwater levels. This pattern suggests that the peat is more degraded where the watertable is lower.

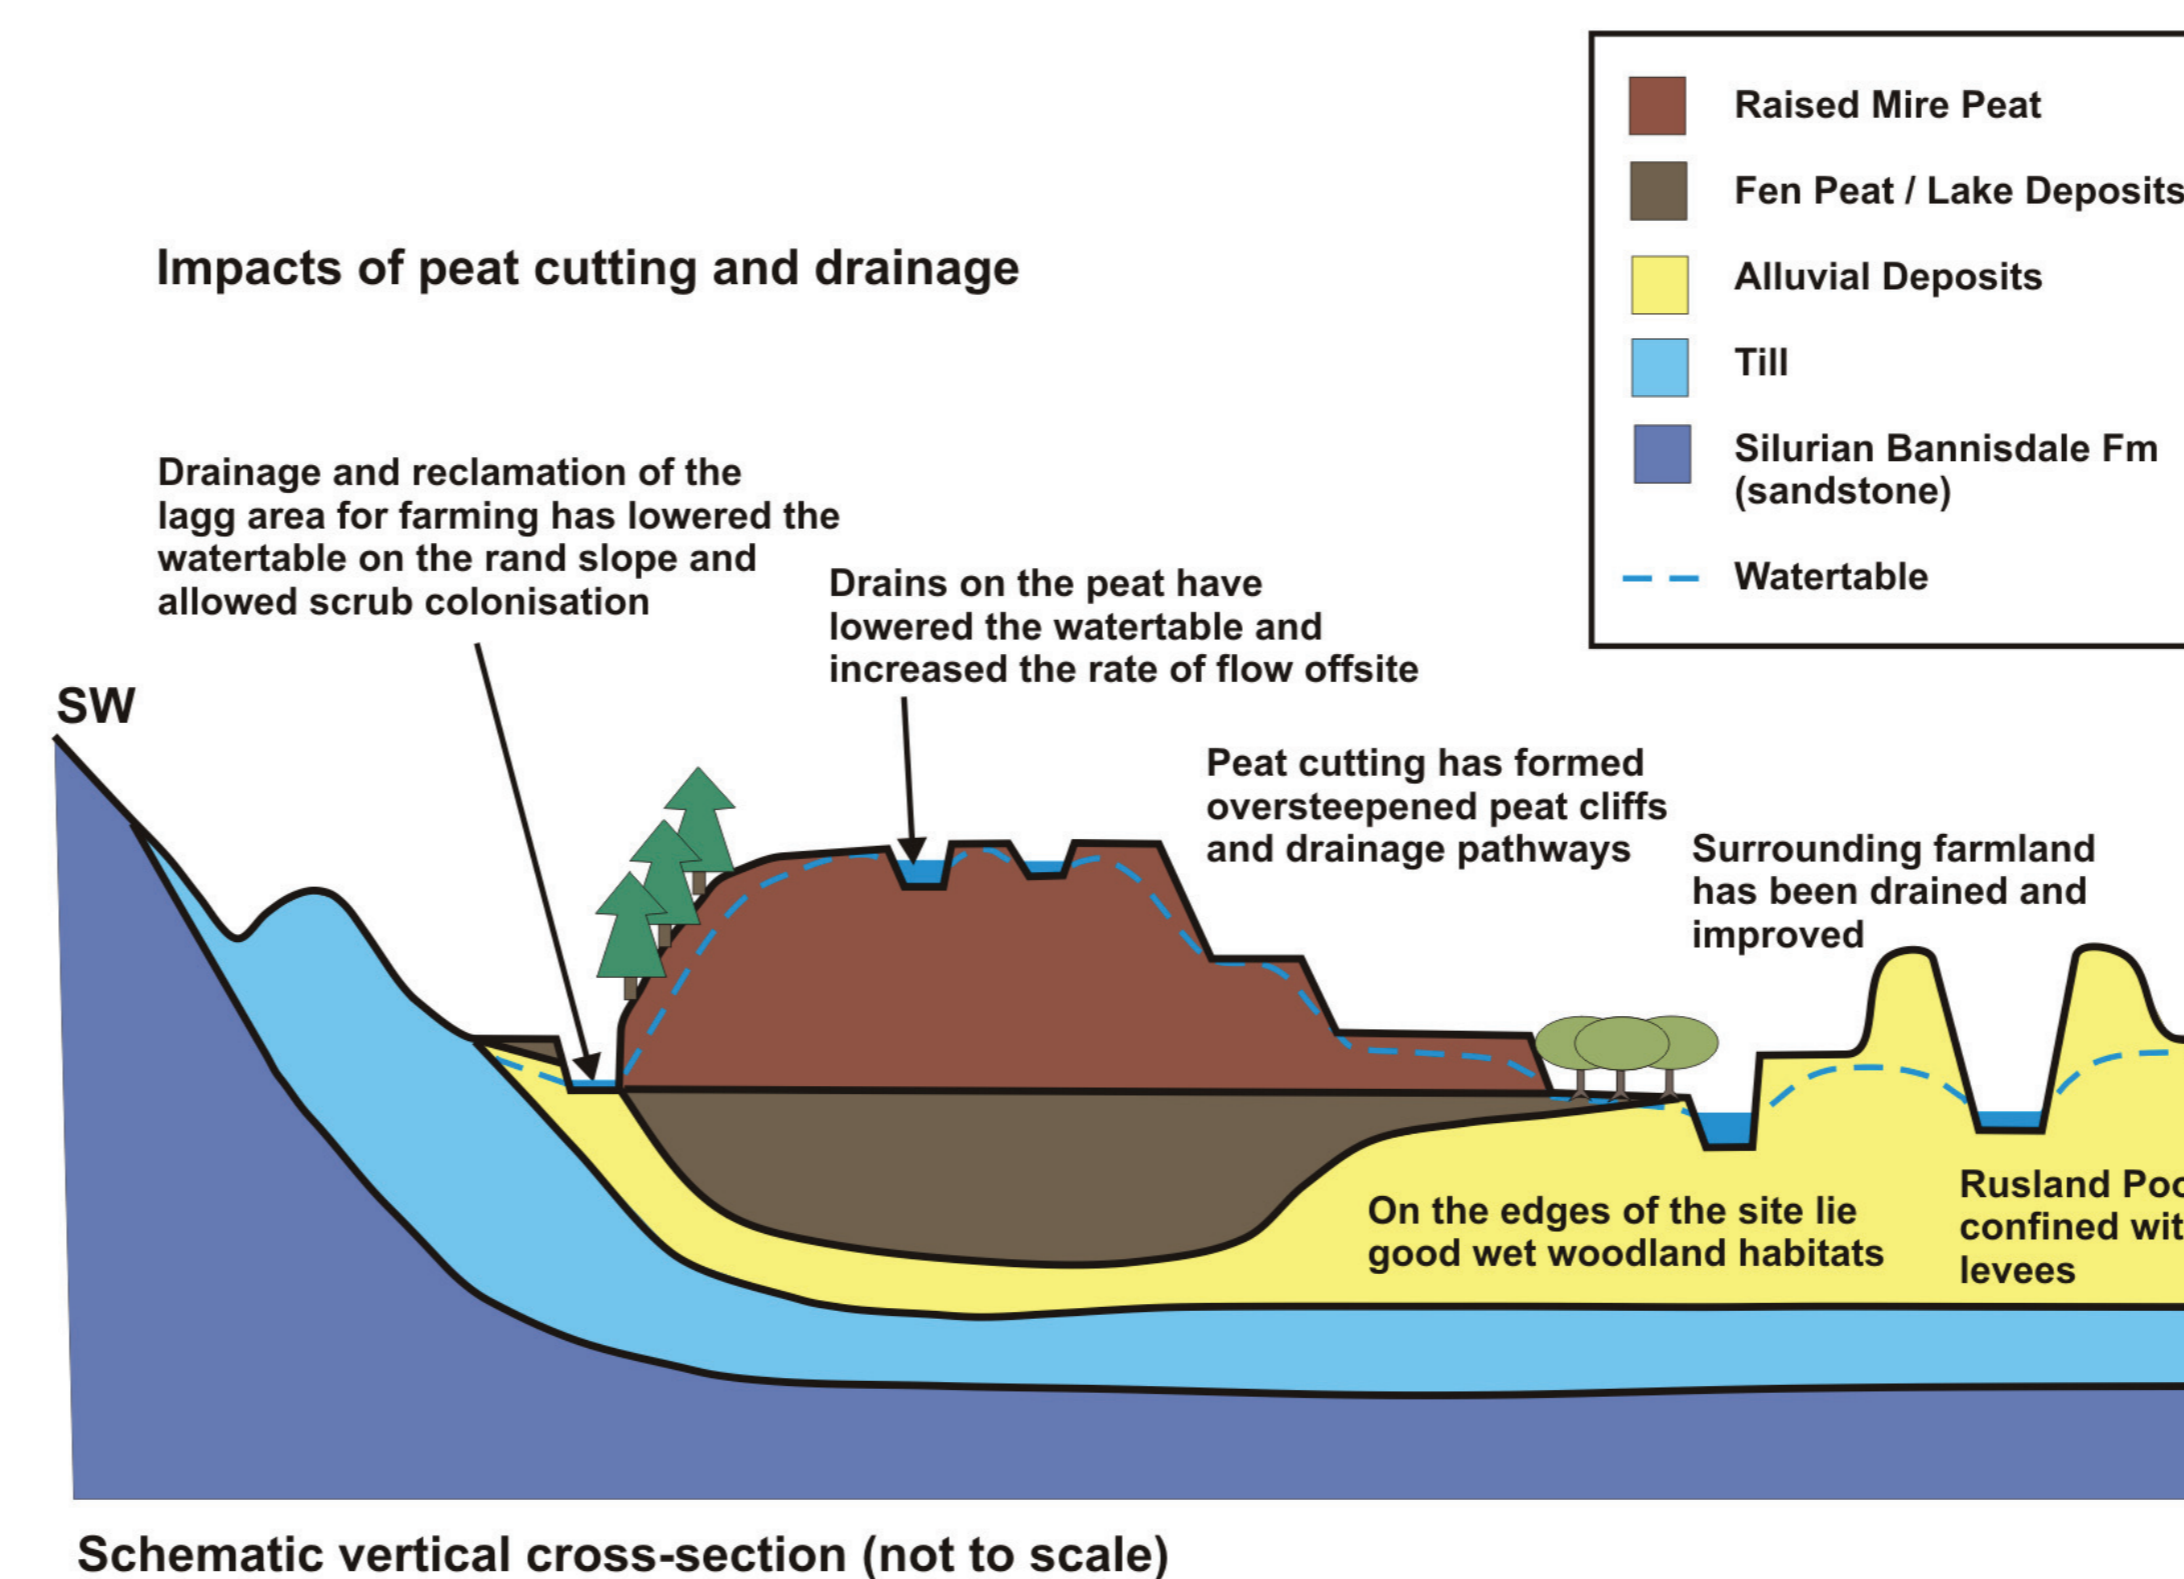
## Conceptual model showing the impacts of peat cutting and drainage

Significant modifications have occurred to the hydrological regime at Rusland Valley Mosses since their formation. Peat cutting, artificial drainage and the encroachment of non-mire vegetation (including scrub and woodland) have all contributed to a general fall in the level of the watertable and an increase in the rate at which water discharges from the site. Natural England is committed to restoring the mosses to intact, fully-functioning, peat bogs. This will require the maintenance of a high and stable watertable over most of the area, giving ideal conditions for the active growth of *Sphagnum* moss and the subsequent accumulation of peat.

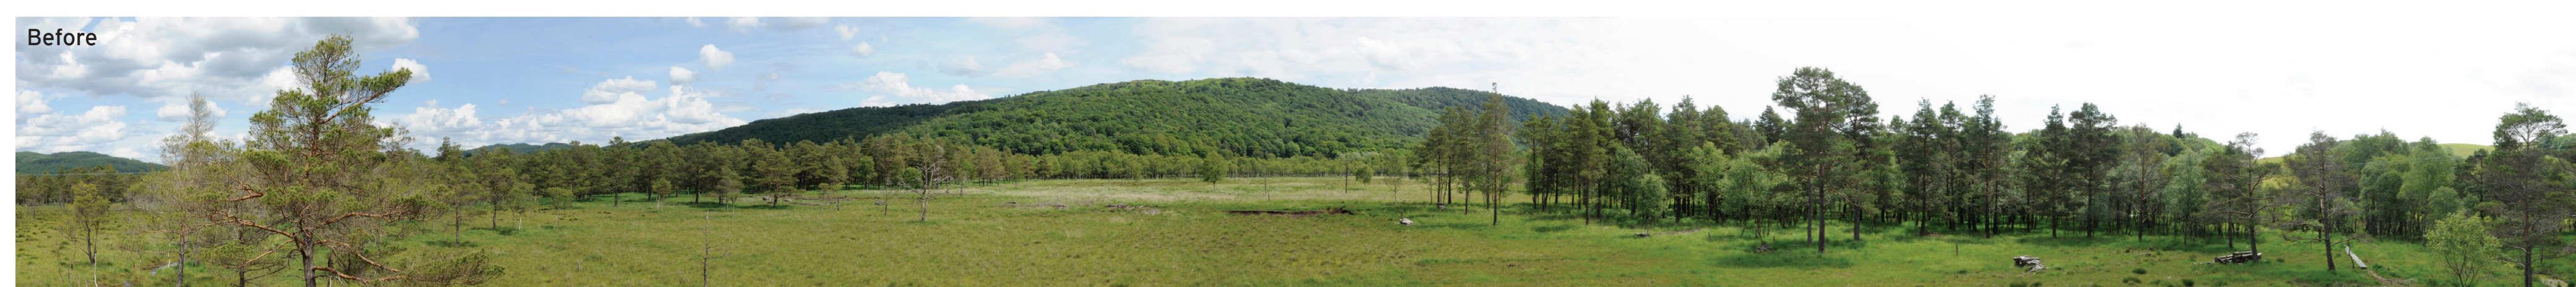
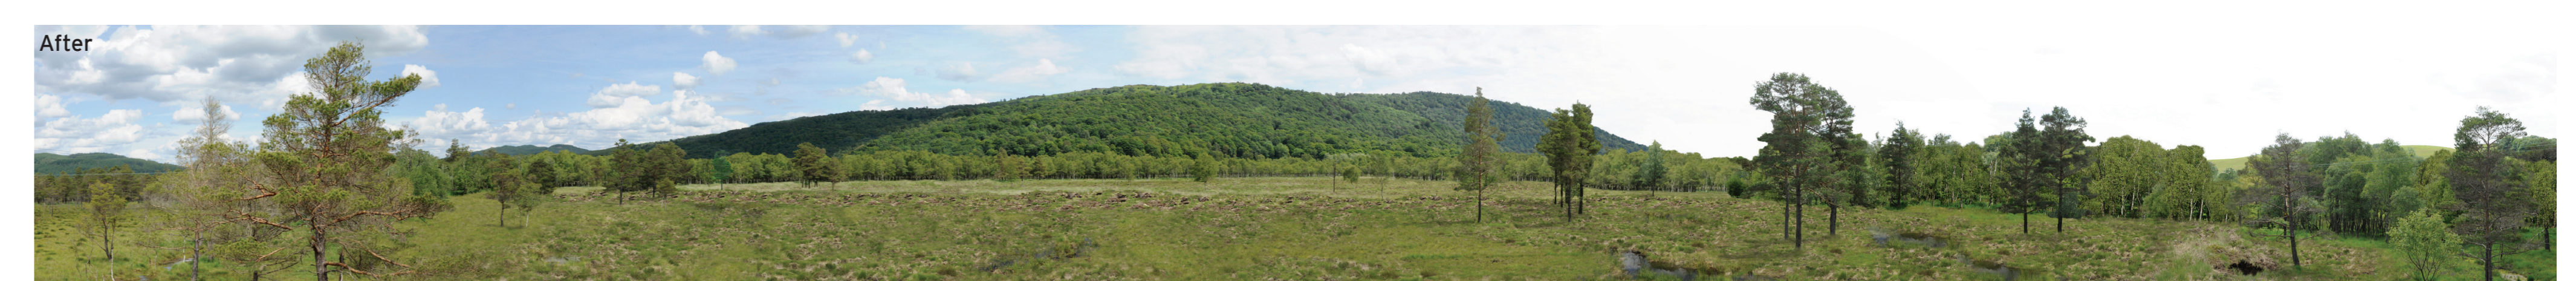
## Landscape Visualisations: Hay Bridge Moss

JBA has used photographic imaging techniques to produce "before and after" visualisations showing the likely changes that restoration would cause to the appearance of the landscape. One of the main challenges facing Natural England is the need to positively engage with local stakeholders to explain the need for restoration measures such as ditch blocking and tree felling. Clearly presented water level monitoring data and landscape visualisations will play a vital role in communicating the conservation issues and restoration proposals.
