# Use of remote sensing for proactive management of geotechnical assets on the strategic road network in England

Ground Related Risk to Transportation Infrastructure

October 26<sup>th</sup>-27<sup>th</sup> 2017

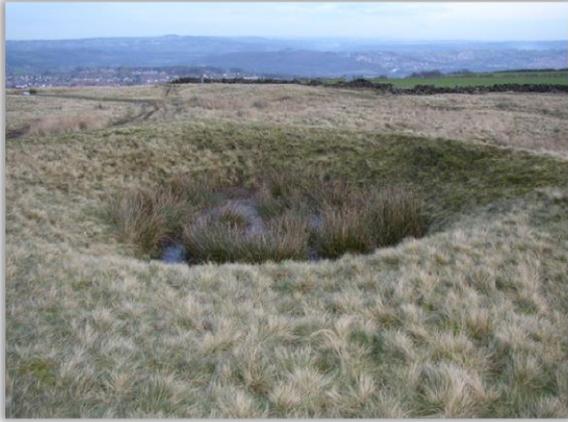
**Settlement and collapse due to coal and other mining**

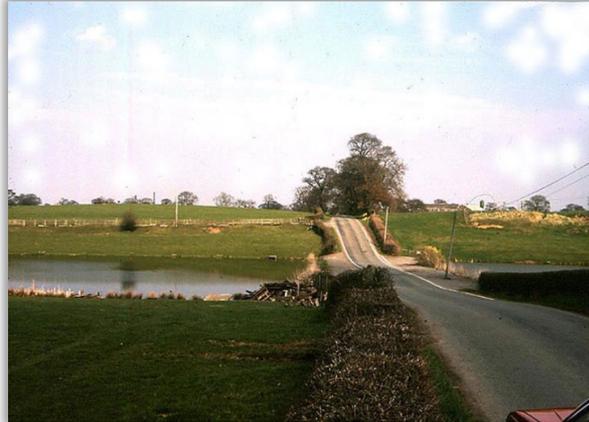
**Subsidence from brine extraction**

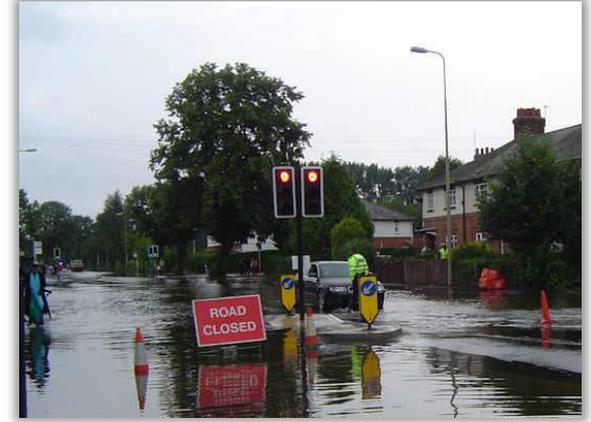
**Groundwater flooding**

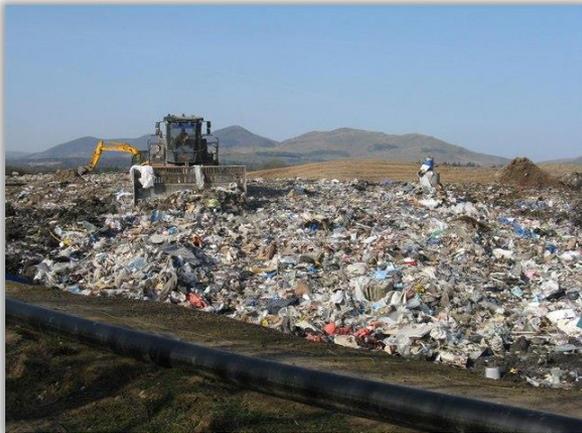
**Subsidence and contamination from landfill**

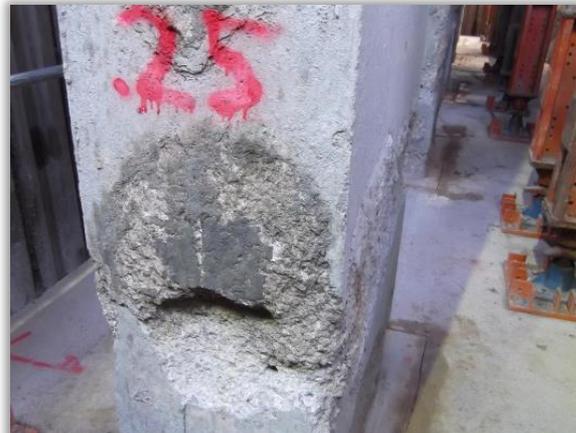
**Aggressive/Corrosive ground and groundwater**

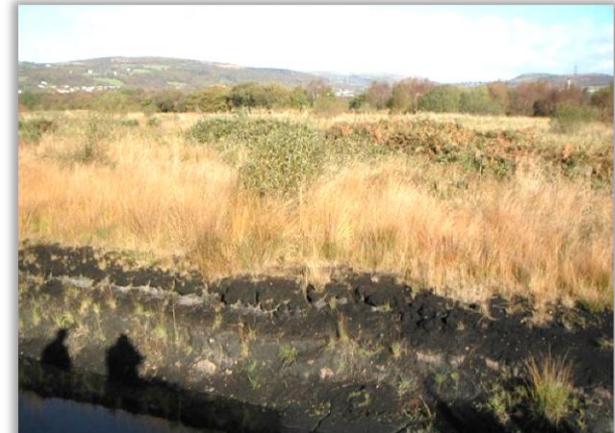
**Compressible soil**

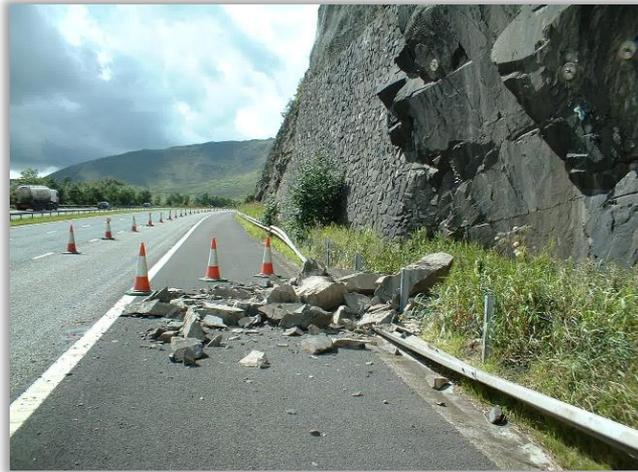
**Rock slope failure**

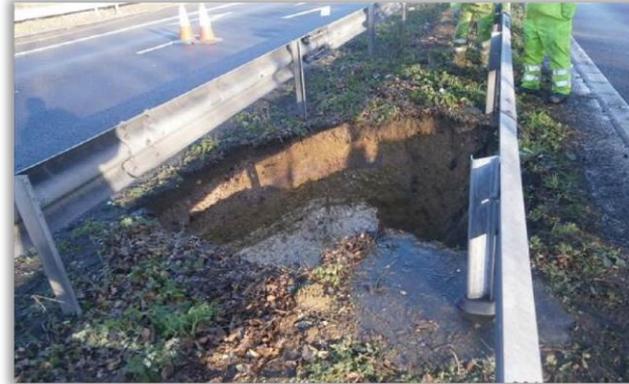
**Soluble ground**

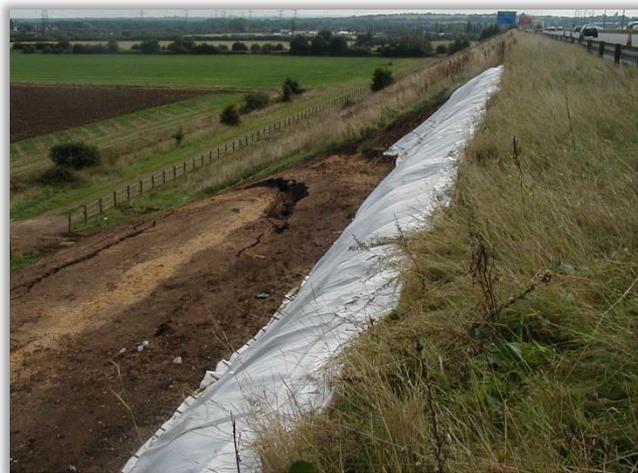
**Engineered soil slope failure**

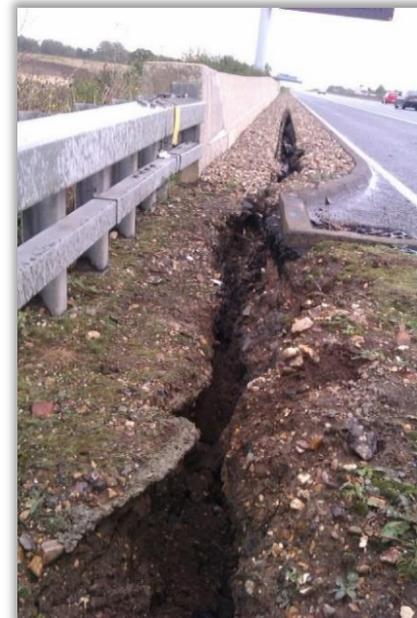
**Shrink/Swell**

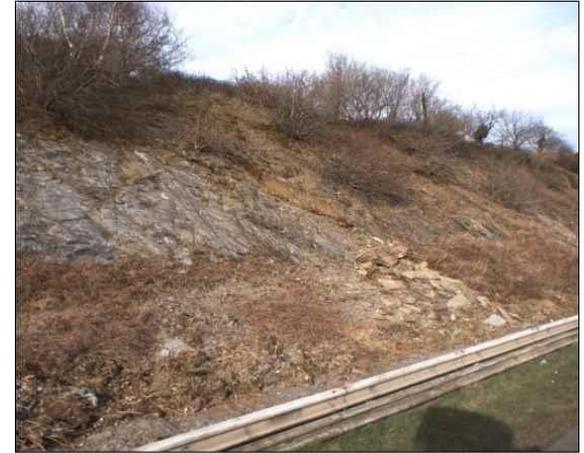
# Asset Visualisation Information System (AVIS)

- Nationwide repository for Highways England’s visual data including photographic imagery and LiDAR point clouds
- Collected via vehicle mounted sensors – provides a “drivers-eye” view
- Imagery collected approximately 1-3 year frequency
- Useful tool for geotechnical applications
  - Allows general observations about geotechnical assets
  - Could be used to support remote inspections of cuttings
- Version 2 has recently been released

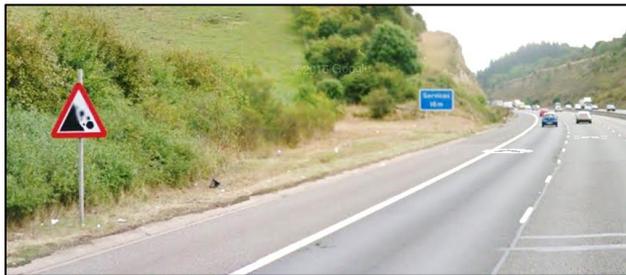
# LiDAR case study: special geotechnical measures

- Site has rockfall mitigation fencing installed at the base of the cutting
- Carried out change detection between 2013 and 2014 LiDAR data captured by vehicle mounted sensors
- No changes found in catch fencing over 1 year
- The analysis highlighted vegetation growth

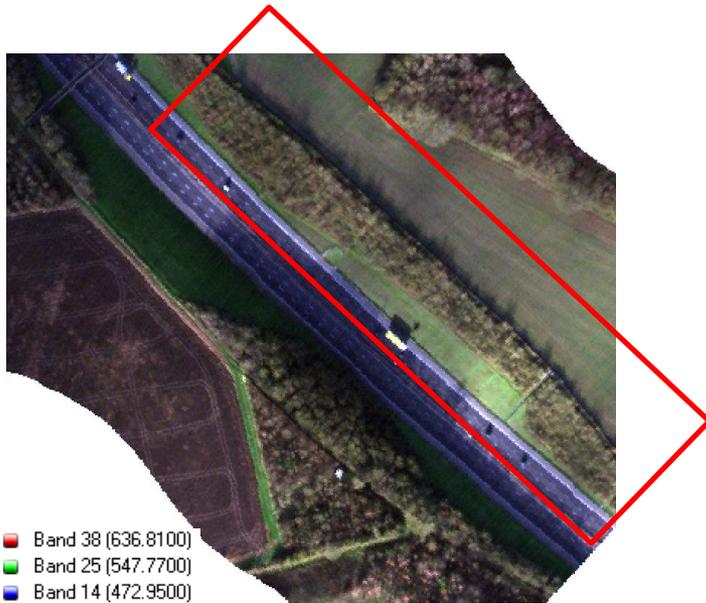
# Hyperspectral imaging case study: drainage and soil moisture

- Drains highlighted clearly in the Colour Infrared band combination
- Spectral profile in the SWIR section shows higher reflectance at point A than point B suggesting the slope is drier at point A (where the drainage is)

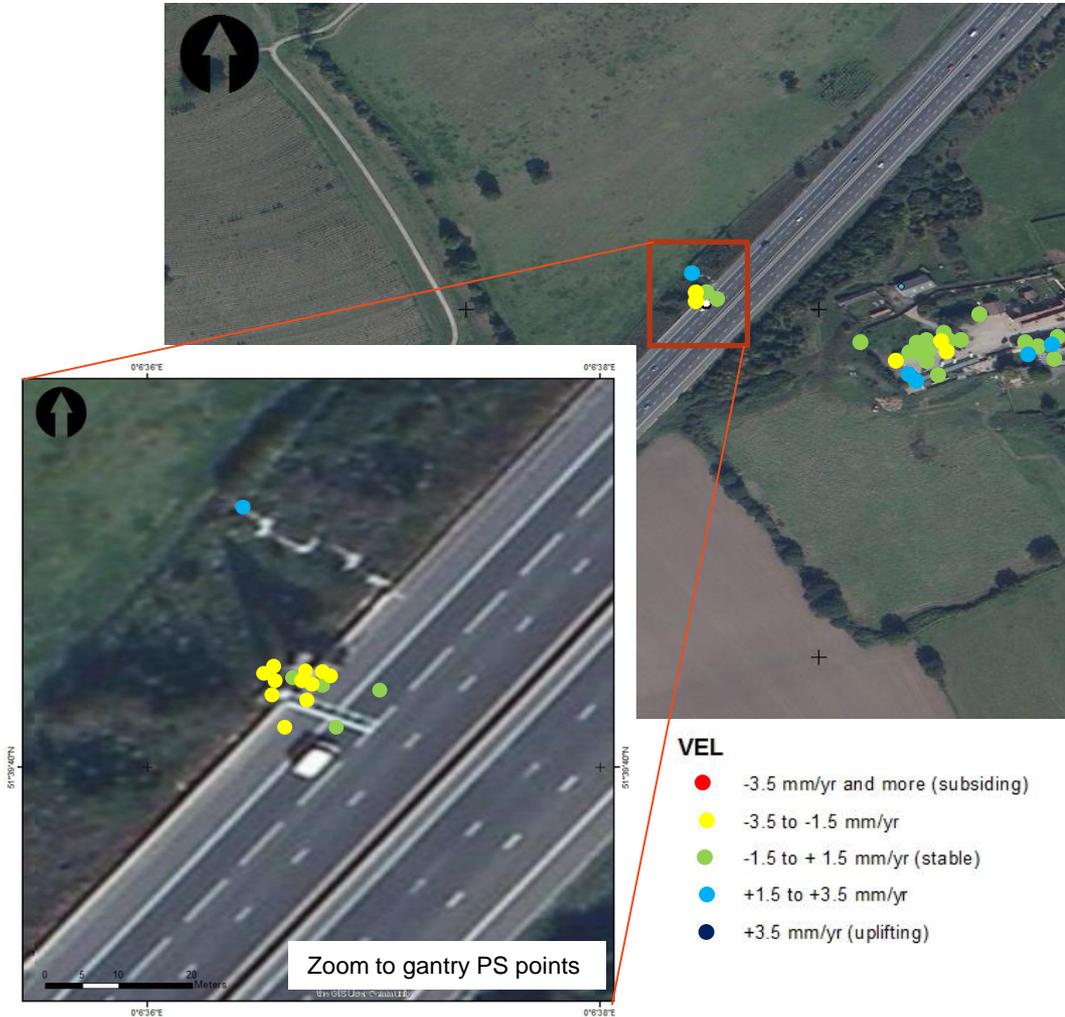
## Persistent Scatterer (PS) results

- Only 19 points on the carriageway, most associated with the gantry
- Average of 1.5-3.5 mm/yr subsidence
