# Use of LiDAR and photogrammetry to develop predictive models of slope stability

Oliver Dabson and Jamie Gilham

**JACOBS**<sup>®</sup>

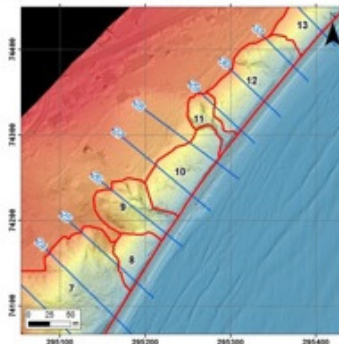
Map 1: Digital elevation model (LiDAR 2014)

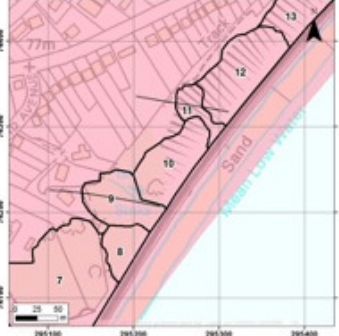
Historical Events (Date and Description) 1920 <del>collapse</del> Deep-seated failure in March 2014		Map 2: Bedrock and Superficial Geology (Based on BGS 1:10,000 data)

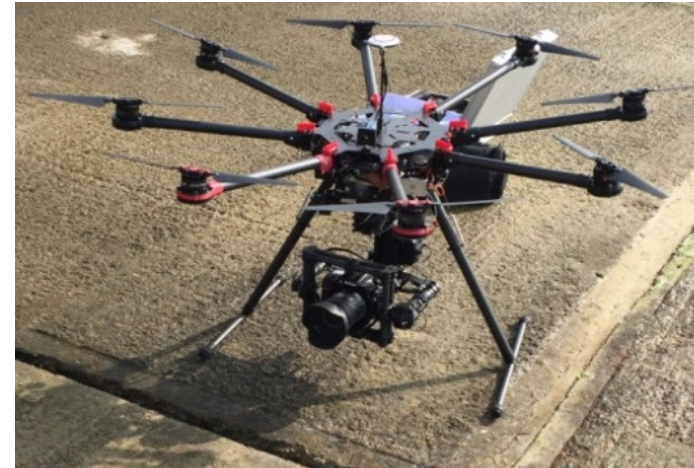
Photogrammetry – UAV deployment (Telscombe cliffs)

<b>UAV model</b>	DJI S1000 octocopter
<b>Max. take-off load</b>	10.89kg
<b>Max. wind</b>	10m/s
<b>Max. altitude</b>	1000m
<b>Max. flight time</b>	15 mins (with load)
<b>Motors and type</b>	8 motors (model 4114-11)
<b>Batteries</b>	Lithium polymer
<b>Flight modes</b>	Manual or GPS aided navigation

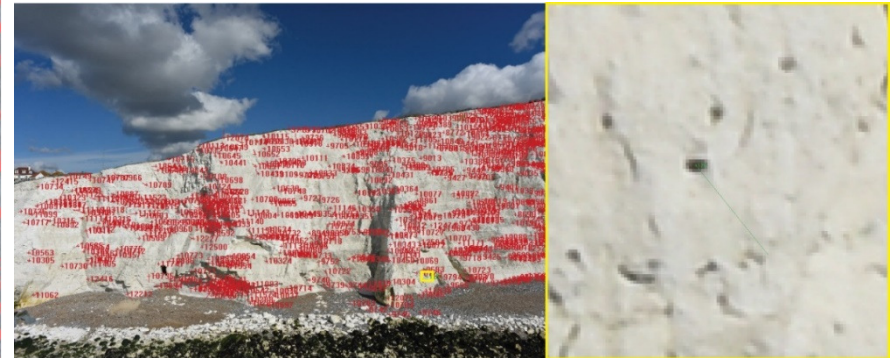
Exterior orientations (3DM Calib Cam)

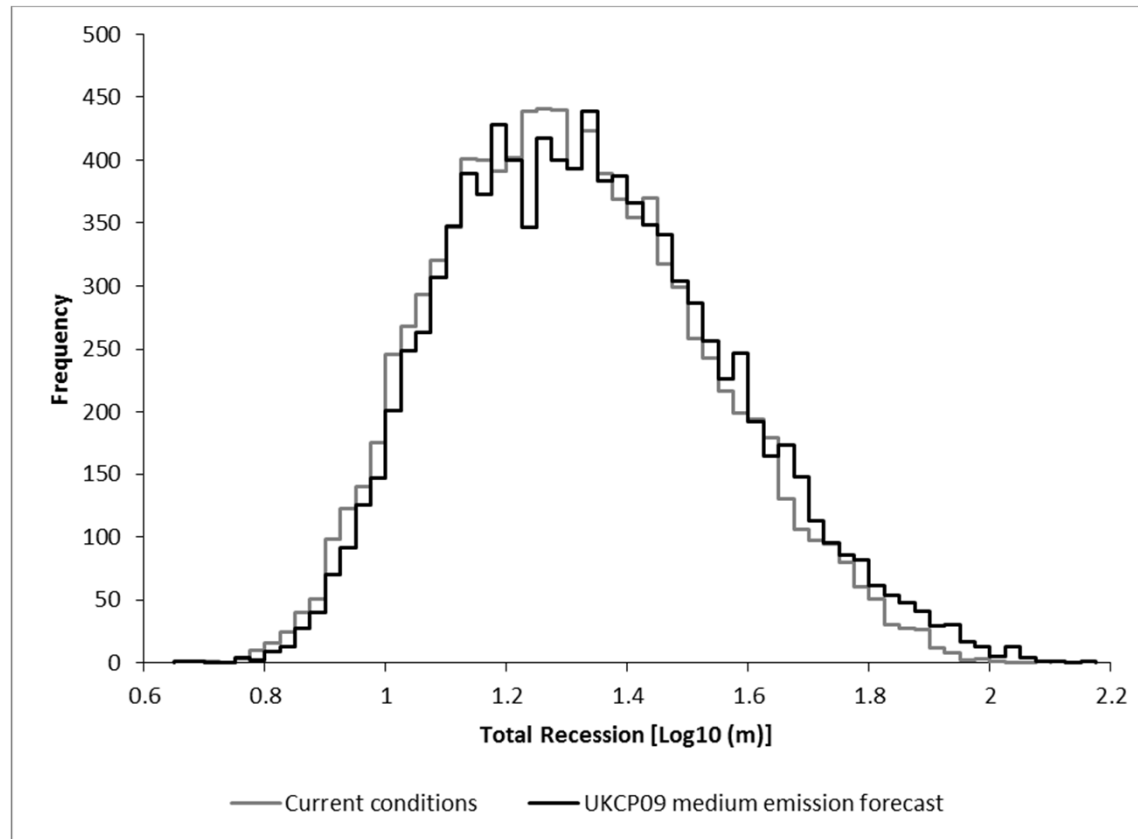
Current Conditions		UKCP09 medium emission forecast	
	Log10	Recession (m)	Log10	Recession (m)
<b>Average</b>	1.311	20.45	1.338	21.76
<b>Max</b>	2.086	121.97	2.157	143.56
<b>Min</b>	0.714	5.18	0.659	4.56
<b>95.5%CI</b>	1.750	56.26	1.797	62.61

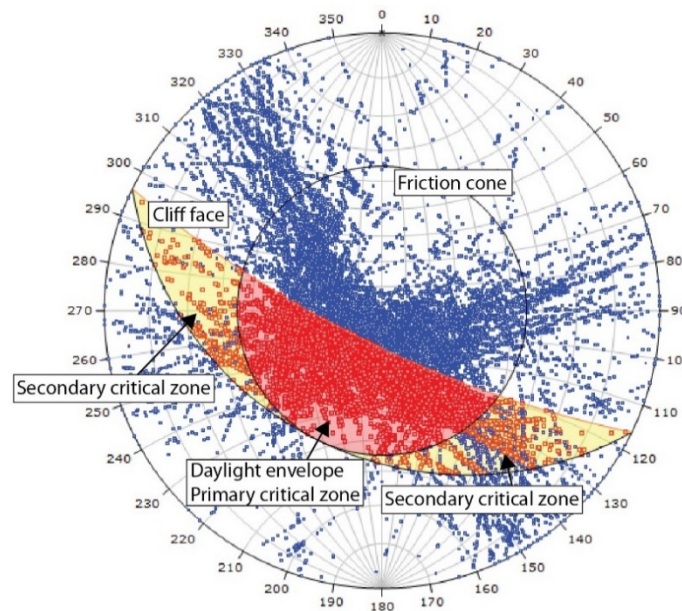
Percentage of mapped intersections favourable to mode:

- Wedge - 39.97%
  - 27.82% (primary)
  - 12.15% (secondary)
- Planar – 7.16%
- Flexural – 0.31%

Symbol	Feature			
•	Critical Intersection			
•	Intersection			
<b>Kinematic Analysis</b> Wedge Sliding				
Slope Dip 76				
Slope Dip Direction 206				
Friction Angle 35°				
		<b>Critical</b>	<b>Total</b>	<b>%</b>
	Wedge Sliding	15946	39899	39.97%
<b>Plot Mode</b> Pole Vectors				
<b>Vector Count</b> 283 (283 Entries)				
<b>Intersection Mode</b> Grid Data Planes				
<b>Intersections Count</b> 39899				
<b>Hemisphere</b> Lower				
<b>Projection</b> Equal Angle
