Basally Reinforced Platforms for Piled Embankments –

Two Case Studies:

A421 M1 Junction 13 to Bedford Improvements, UK Martin Curd, Scott Wilson Ltd

N210, Netherlands Hartmut Hangen, Huesker GmbH

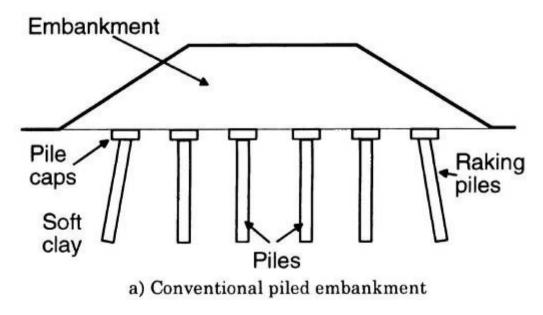
⁽Fig 66a from BS8006)

Relies solely on arching in embankment fill, can lead to punching failure where the piles punch through into the embankment fill. Consideration required to ensure the edge piles can take the lateral loads imposed by lateral thrust in the embankment, i.e. stronger piles or raking piles.

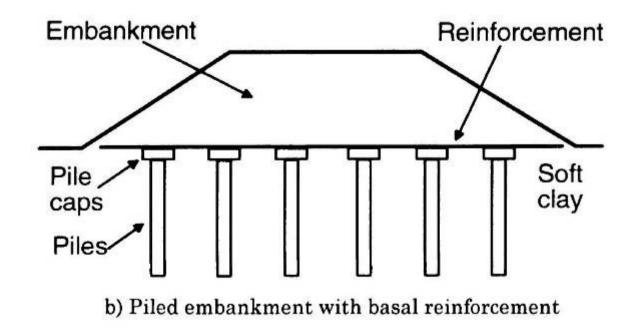
(Fig 66b from BS8006)

Relies on soil arching in the embankment and membrane action within the reinforcement. The reinforcement takes the lateral embankment thrust loads so raking piles not required.

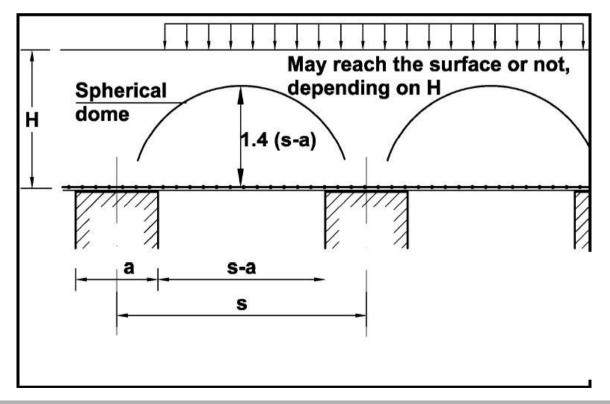
General Mechanism of Piled Embankments with Reinforcement

• Arching Mechanism

(as BS8006 1997)

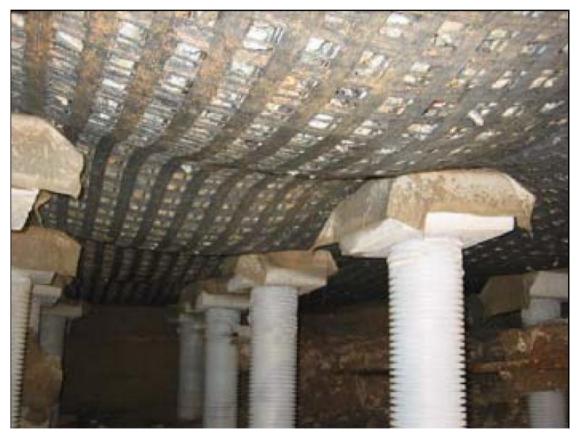
General Mechanism of Piled Embankments with Reinforcement

• Membrane action mechanism

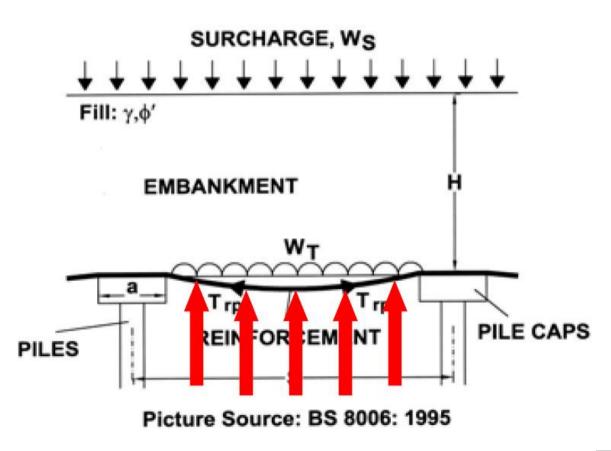
General Mechanism of Piled Embankments with Reinforcement

Counter pressure – subsoil support acting to resist the formation of hammocks in the reinforcement

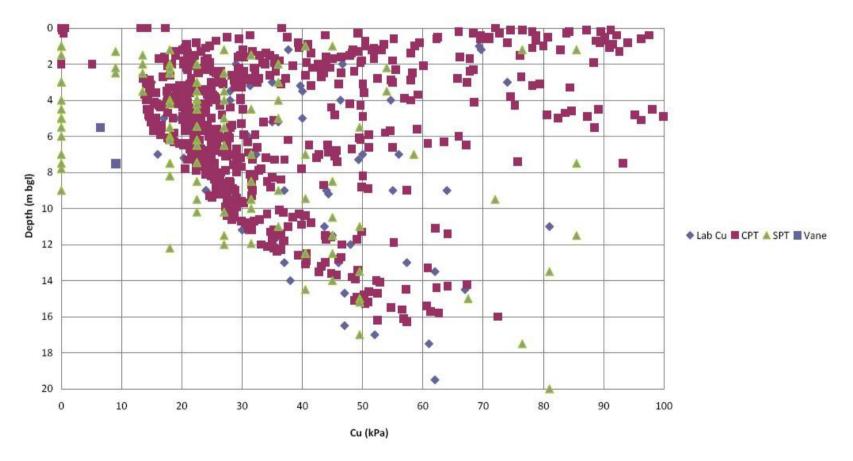
Brogborough Lake Made Ground Undrained Shear Strength

Brogborough Lake -Undrained Shear Strength

Made ground consisting of soft clay to depths up to 20m:

- Desiccated crust
- Soft clay, increasing in stiffness below around 8m depth
- Oxford Clay Formation

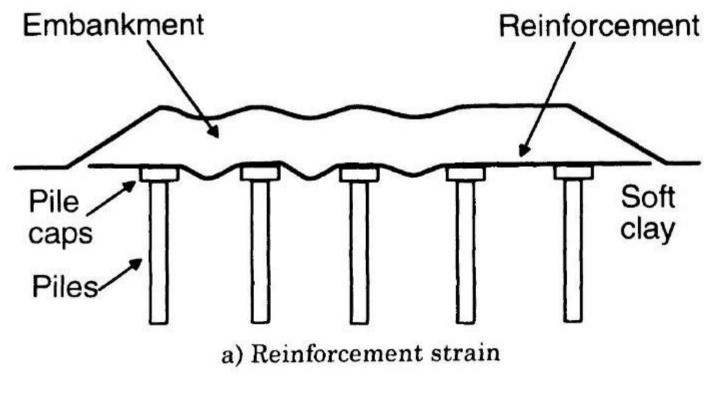
Fig 68a from BS8006

BS 8006 – limit strain / deformation

Low Embankment Heights: Maximum Design Strain 3%

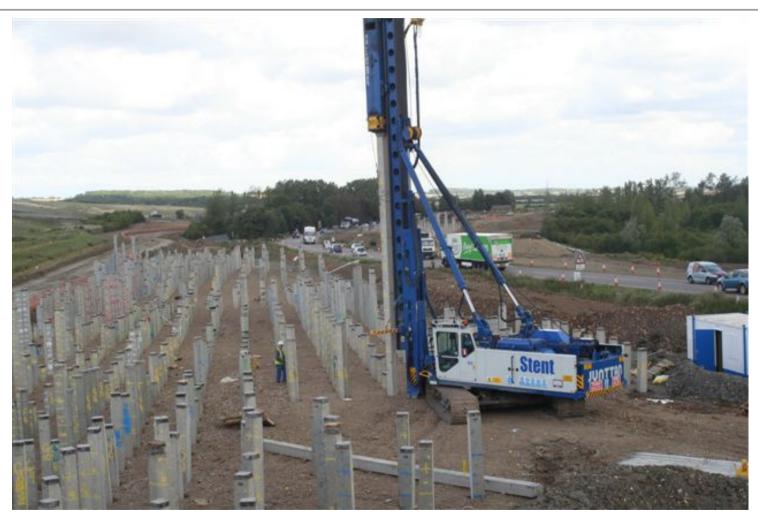
Construction - Driving Piles

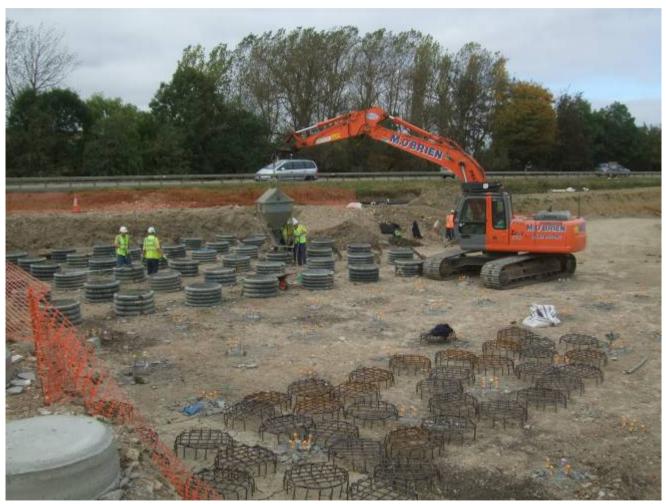
Construction - Casting Pile Caps

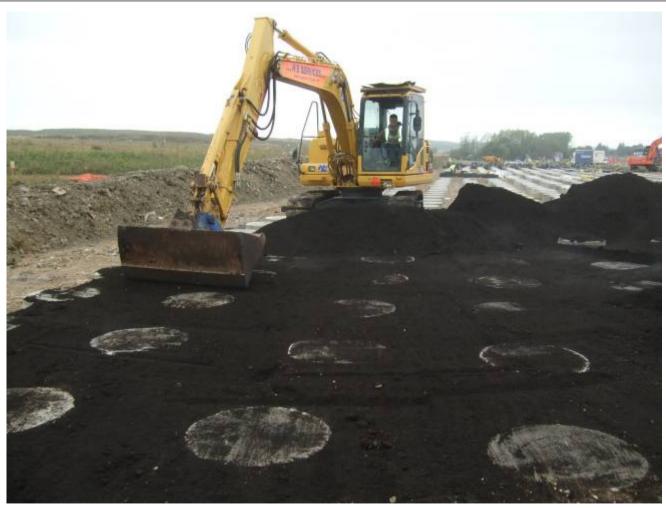
Construction - Placing Compost Between Pile Caps

Fill between pile caps needs to be:

- Sufficiently stiff to allow the reinforcement to be placed flat and without sagging
- Compressible enough to allow rapid deflection under load.

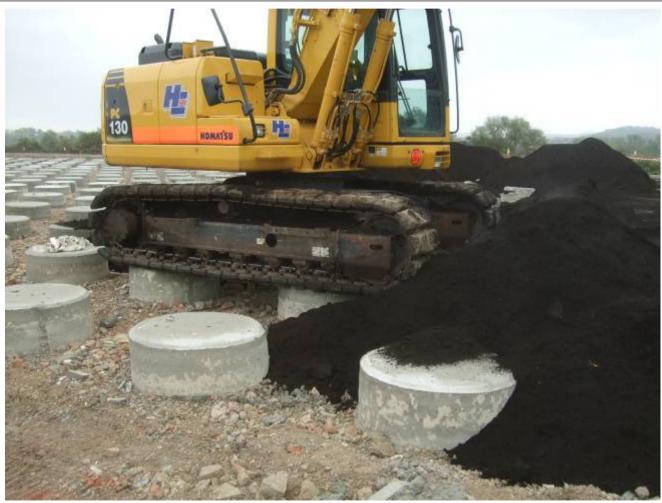
Construction - Excavator Tracks on Pile Caps

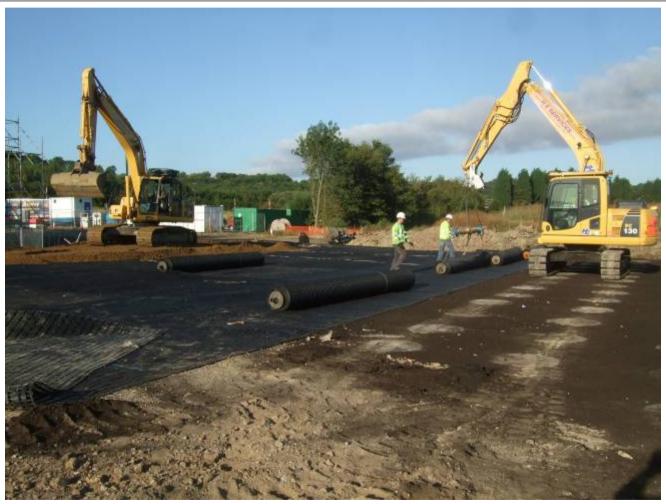
Construction - Rolling Out Reinforcement

- Lay the reinforcement flat and even
- Adequate anchoring of reinforcement
- Allow reinforcement to form hammocks during construction – minimise counter pressure: use compressible fill.

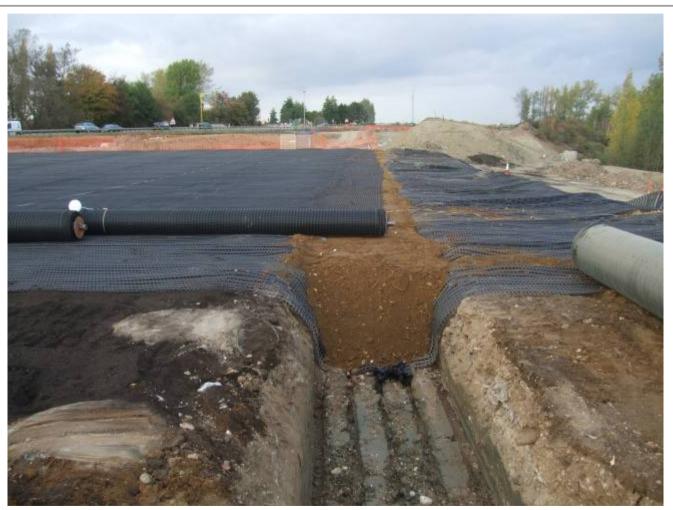
Construction - Anchor Trench

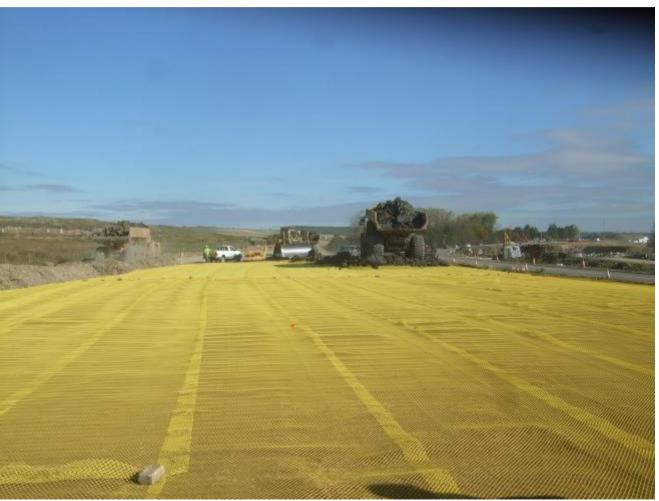
Construction - High-Visibility Warning Layer
